Foundation Report for Log Fill Repair Wall dated October 2, 2014

Date: October 2, 2014
File: 01-DN-101-PM 17.5
EFIS ID: 0112000112
Retaining Wall No.: 01E0016

Subject: Foundation Report for Log Fill Repair Wall

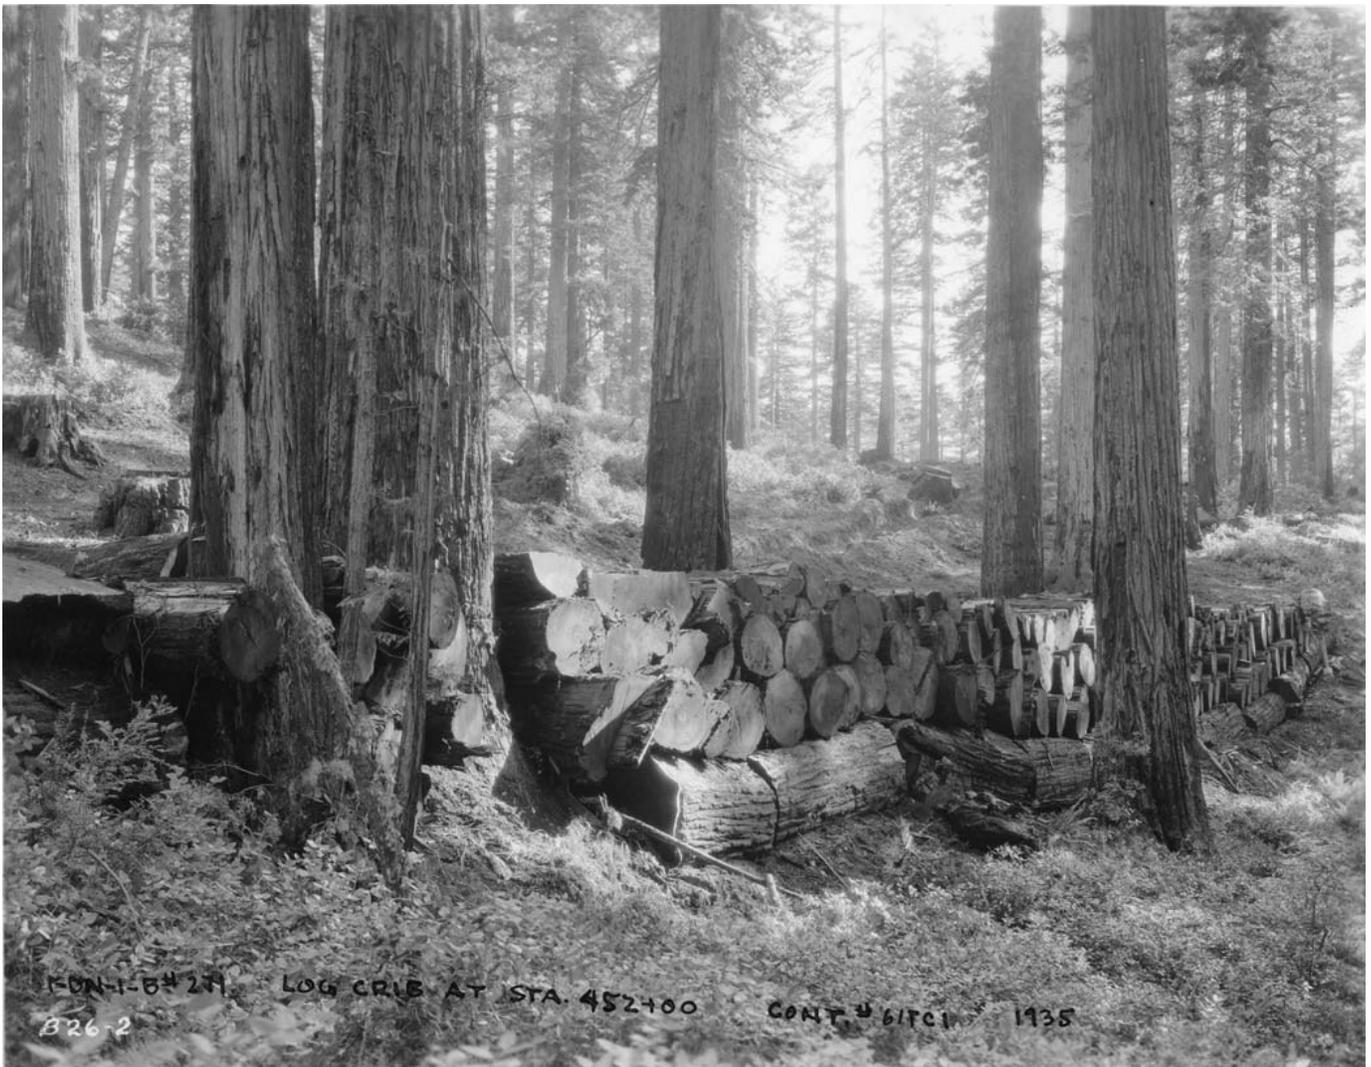
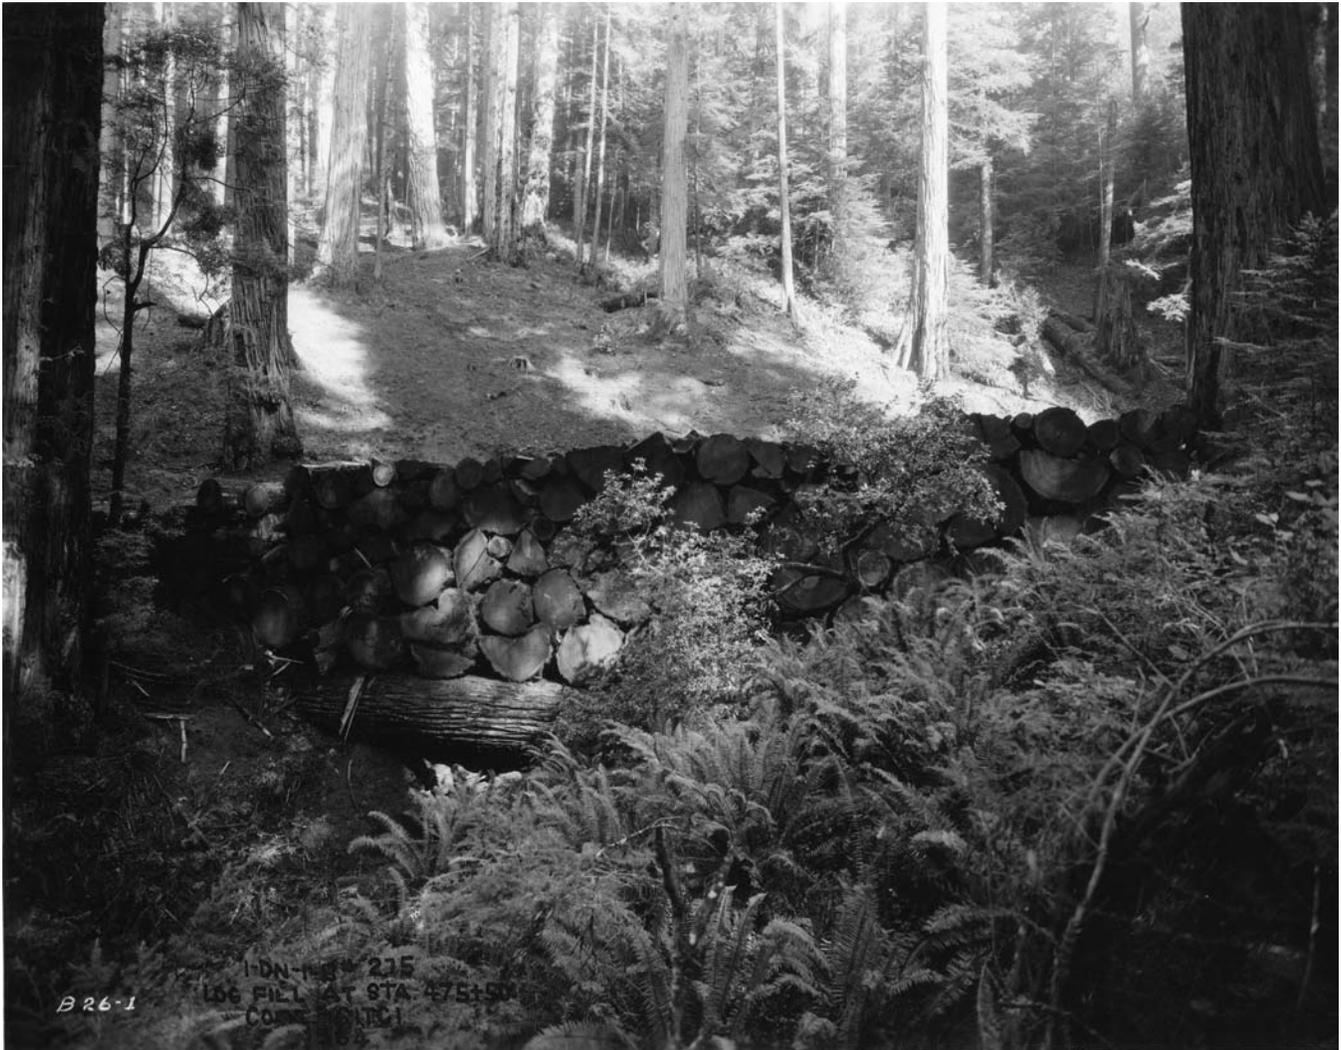
Construction photos of typical log fill structures from the 1933 highway construction are shown

The slope failure is characterized as a fill failure of the log fill probably caused by deterioration of the logs in the roadway fill. At this location, District 1 plans to construct a soldier pile wall with ground anchors to repair the failing slope and support the roadway. The project scope includes restoring the tangent alignment, shoulder widening, and associated minor drainage improvements. The cross culverts located at PM 17.41 and 17.51 will be replaced. A location map showing the project location (Figure 1) and a Site Plan (Figures 2A and 2B) are attached.

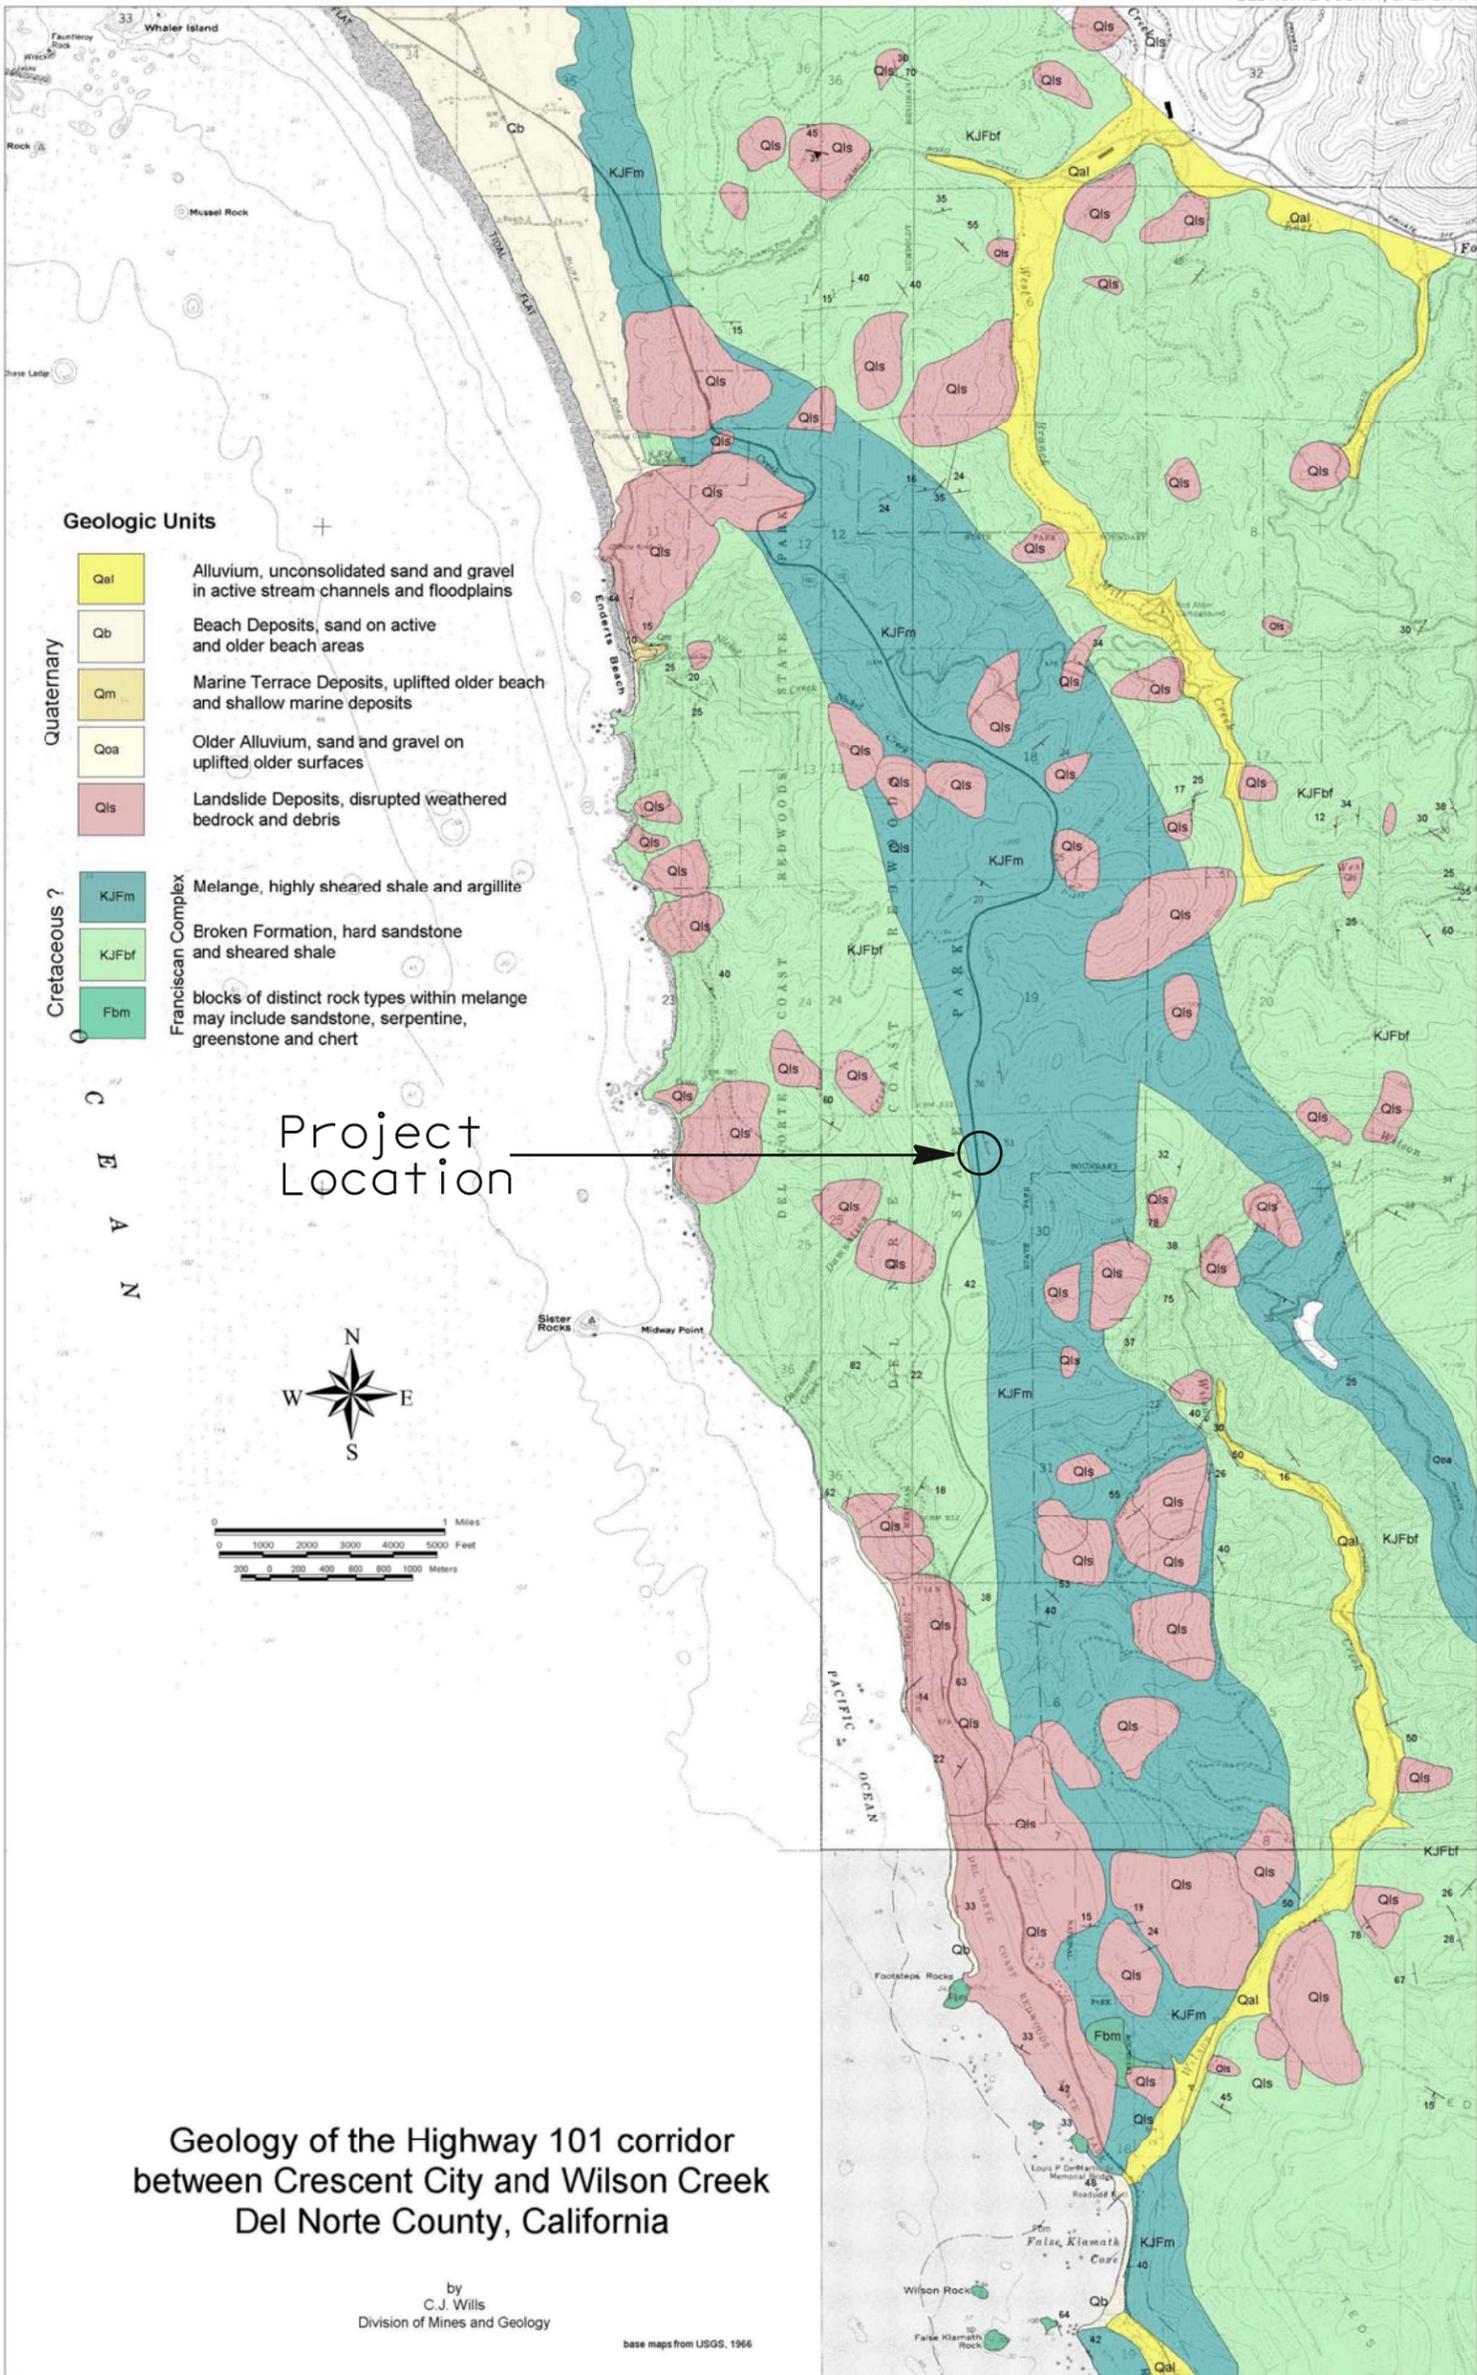
**FIGURE 3
GEOLOGIC MAP**

A geologic map of the area is provided in Figure 3. Bedrock within the project limits is mapped as Franciscan Mélange (KJfm) consisting of highly sheared shale and argillite near the contact with Cretaceous to Jurassic age rock of the Franciscan Broken Formation (KJfbf) consisting of hard sandstone and sheared shale.

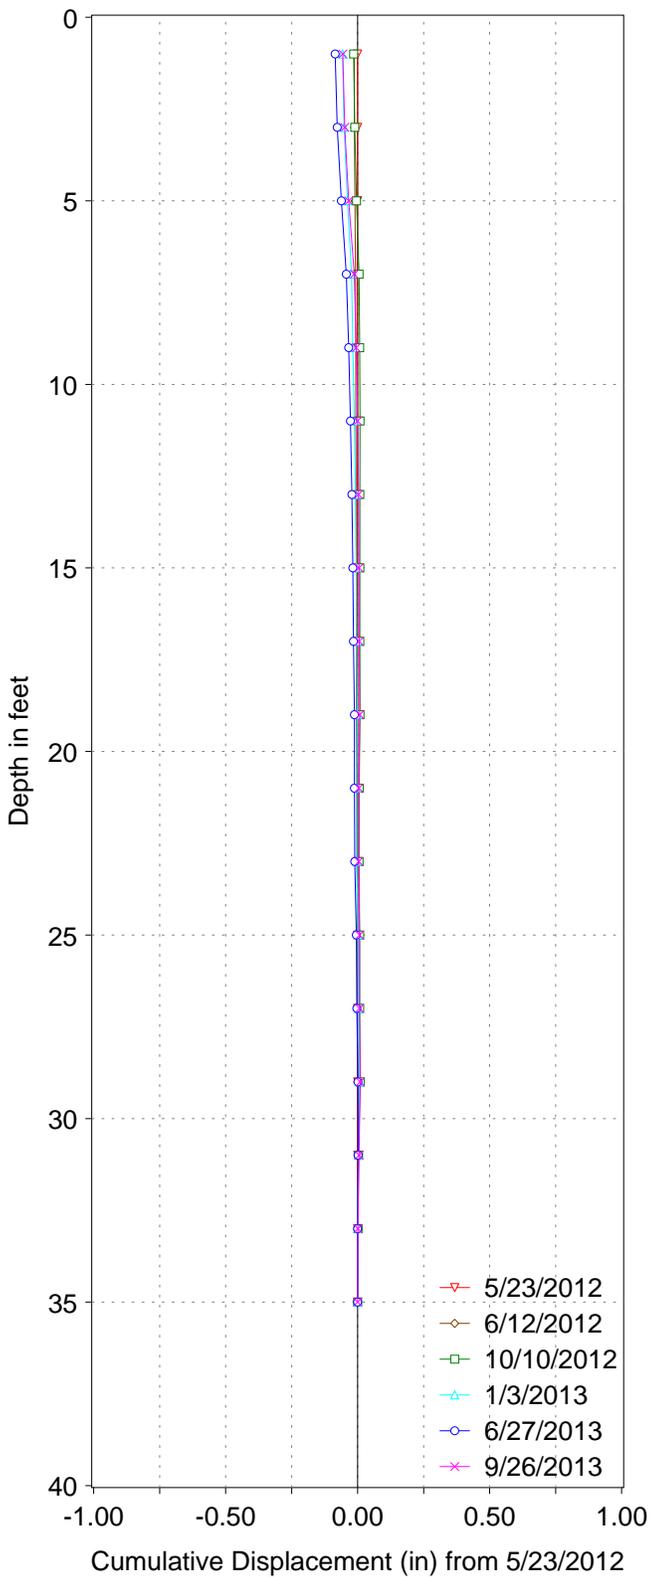
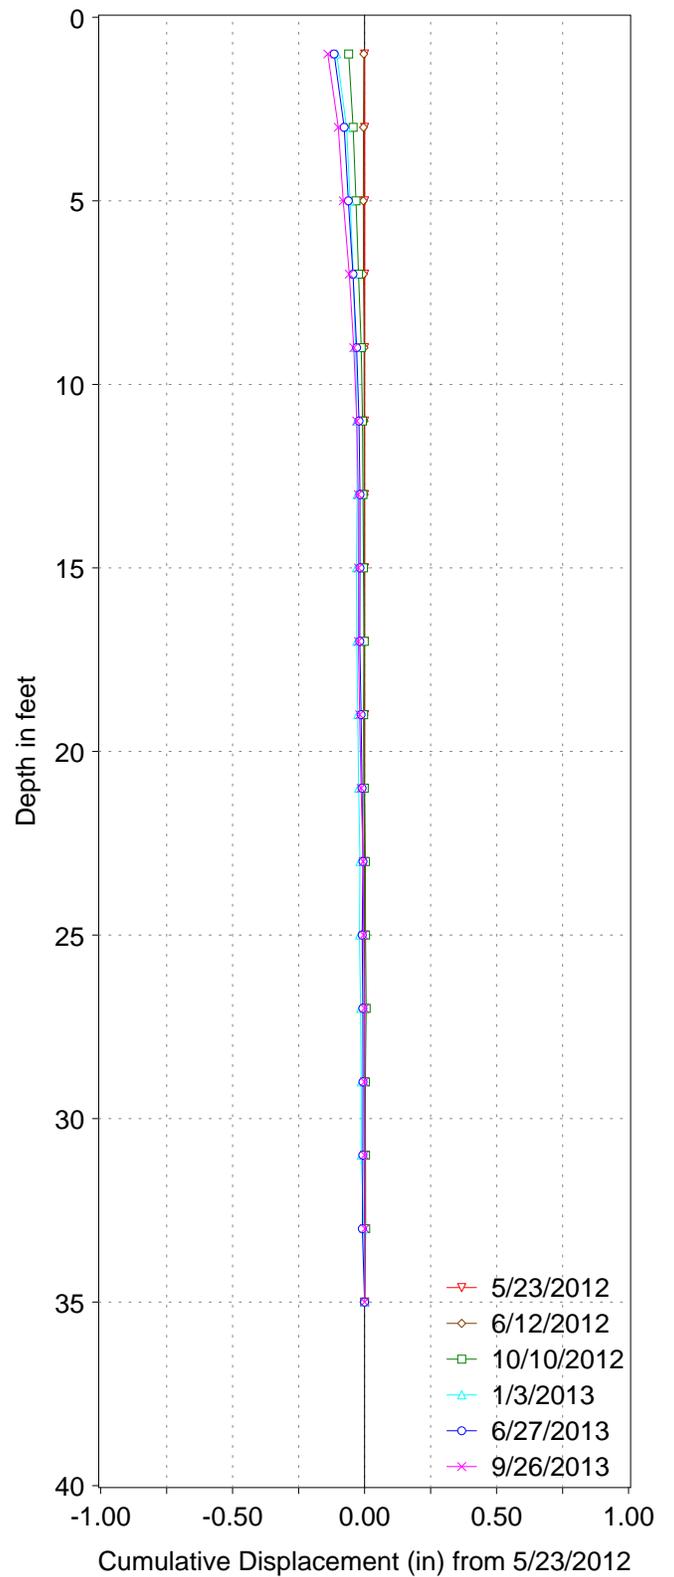
RESULT OF SI MONITORING
 01-DN-101-PM17.5
 Site: Humboldt Crossing RC-12-001
 E.A.: 0112000112/230

I.D.	STATION/ OFFSET ("A" LINE)	DEPTH OF BORING (ft, bgs)	SURFACE ELEVATION (ft, MSL)	DATE COMPLETED	DEPTH TO TKfs ROCK (ft, bgs)	DEPTH TO FAILURE SURFACE (ft, bgs)
RC-12-001	263+24.48 LT 17.48'	40	1061.57	5/15/2012	20	N/A

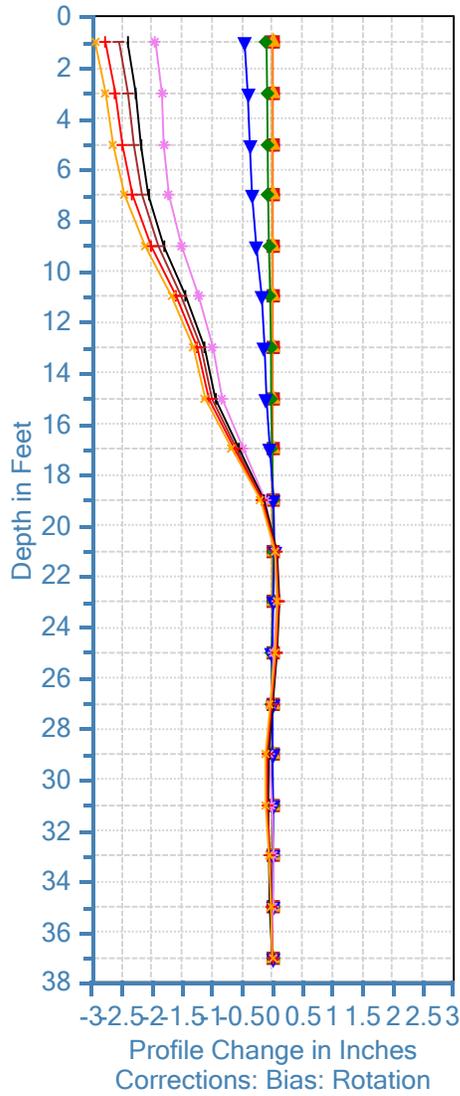
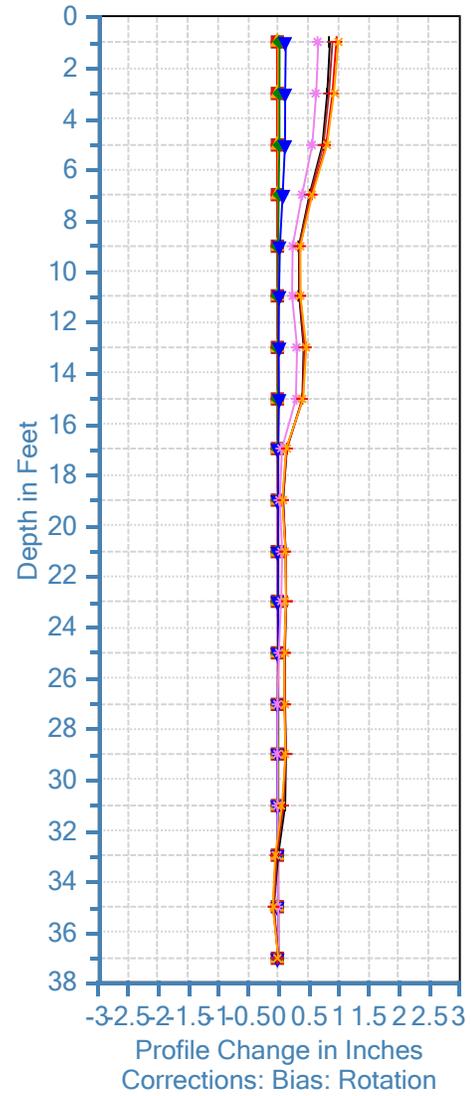
RESULT OF SI MONITORING

I.D.	STATION/ OFFSET ("A" LINE)	DEPTH OF BORING (ft, bgs)	SURFACE ELEVATION (ft, MSL)	DATE COMPLETED	DEPTH TO TKfs ROCK (ft, bgs)	DEPTH TO FAILURE SURFACE (ft, bgs)
RC-12-002	263+36.35 LT 22.23'	40	1061.70	5/16/2012	28	20
RC-12-003	262+40.15 LT 14.15'	60	1058.01	5/17/2012	21	N/A
RC-12-004	263+19.58 LT 25.50'	50	1059.71	5/17/2012	30 ²	12
RC-12-005	261+39.65 LT 17.48'	60	1053.14	6/13/2012	23	8
RC-13-006 ¹	261+89.65 RT 16.25'	65	1055.4	5/08/2013	15	N/A
RC-13-007 ¹	261+89.65 LT 16.55'	99	1055.5	5/16/2013	41.5	22
RC-13-008 ¹	263+49.66 LT 14.16'	50	1062.0	5/22/2013	30 ²	N/A
RC-13-009 ¹	260+92.35 LT 22.47	60	1050.3	5/22/2-13	28	N/A
