INFORMATION HANDOUT

At Paradise Valley Maintenance Station in San Bernardino County

**ASBESTOS AND DETERIORATED LEAD-CONTAINING PAINT SURVAY
REPORT**

Subject: ASBESTOS AND DETERIORATED LEAD-CONTAINING PAINT SURVEY
REPORT
CALTRANS MAINTENANCE YARD
6690 LA CONTENNA ROAD
YUCCA VALLEY, CALIFORNIA

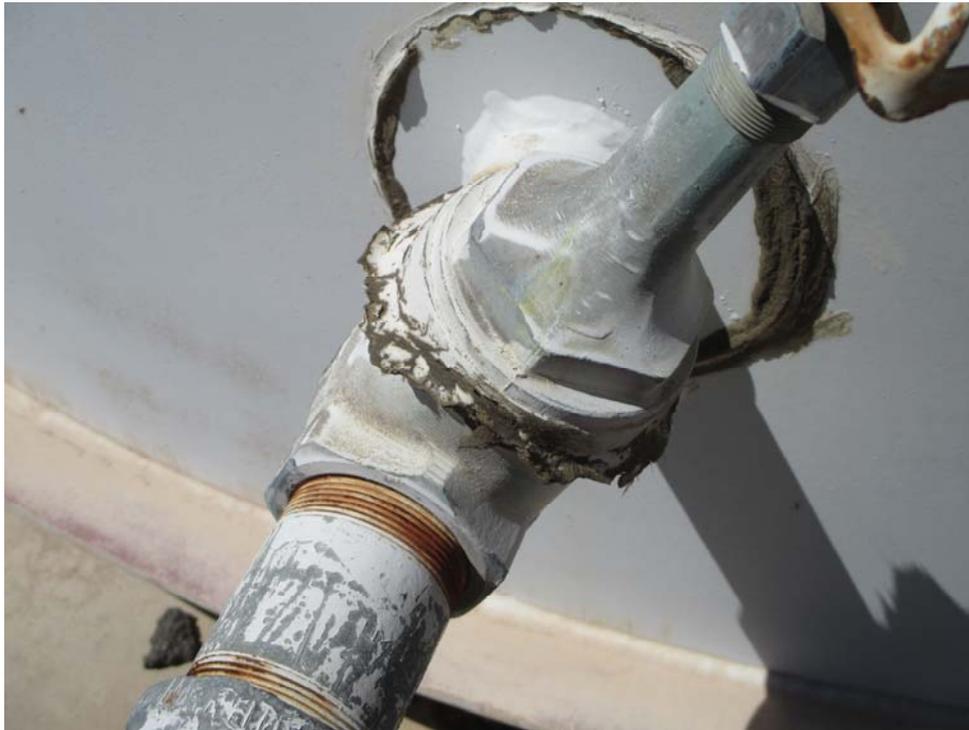
Chrysotile asbestos at a concentration of 25% was detected in three samples (sample group 1-3) representing approximately 3 square feet of nonfriable sealant located on various pipe threads/joints and locations on the water tank.

Photo 3 – View of ACM sealant on the water tank.

Mojave Desert Air Quality Management District (MDAQMD) regulations require that the asbestos-containing sealant on the water tank and white/gray sealant on the emulsion tank, (NESHAP Category I nonfriable/nonhazardous material) identified during our asbestos survey be removed and disposed of prior to renovation or demolition activities that would disturb the material. This material can be disposed of as non-hazardous waste. However, *disturbance* of the material is still covered by the Cal/OSHA asbestos standard (Title 8, CCR Section 1529).

We recommend the notification of contractors (that will be conducting demolition, renovation, or related activities) and/or facility occupants of the presence of asbestos in their work areas (i.e., provide the occupants and contractor[s] with a copy of this report and a list of asbestos removed by asbestos abatement contractor[s] during subsequent abatement activities). Contractors should be instructed not to disturb asbestos during their work.

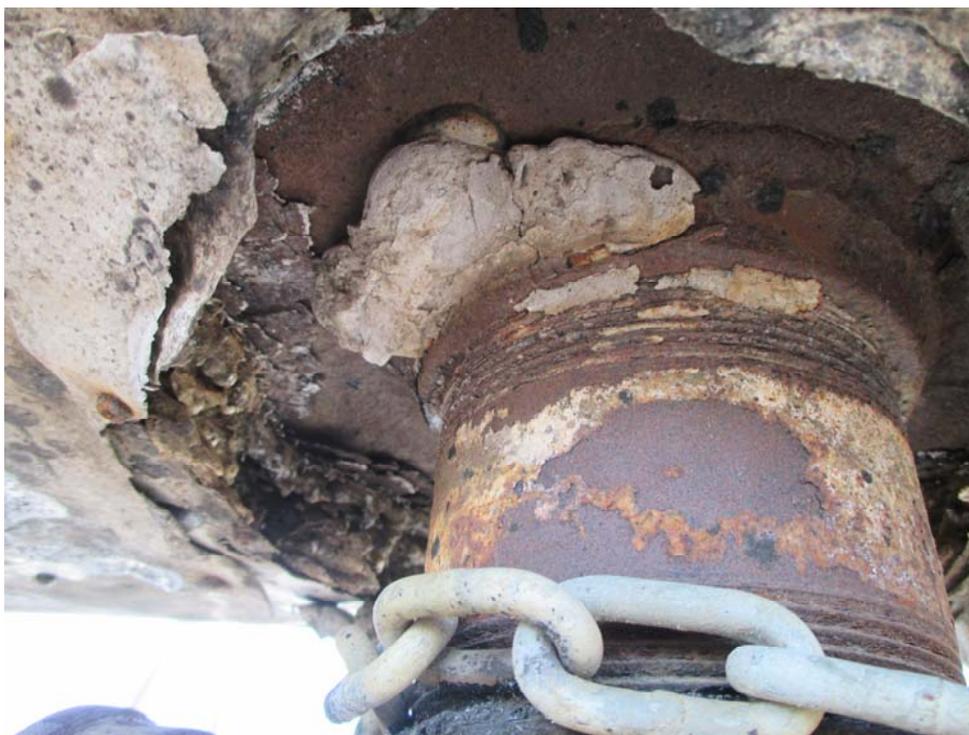
Chrysotile asbestos at concentrations ranging from 5-10% was detected in three samples (sample group 10-12) representing approximately 5 square feet of nonfriable white/gray sealant located on several seams and the opening at the bottom of the emulsion tank.

Photo 4 – View of ACM white/gray sealant on bottom of the emulsion tank.

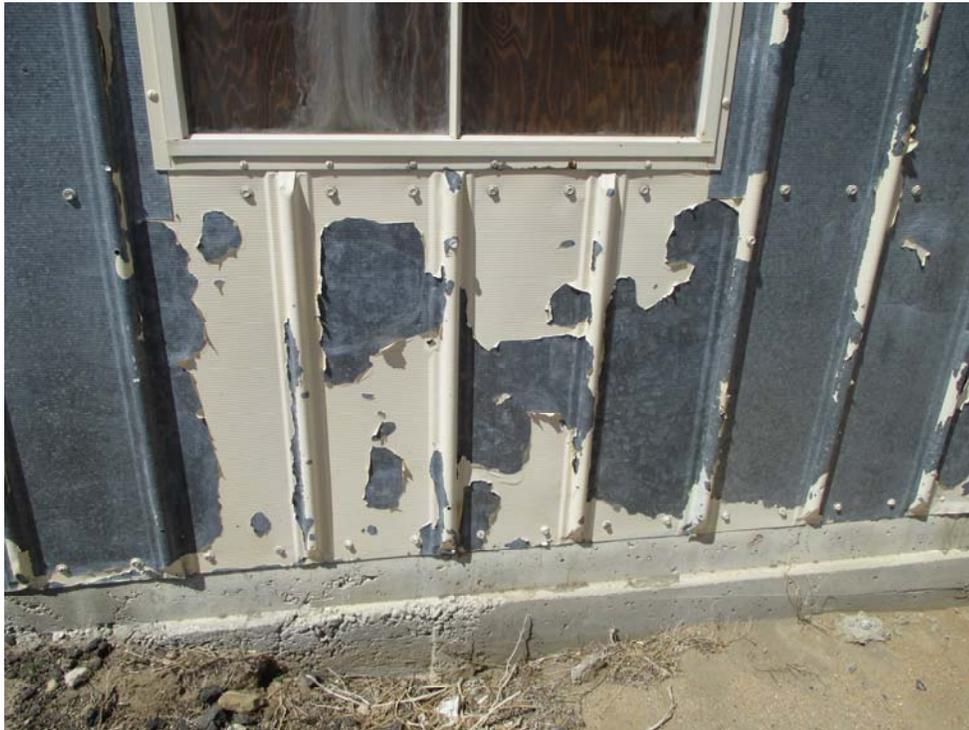
A sample representing approximately 200 square feet of deteriorated yellow paint on the metal exterior walls of the water pump shed exhibited a total lead concentration of 1.7% by weight, or 17,000 mg/kg.

Subsequent analysis of the sample indicated a TCLP lead concentration of 8.5 mg/l.

The deteriorated yellow exterior paint located on the water pump shed would be classified as California and RCRA hazardous based on lead content.

Photo 5 – View of deteriorated LCP on the exterior of the water pump shed.

Deteriorated paints classified as RCRA and/or California hazardous waste must be removed and disposed of prior to renovation, demolition, or other activities that would disturb them. We recommend that the contractor be required to use personnel who have lead-related construction certification as supervisors or workers, as appropriate, from the California DPH for any LCP removal work. Loose and peeling/flaking LCP classified as RCRA and/or California hazardous waste require removal prior to demolition for waste segregation purposes: to separate potentially hazardous waste (Category III concentrated lead such as loose paint, paint sludge, vacuum debris, and vacuum filters) from non-hazardous demolition debris (Category II intact lead-painted architectural components such as doors, windows, framework, cladding, and trim). Category I waste is low lead waste (typically non-hazardous) such as construction materials, filtered wash water, and plastic sheeting. Contractors are responsible for informing the landfill of the contractor's intent to dispose of RCRA waste, California hazardous waste, and/or architectural components containing intact LCP. Some landfills and recycling facilities may require additional waste characterization. Contractors are responsible for segregating and characterizing waste streams prior to disposal.

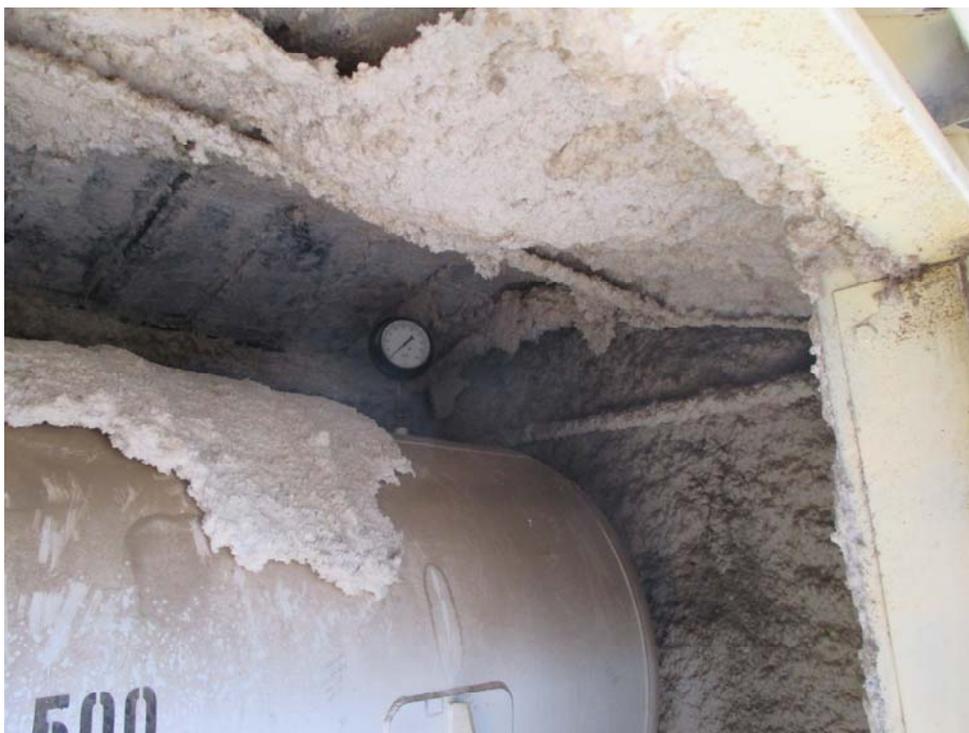
Photo 6 – View of non-asbestos insulation in the water pump shed.
