# **INFORMATION HANDOUT**

**GEOTECHNICAL DESIGN REPORT**

**ROUTE: 08-SBd-40-R151.7/R153.3**

Subject : Geotechnical Design Report

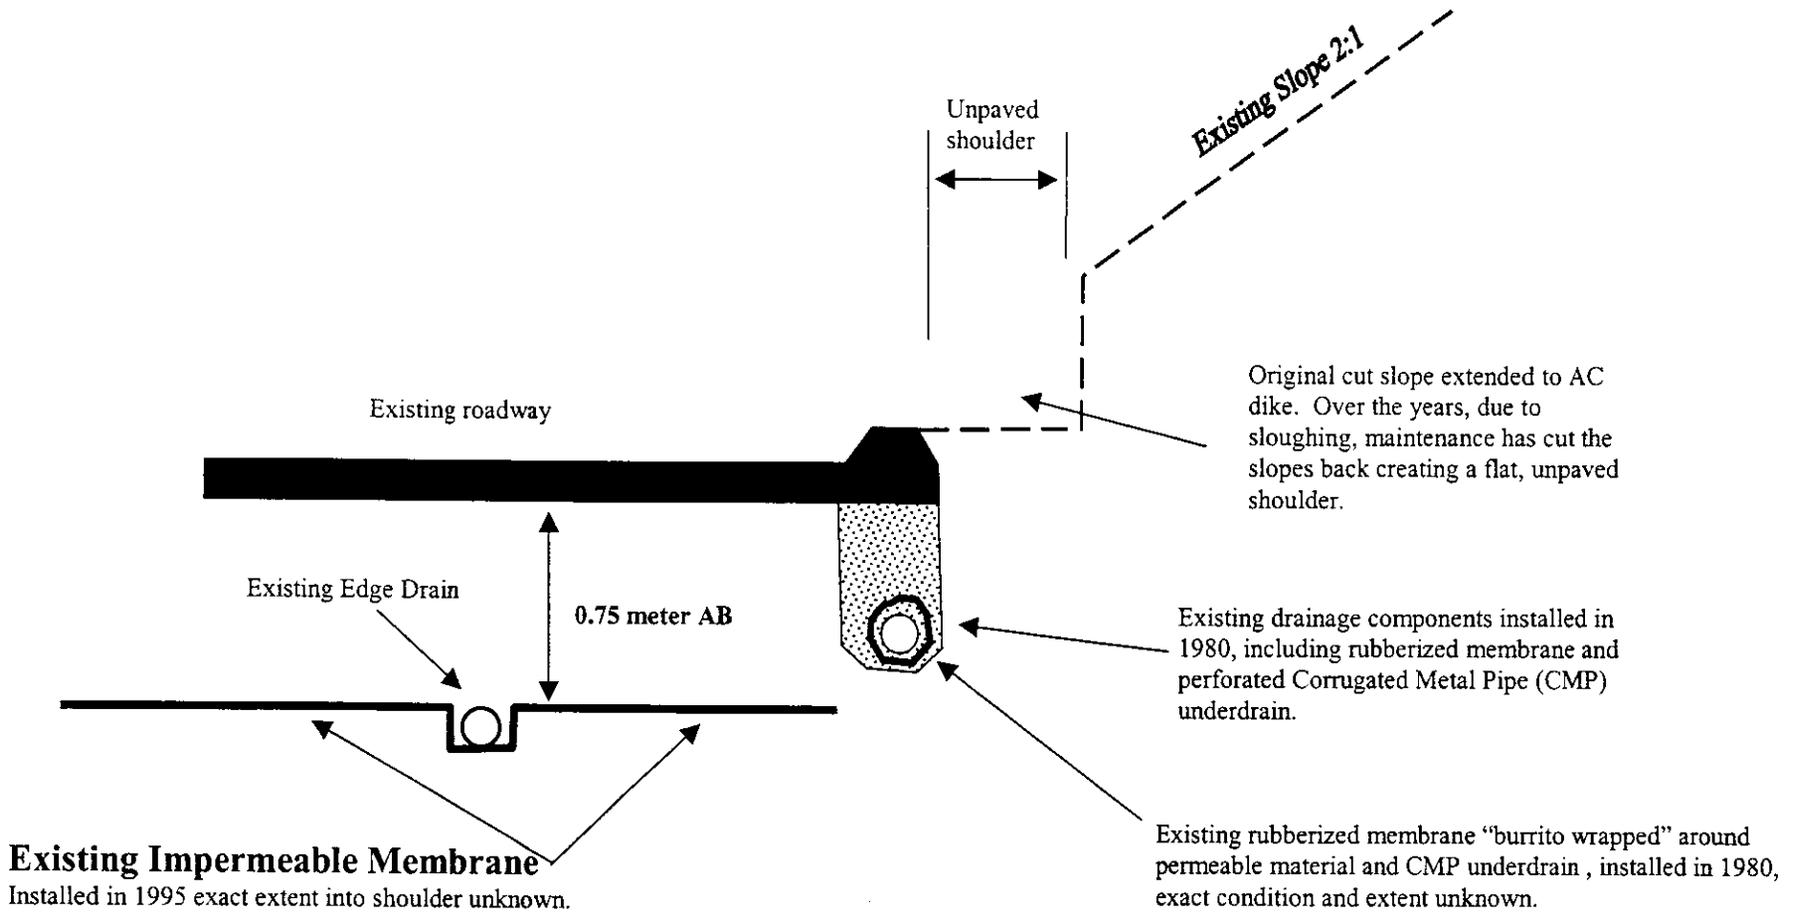
More recently, as sloughing material has fallen onto the paved shoulder following rain events, the unpaved shoulders have been cut back vertical, producing a flat unpaved shoulder ideal for rain runoff to pond, percolate into the soil, and migrate through the permeable base materials an reach the expansive clays below.

**FIGURE 2.** Schematic of assumed existing conditions along cut sections of Route 40 approximately between post miles 152+00 and 153+00.

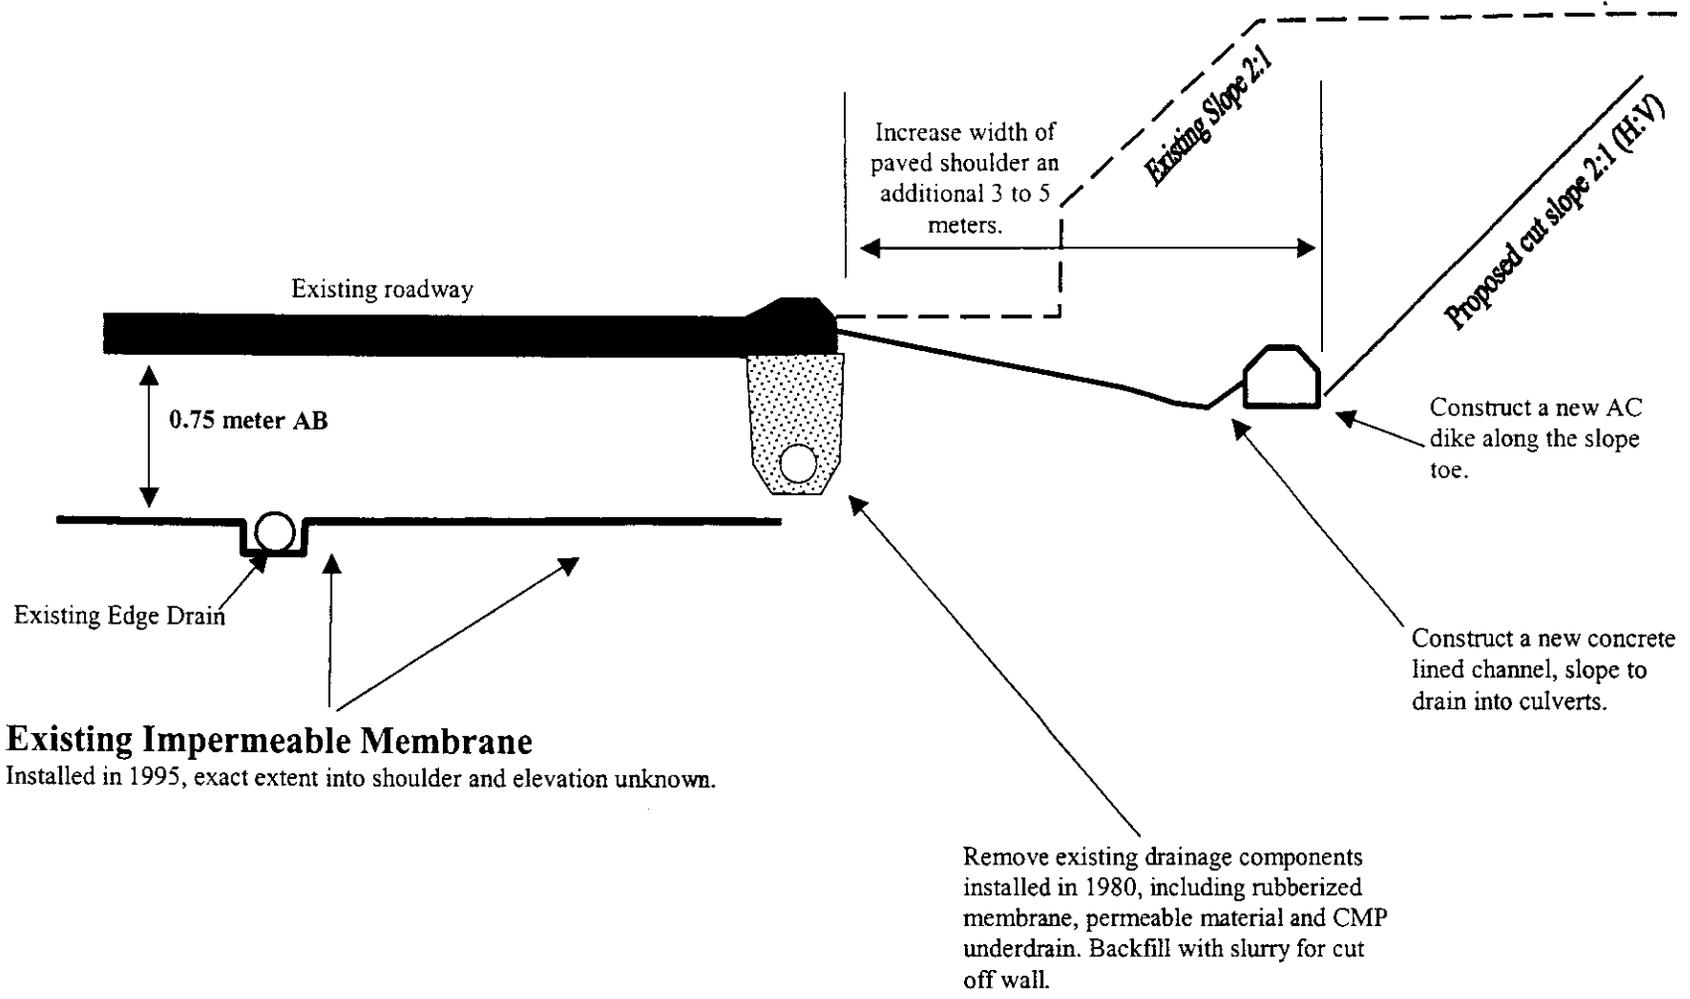
**FIGURE 3. Schematic of Alternative 1 –Remove underdrain, widen paved shoulders and provide slurry cut off wall.**

1. Widen existing paved shoulders in cut sections by 4 meters increasing paved shoulder to a total of 7 meters. The paved shoulder should slope down and away from the roadway at 5% to a new drainage system. See Schematic 1.
2. Place impermeable membrane so as to extend existing membrane to slope toe.
3. Provide under drain system at slope toe.
4. Alternative 1 may require the shoulders in fill sections to also be widened and existing culverts extended for safety reasons.

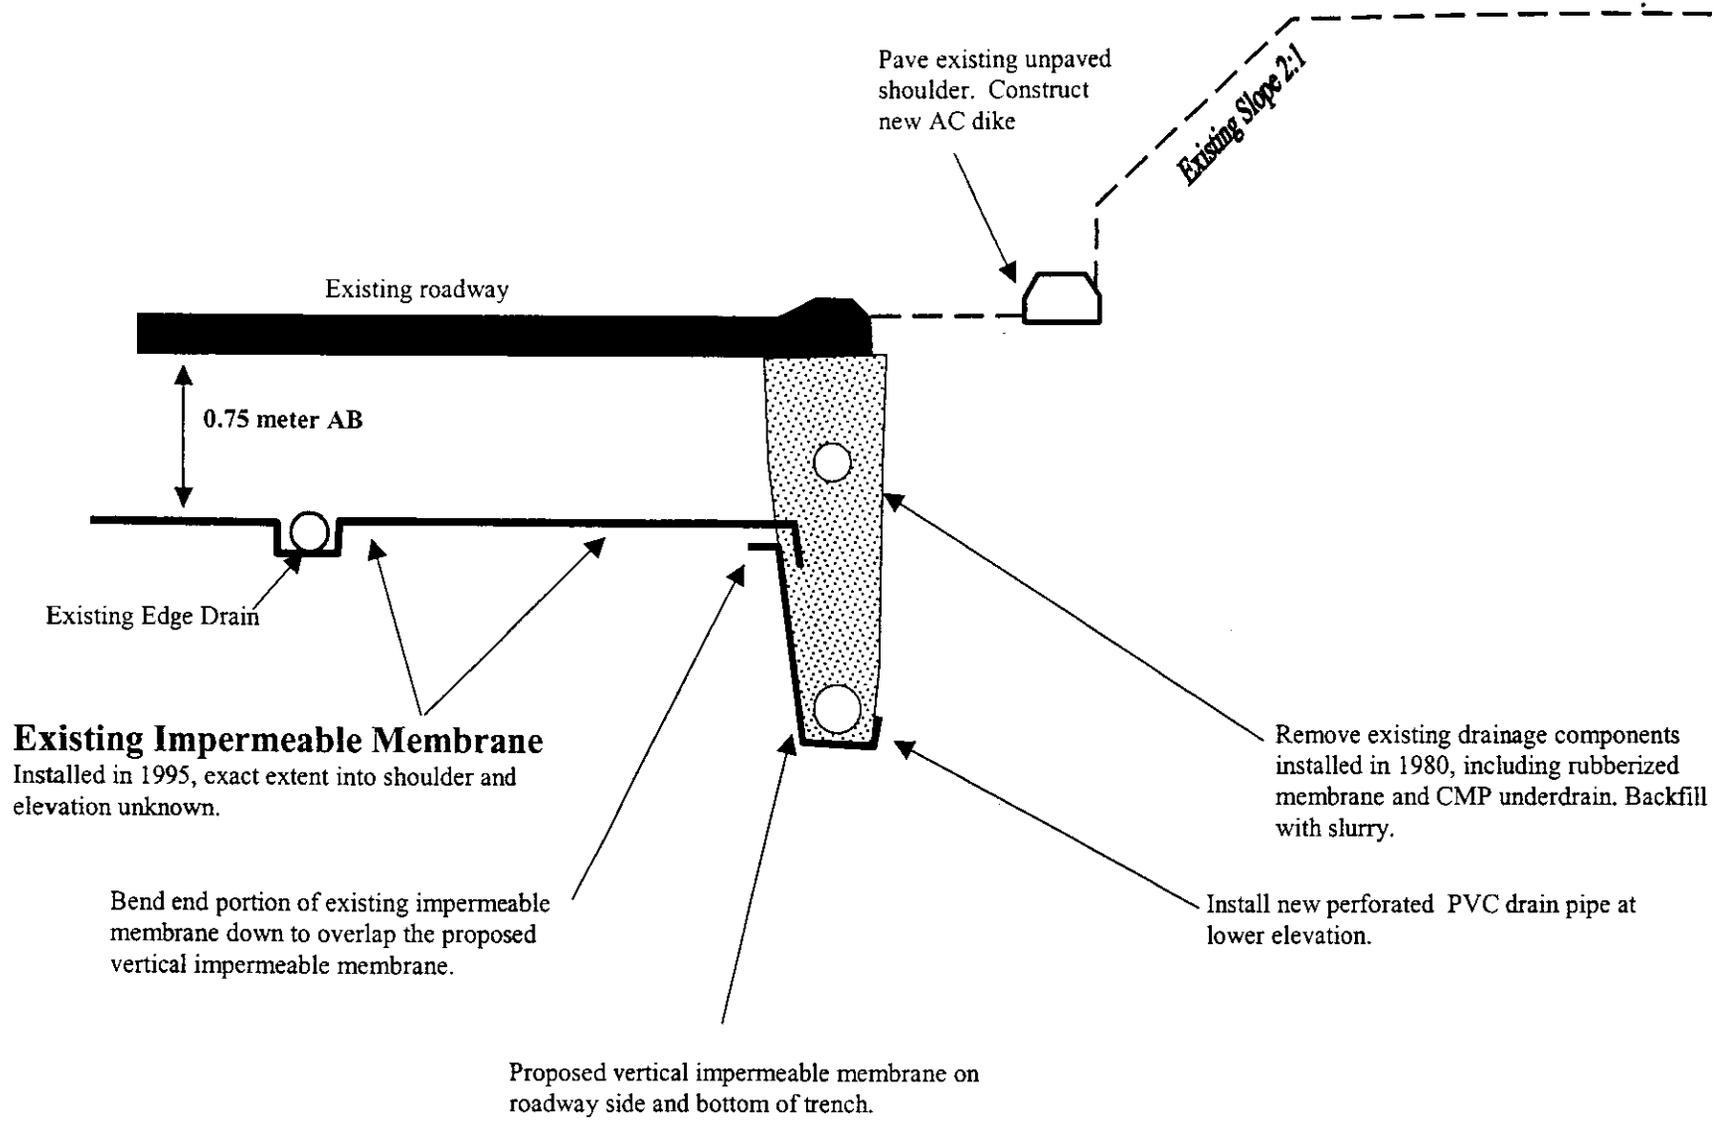
**FIGURE 4. Schematic of Alternative 2 – Replace underdrain with deeper underdrain, add vertical impermeable membrane.**

1. Excavate a 0.5 to 1.0 meter wide trench to a depth of 2 to 3 meters below the final profile grade in the paved shoulder. See Schematic 2.
2. Place impermeable membrane so that the existing impermeable membrane overlaps it. Extend membrane 0.5 meters vertically up the cut slope side of the trench.
3. Use engineering filter fabric to wrap or encapsulate the trench backfill material.
4. Place a perforated drainpipe in the bottom of the trench on top of the impermeable membrane.
5. Backfill trench using a non-expansive permeable material.

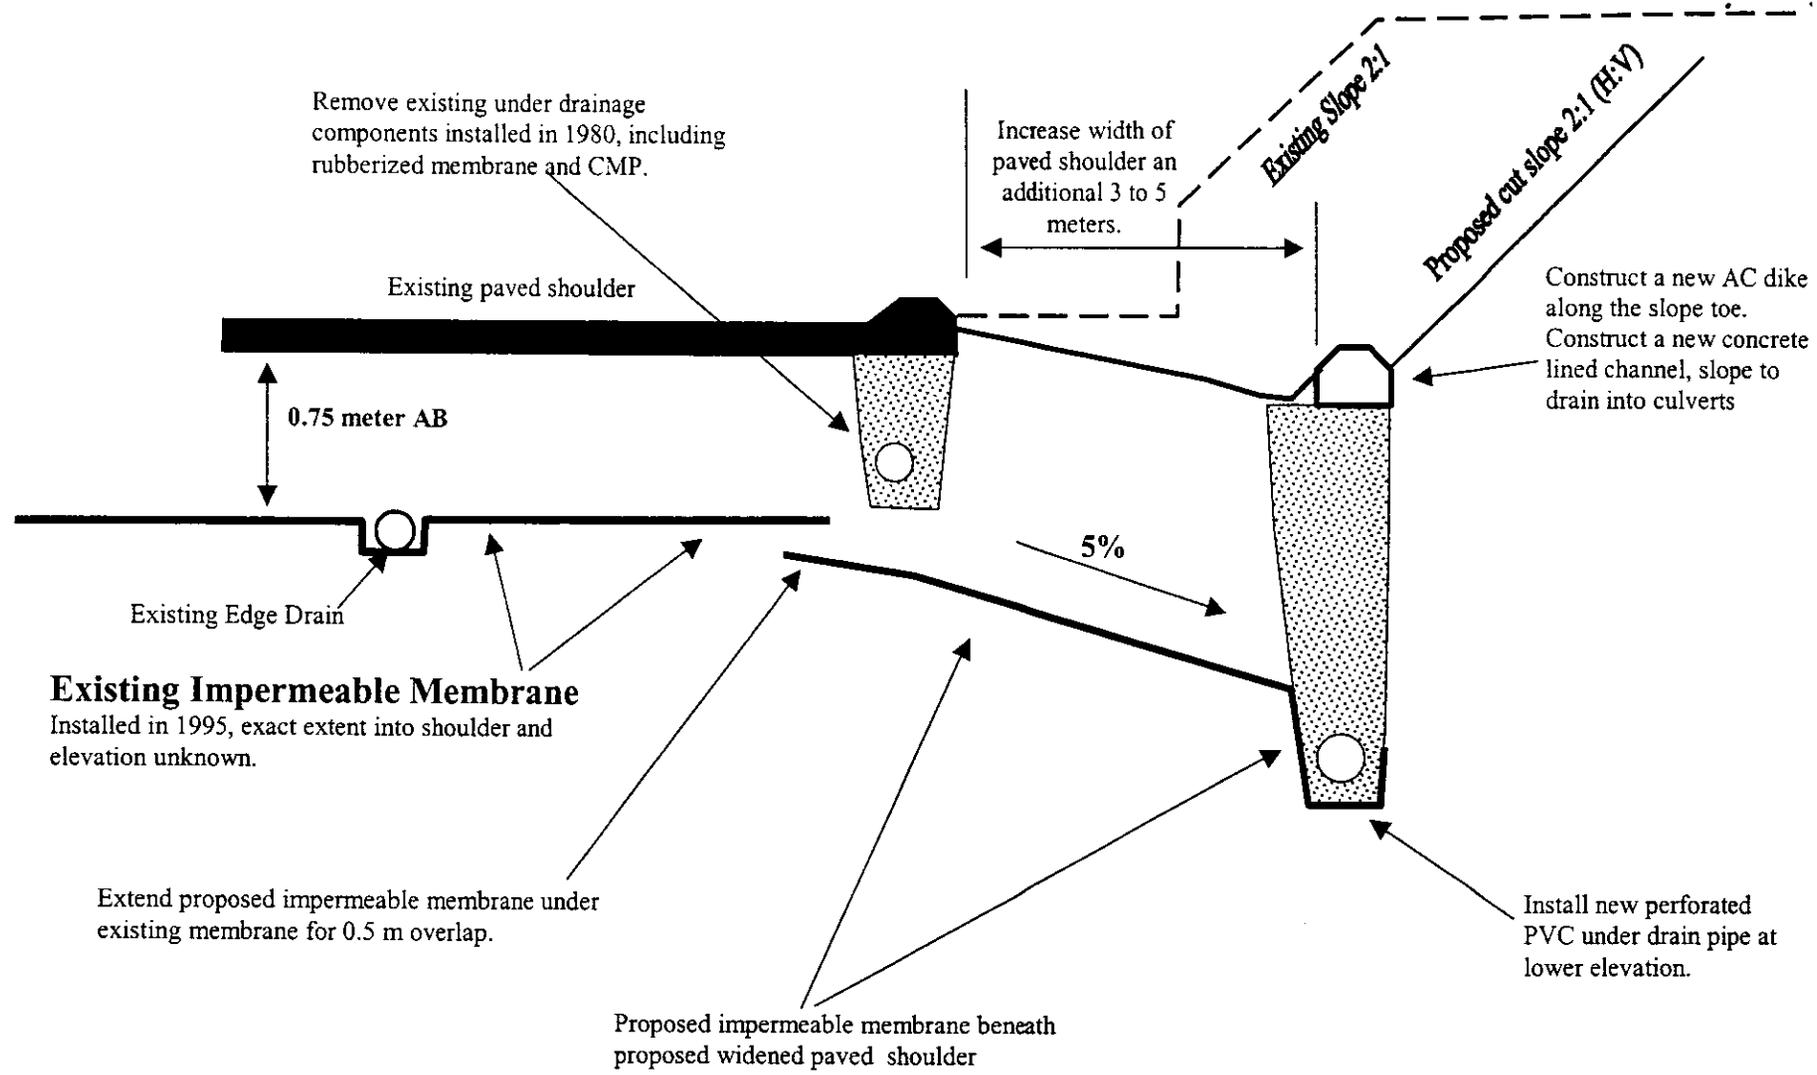
**FIGURE 5.** Schematic of Alternative 1A –Widen paved shoulders, replace drain with deeper drain, add vertical cut off trench lined with impermeable membrane.

1. Widen existing paved shoulders in cut sections. The paved shoulder should slope down and away from the roadway on a 5% slope to a new drain system. See Schematic 3.
2. Place impermeable membrane so as to extend existing membrane at least 7 meters beyond edge of traveled way
3. Excavate a 0.5 to 1.0 meter wide trench to a depth of 1.5 to 2 meters below the final profile grade in the paved shoulder, provide under drain system at slope toe and extend impermeable membrane.
4. Alternative 3 may require the shoulders in fill sections to also be widened and existing culverts extended.
