INFORMATION HANDOUT

ASBESTOS AND LEAD-CONTAINING PAINT SURVEY REPORT

**Tuolumne River Bridge (32-0018)
Tuolumne County, California**

FEBRUARY 2013

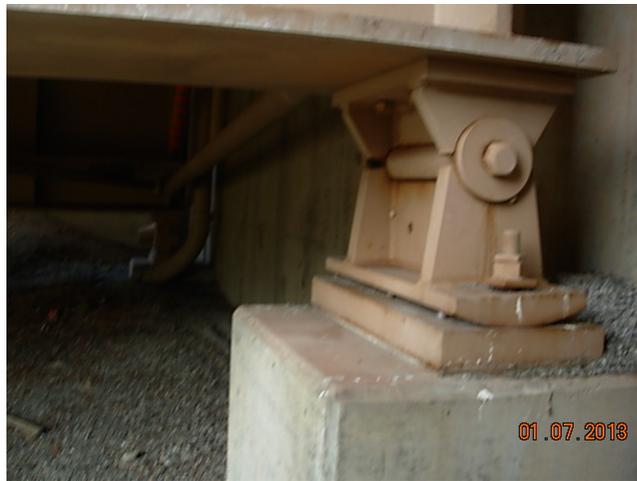
Two samples representing intact beige paint applied to steel members of the bridge exhibited total lead concentrations of 59,000 and 96,000 mg/kg, greater than the TTLC of 1,000 mg/kg. A composite of the two paint samples contained a TCLP soluble lead concentration of 30 mg/l, greater than the TCLP of 5 mg/l.

Photo 2 – Bridge bearings

LCP identified during our survey would be considered a California and Federal hazardous waste based on lead content if stripped, blasted, or otherwise separated from the substrate.

We recommend that all paints at the project location (graffiti, graffiti abatement, signage, etc.) be treated as lead-containing for purposes of determining the applicability of the Cal/OSHA lead standard during maintenance, renovation, and demolition activities. This recommendation is based on LCP sample results and the fact that lead was a common ingredient of paints manufactured before 1978 and is still an ingredient of some paints.

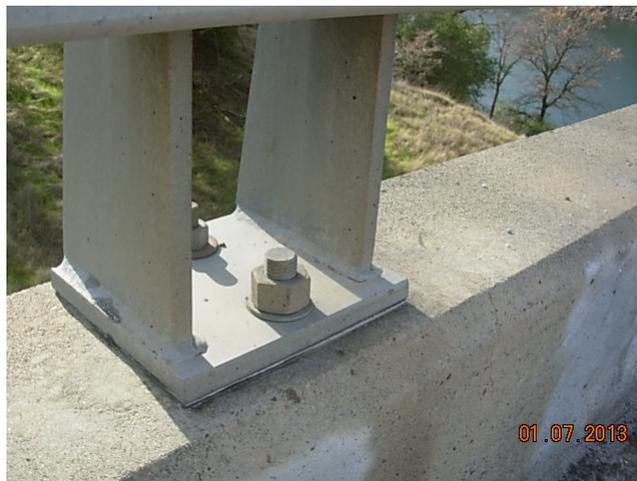
Chrysotile asbestos at a concentration of 70% was detected in samples representing nonfriable sheet packing used as barrier rail shims on the bridge. A thorough quantification of the shims was not possible due to safety concerns (i.e., traffic); however, it is our opinion that the total amount of asbestos sheet packing used on the bridge is less than 100 square feet.

Photo 3 – Bridge barrier rail assemblies

NESHAP regulations do not require that asbestos-containing sheet packing (a Category I nonfriable/nonhazardous material) identified during our survey be removed prior to renovation/demolition or be treated as hazardous waste. The sheet packing may also be reused or stored for subsequent reuse. However, activities causing *disturbance* of the sheet packing matrix (i.e., cutting, abrading, sanding, grinding, etc.) would require compliance with the Cal/OSHA asbestos standard (Title 8, CCR Section 1529).

We also recommend the notification of contractors (that will be conducting demolition, renovation, or related activities) of the presence of asbestos in their work areas (i.e., provide the contractor[s] with a copy of this report and a list of asbestos removed by contractor[s] during subsequent activities). Personnel not trained for asbestos work should be instructed not to *disturb* asbestos.

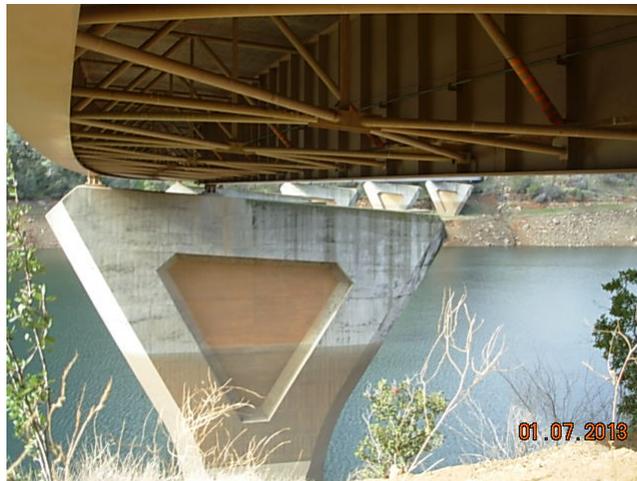
Photo 5 – Truss and girder system

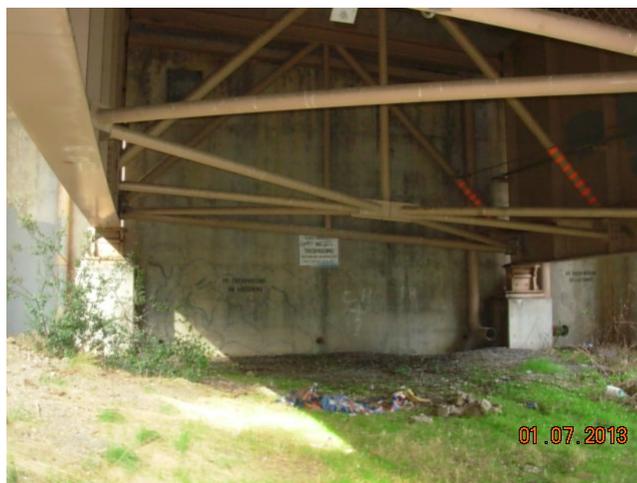
Photo 6 – West abutment
