# INFORMATION HANDOUT

For Contract No. 10-0X2104

# LIMITED ASBESTOS AND DETERIORATED LEAD-CONTAINING PAINT SURVEY REPORT

District 10 Maintenance Stations  
Camp Connell, Peddler Hill,  
and Woodfords, California

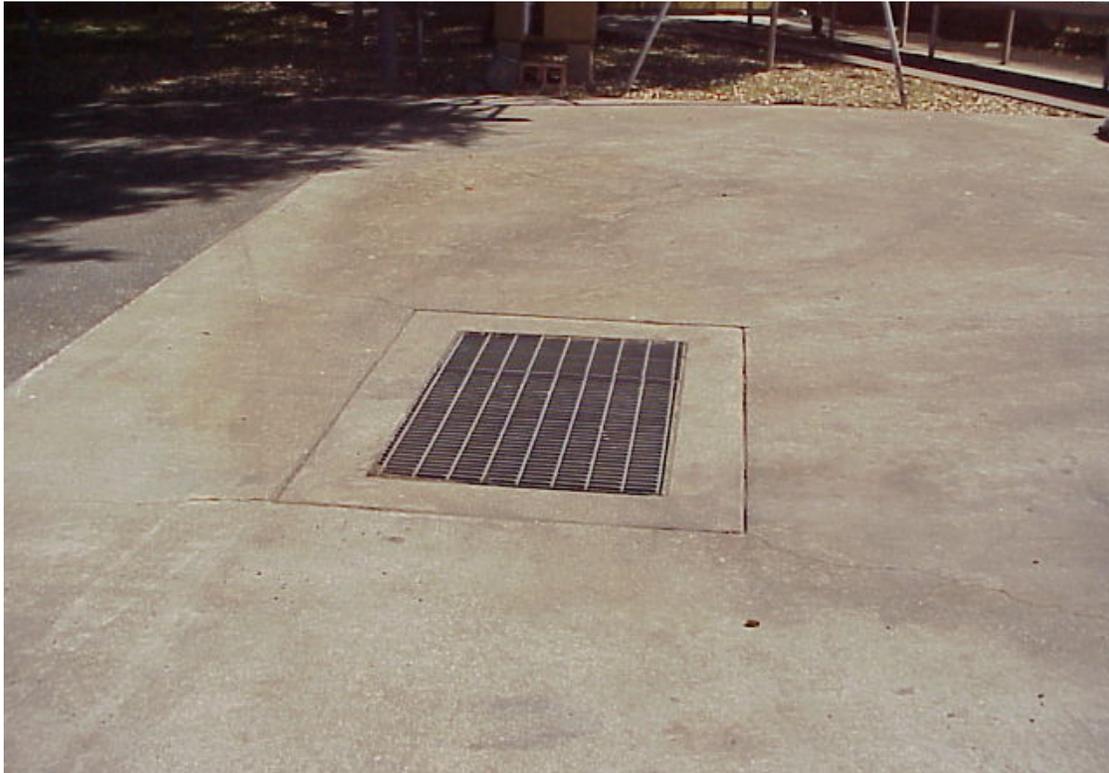
Photo No. 1 Wash Rack at the Adjacent CDF Facility (Map ID No. 2)

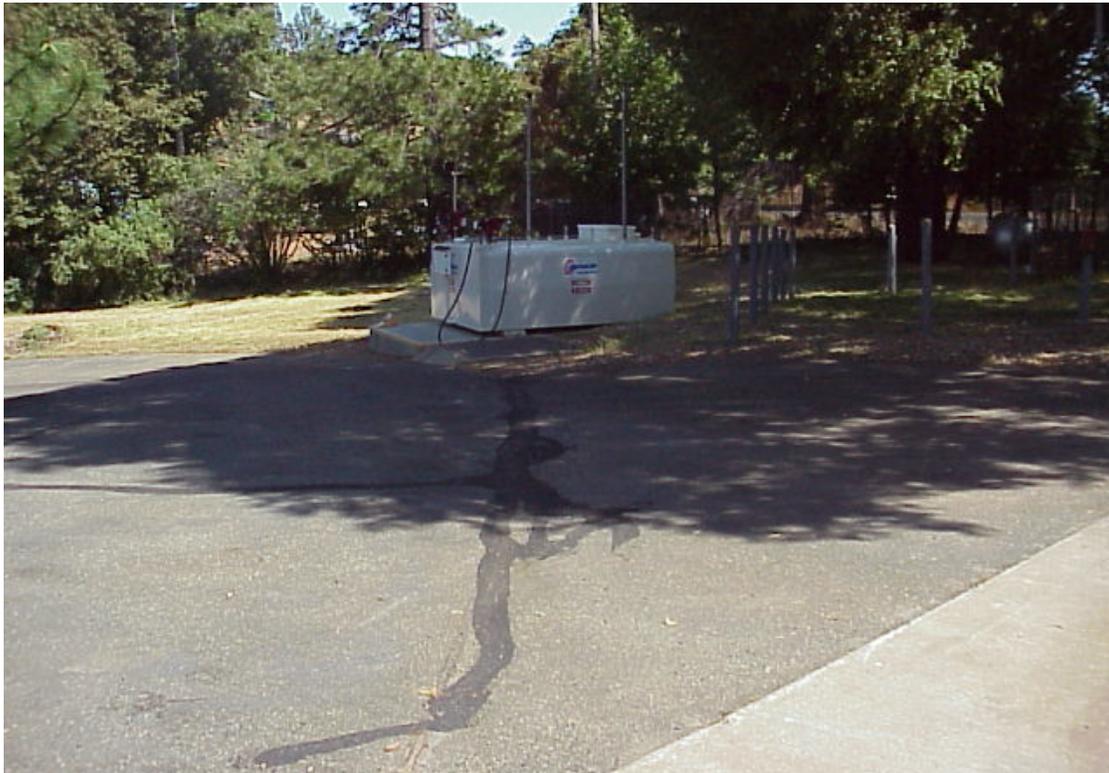
Photo No. 2 Gasoline/Diesel Split AST Located at the CDF Facility (Map ID No. 2)

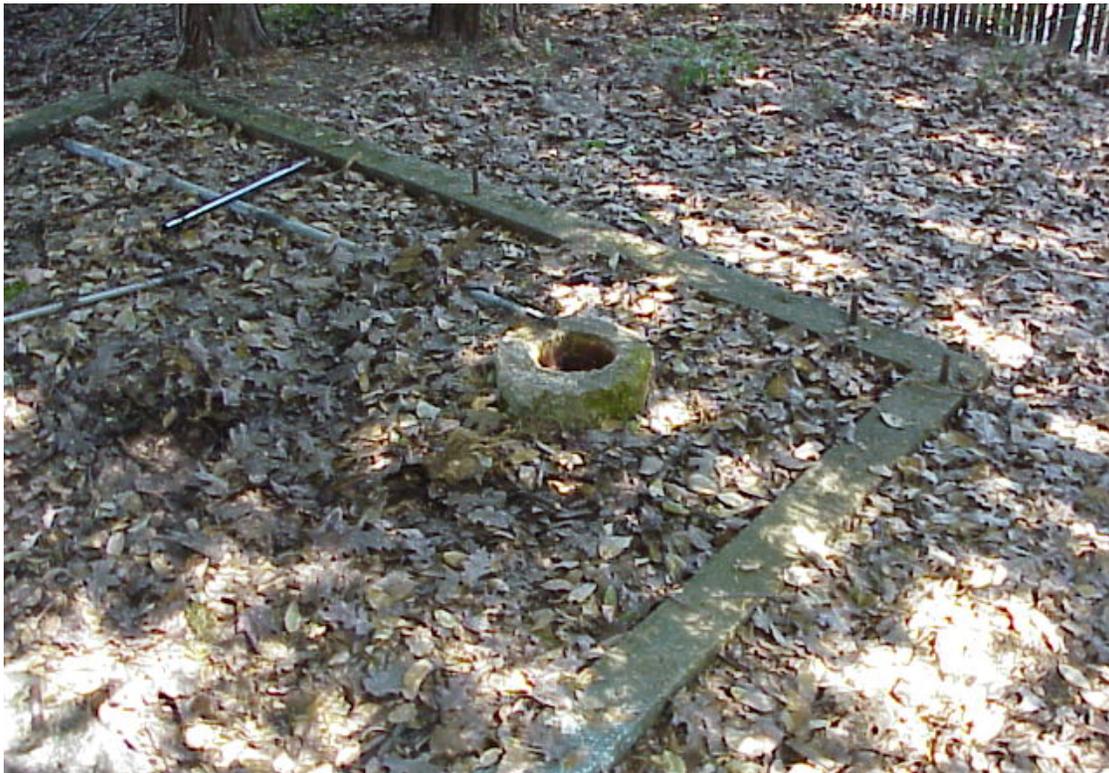
Photo No. 3 Reportedly Capped Water Well in the Northeast Corner of the CDF Facility (Map ID No. 2)

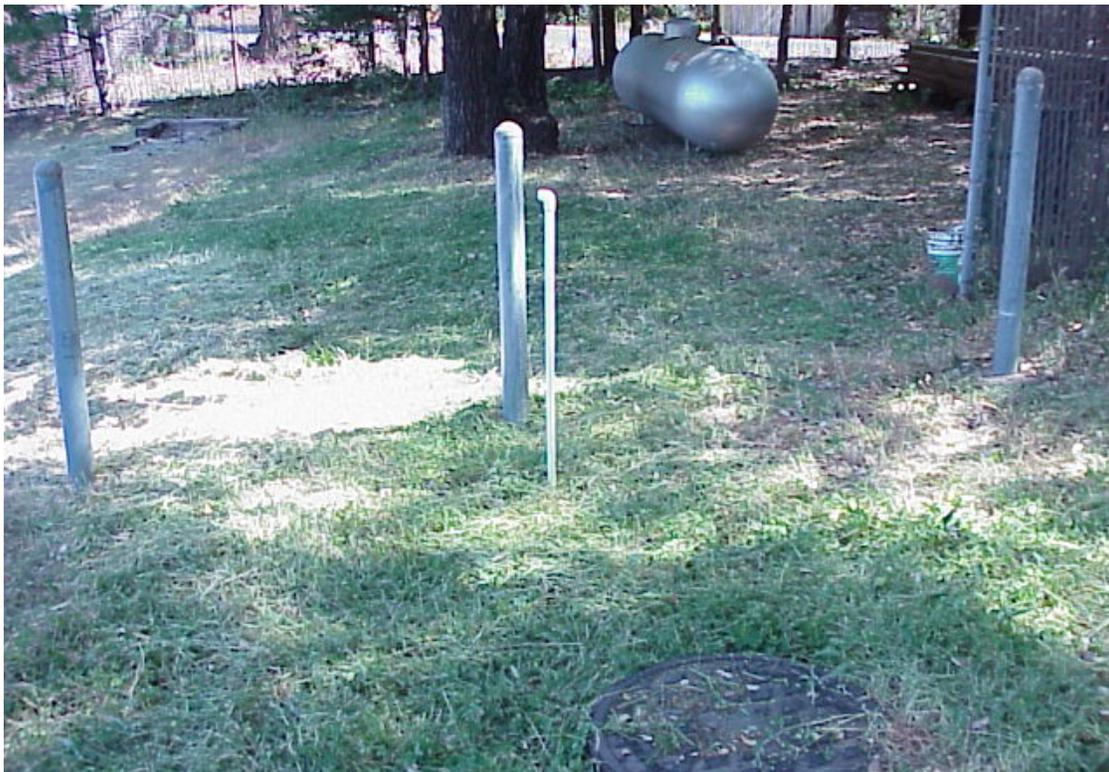
Photo No. 4 Septic Tank Vent and LPG AST at the CDF Facility (Map ID No. 2)

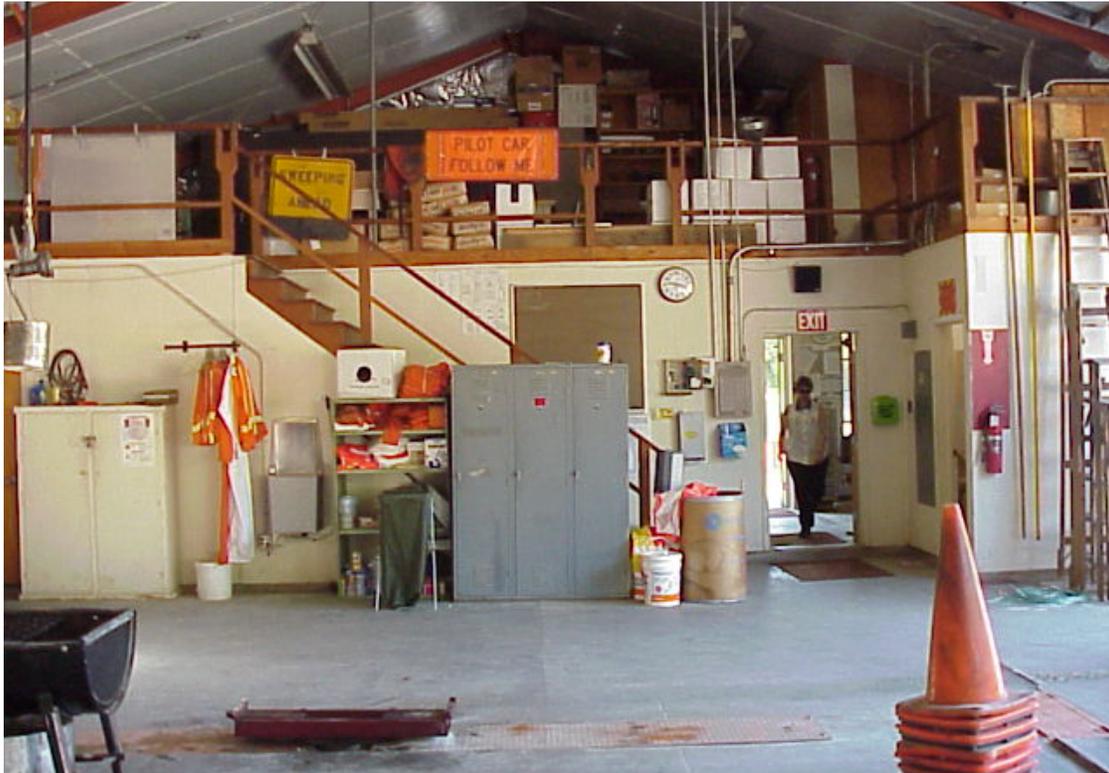
Photo No. 1 South Wall of Bay 1 and Hydraulic Lift in the Equipment Building

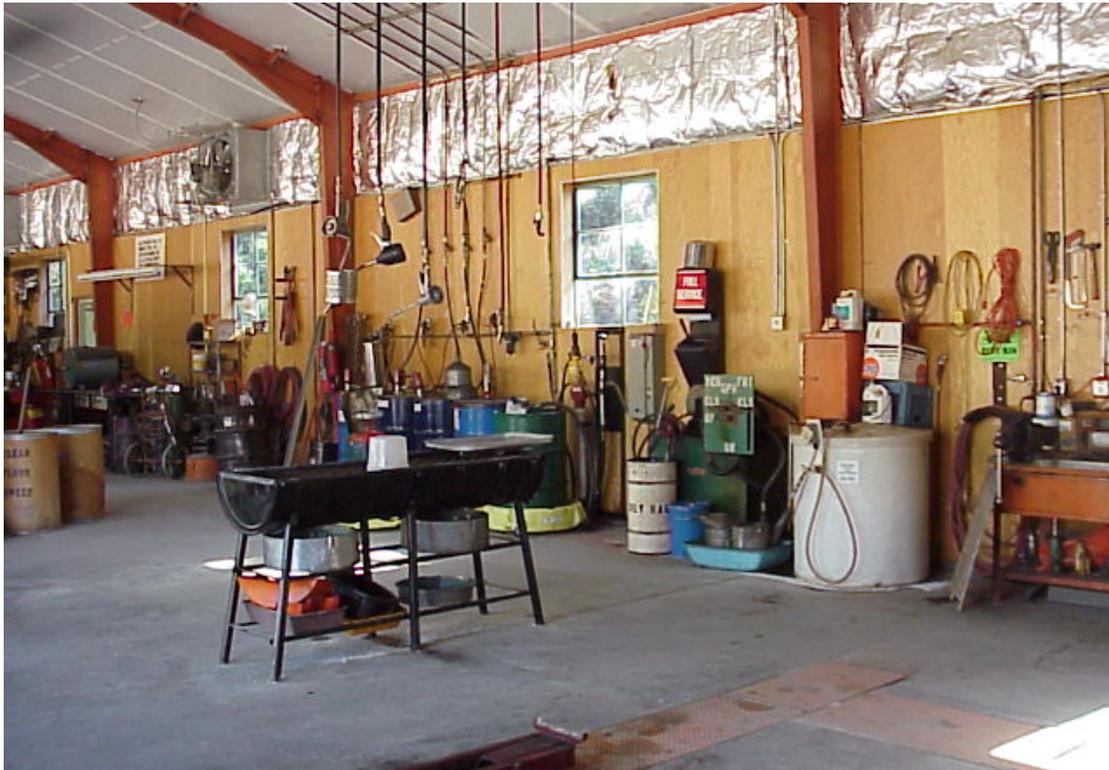
Photo No. 2 North Wall of the Equipment Building, Antifreeze and Hydraulic Oil ASTs, Oil Drip Drain and Oil Drain Drum, Petroleum Drums with Overhead Hose Reels

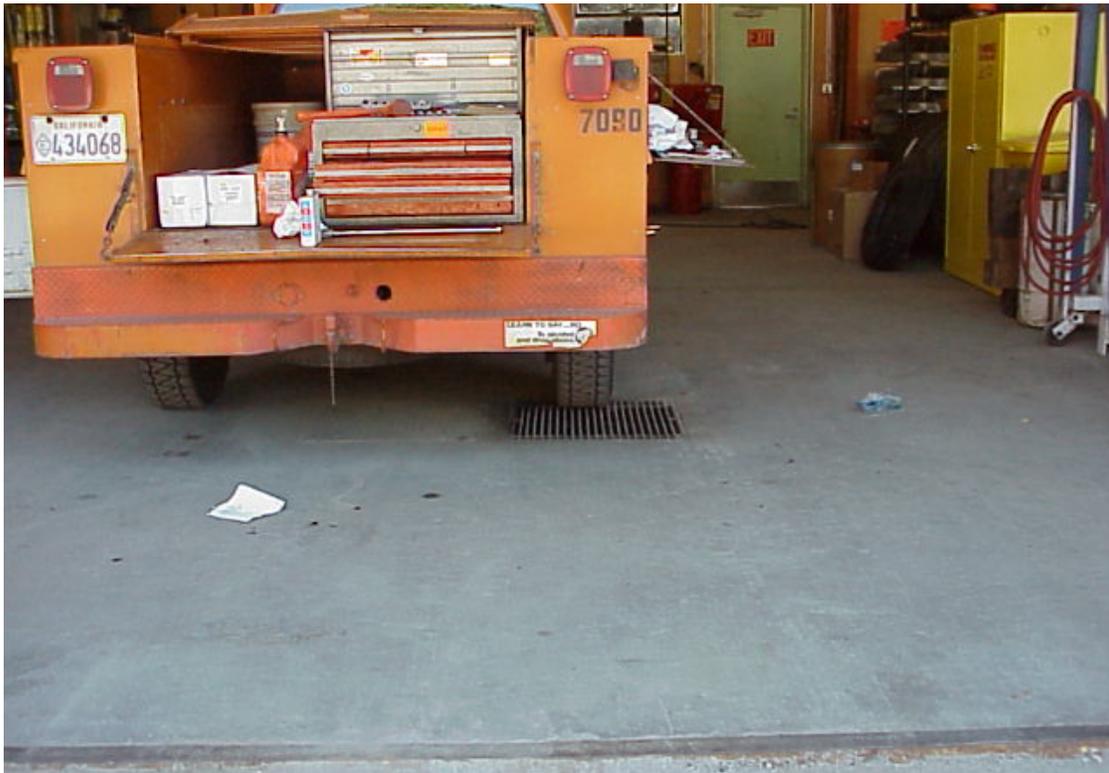
Photo No. 3 Floor Drain in Bay 3 of the Equipment Building

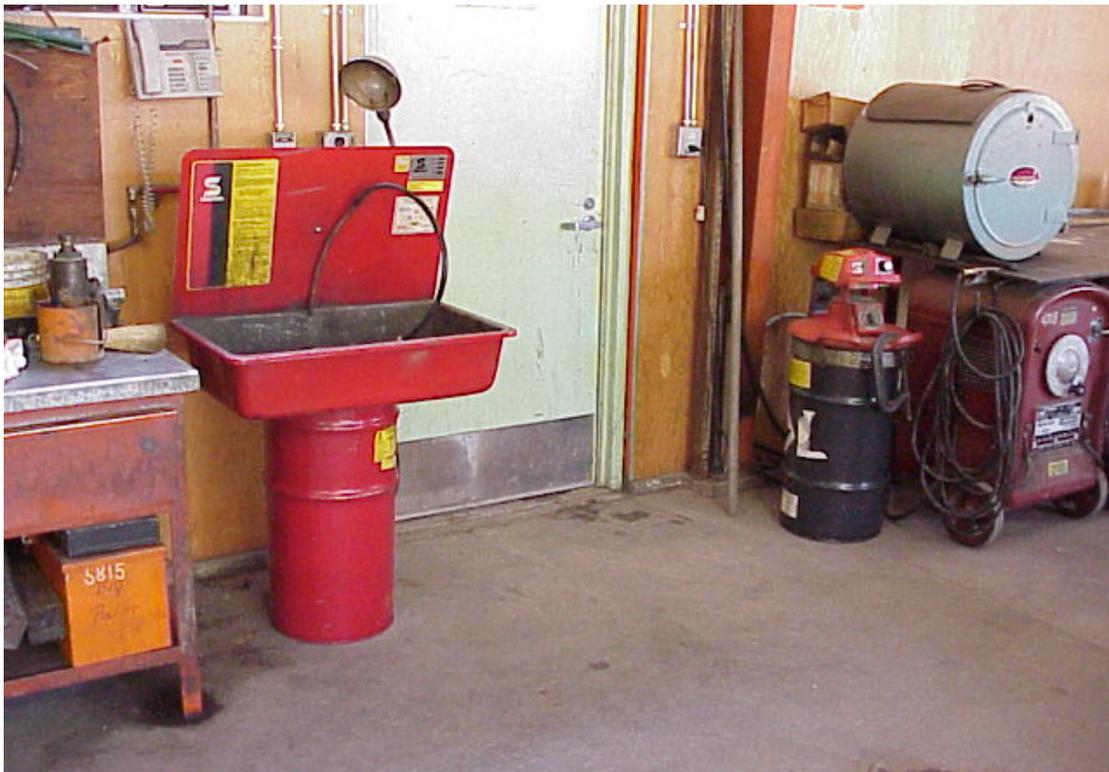
Photo No. 4 Safety Kleen Parts Cleaner Unit (Left) and Carburetor Cleaner AST (Right)

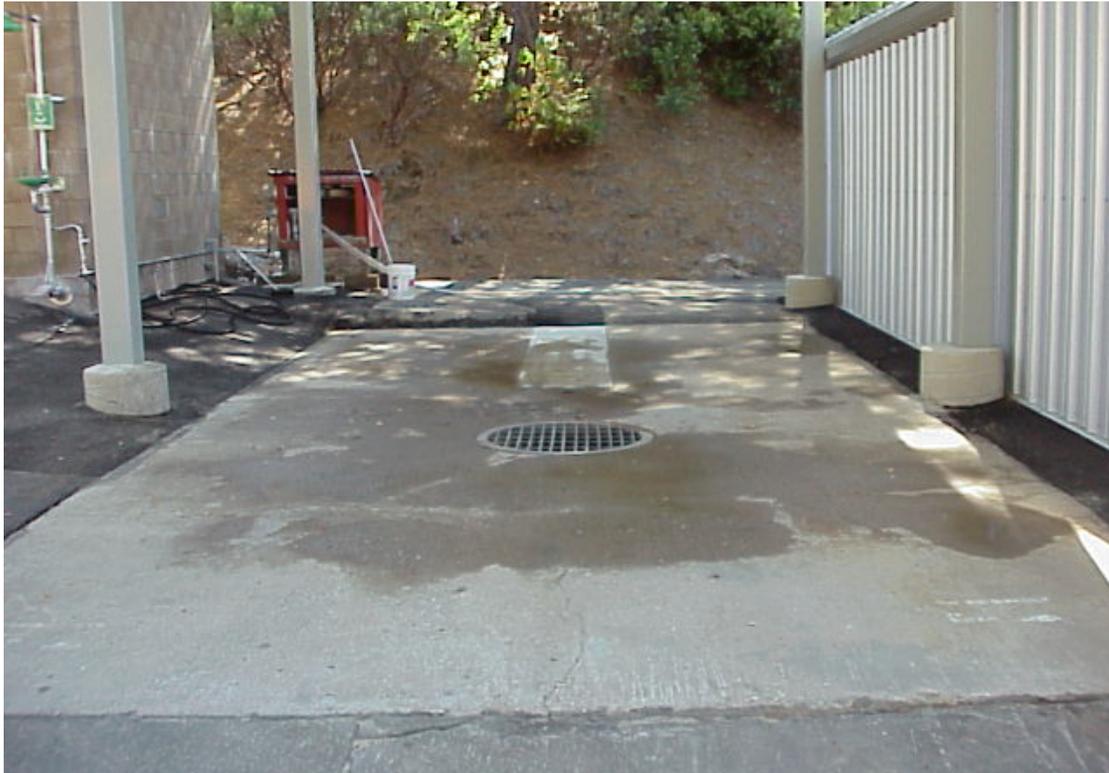
Photo No. 5 Wash Rack and Floor Drain Located North of the Equipment Building

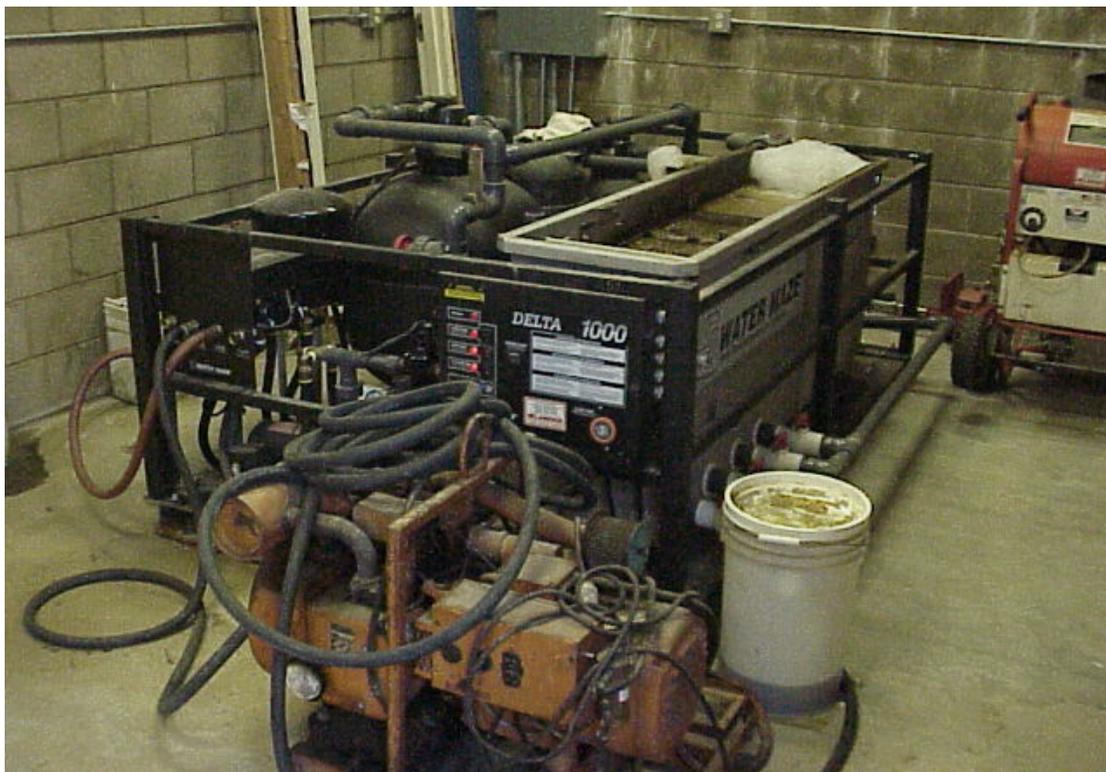
Photo No. 8 Water Clarifier Located in the Chemical Storage Building

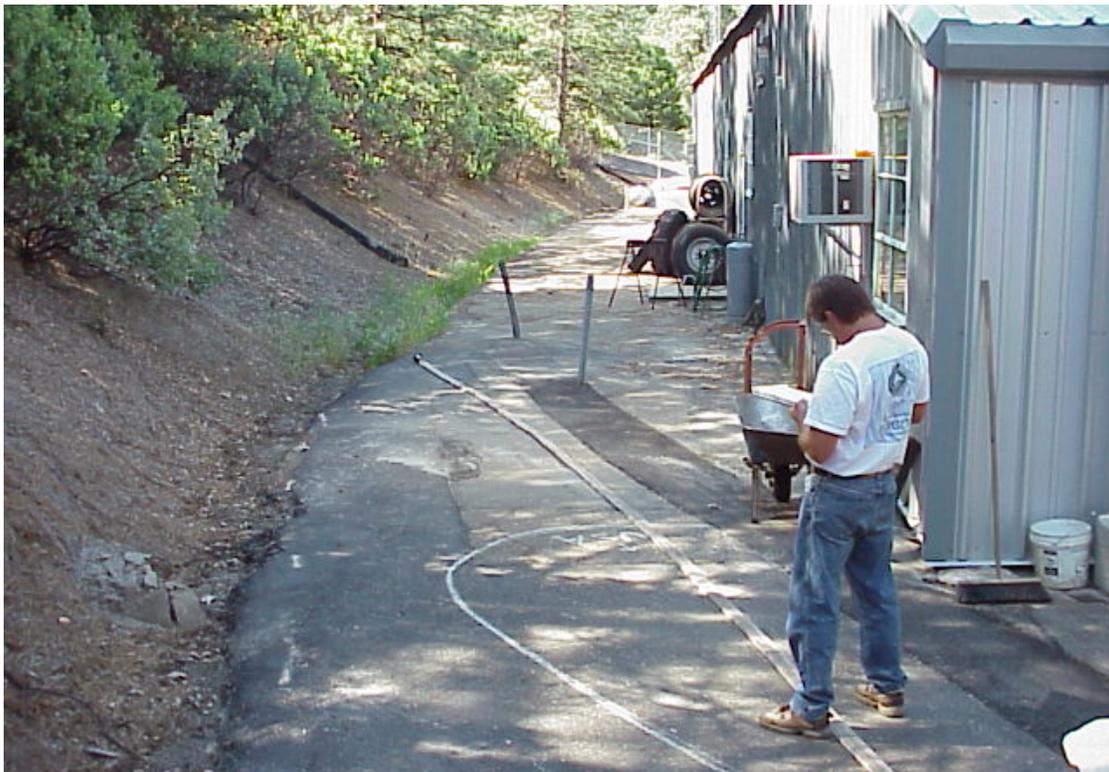
Photo No. 16 Oil/Water Separator, Unlined Ditch and Corrugated Metal Pipe on Slope from the CDF Facility

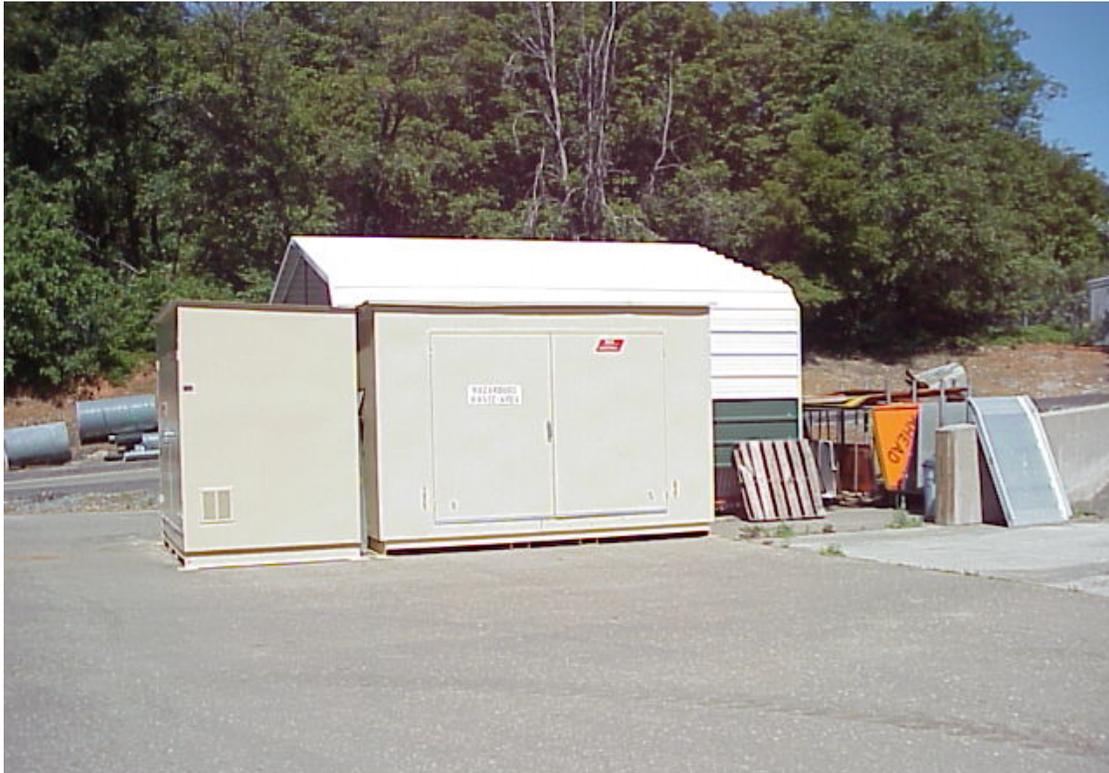
Photo No. 17 Looking Northwest at the Hazardous Material Storage Containers

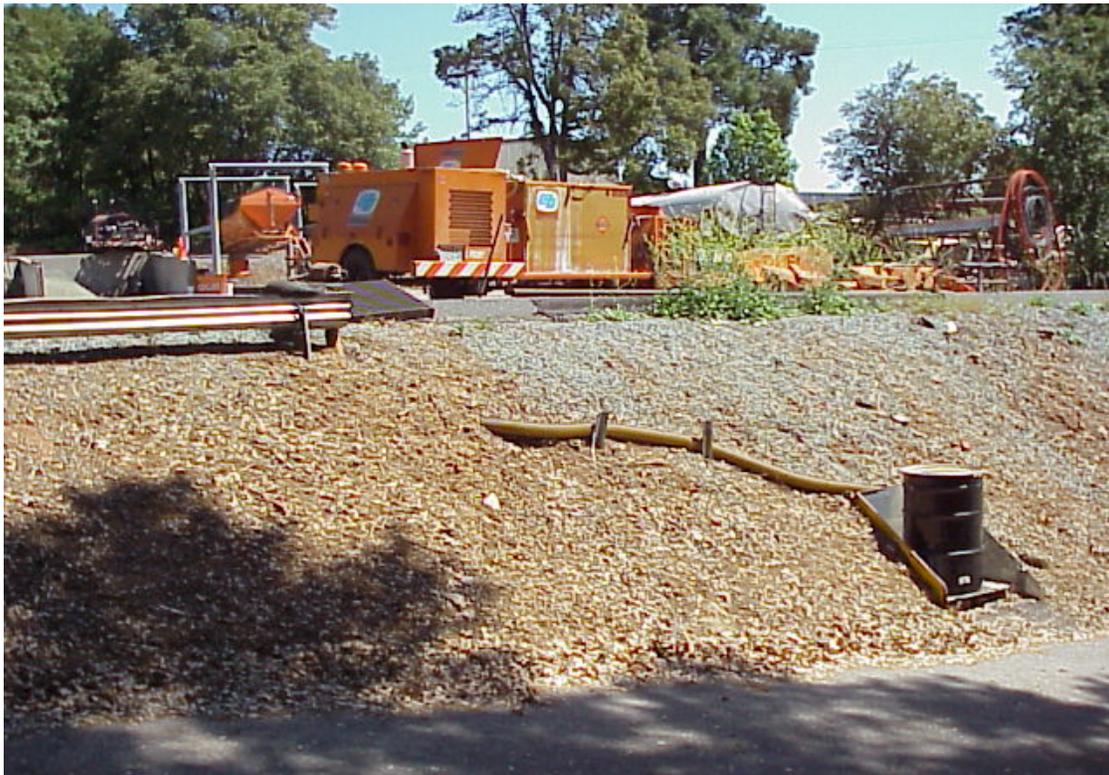
Photo No. 19 Asphalt Cleaning Trough, Drain Line and Drum

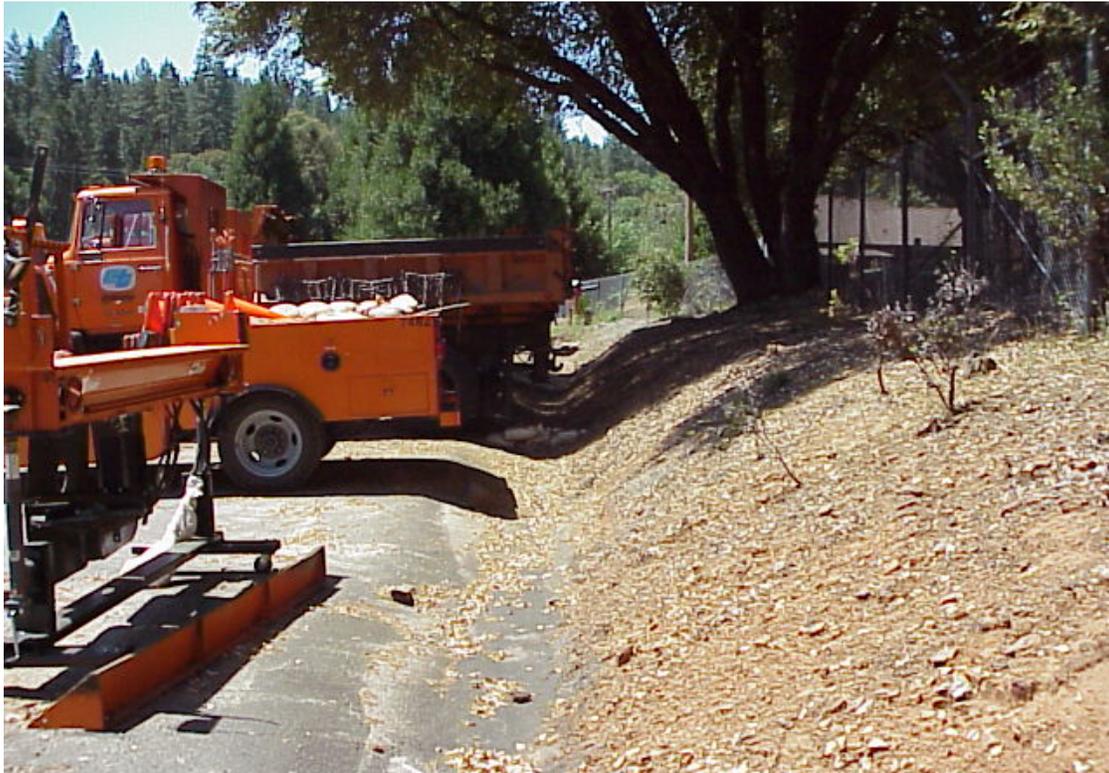
Photo No. 25 Looking South at the Unlined Ditch Located on the Western Site Boundary

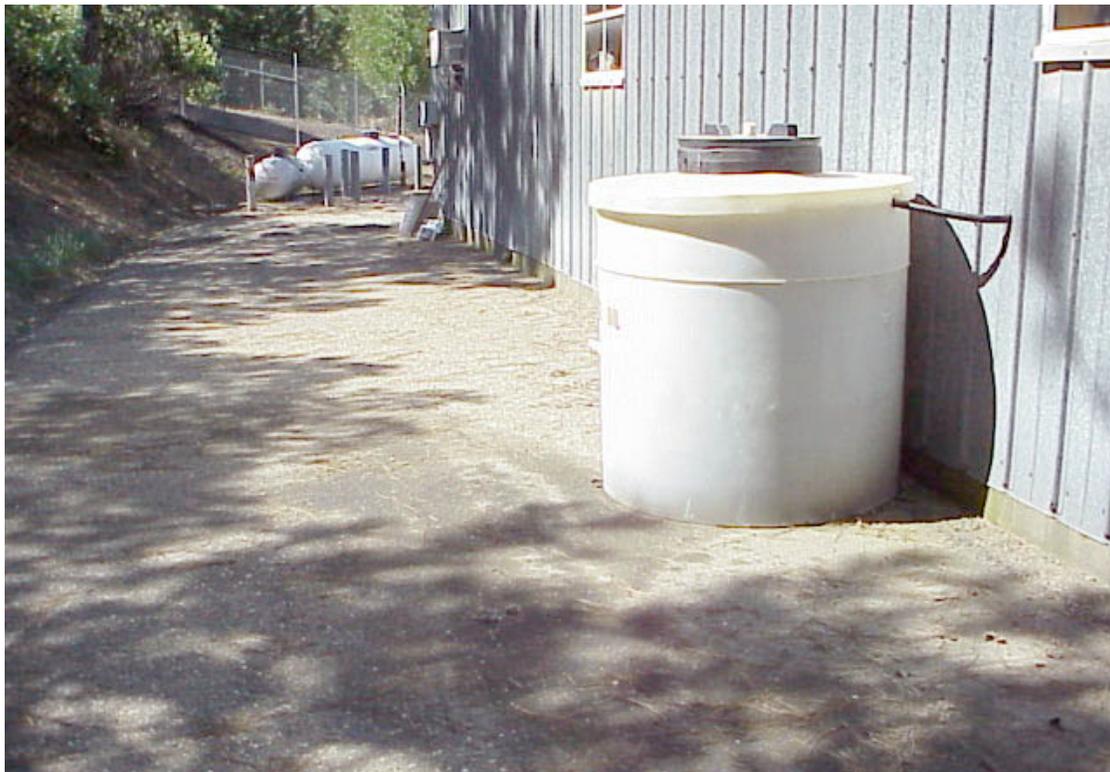
Photo No. 28 Waste Oil AST Located on the Eastern Exterior Wall of the Equipment Building
