# **ASBESTOS ASSESSMENT REPORT FOR BRIDGE STRUCTURES**

## **I-5 HOV Improvement Project PCH to San Juan Creek Road Orange County, California**

EA 12-0F96E1

March 23, 2012

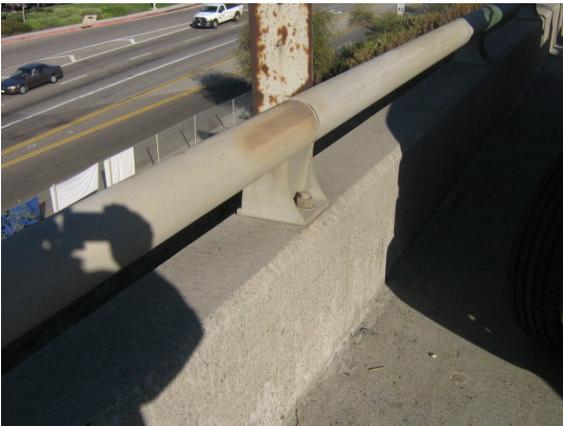
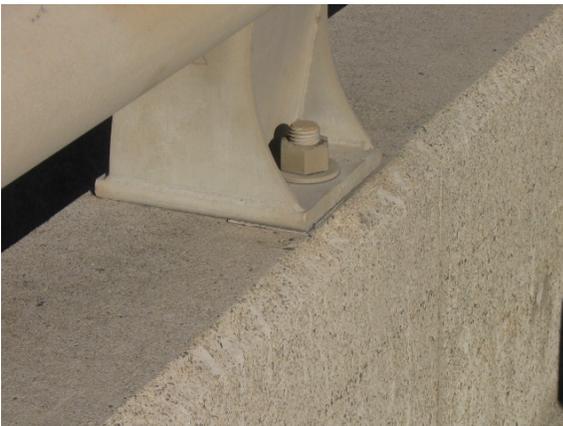
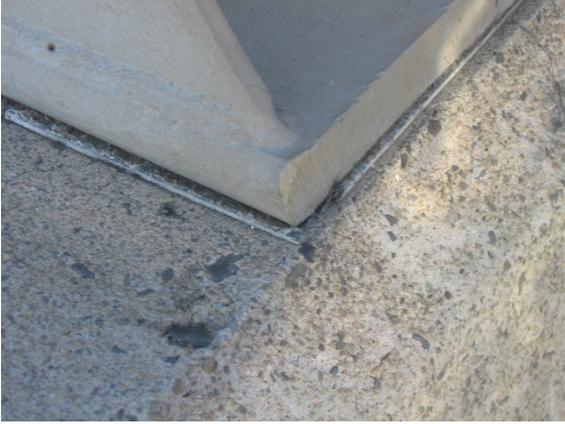
- **Bridge #55-0227 at I-5 / Camino Capistrano Undercrossing** - the Grayish shim material found at the interface of the metal guardrail and the concrete bridge was found to contain 70% Chrysotile asbestos. This asbestos material is expected to be disturbed during the partial demolition work. There are approximately 50 shims on this bridge.

Sample Number	Material Description	Sample Location	Material Condition	Approx. Quantity	Asbestos Content	Friable/ Non-Friable
03	Black fibrous spacer material	At interface of metal guardrail and concrete bridge	Good	50 Ea.	70% Chrysotile	Friable

Photo 5 - Bridge #55-0227, Las Camino Capistrano Undercrossing. Sample 03 of shim/spacer material - wide view

Photo 6 - Bridge #55-0227, Las Camino Capistrano Undercrossing. Sample 03 of shim/spacer material – close up view

Photo 7 - Bridge #55-0227, Las Camino Capistrano Undercrossing. Sample 03 of shim/spacer material - close up view

The White/Black/Grayish asbestos containing shim material found at the interface of the metal guardrails on all three bridges referenced above, must be abated by a California licensed asbestos abatement contractor prior to any construction activity that will disturb the friable shim material.

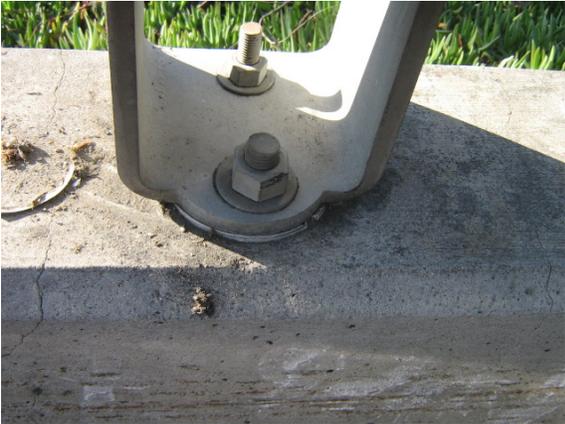
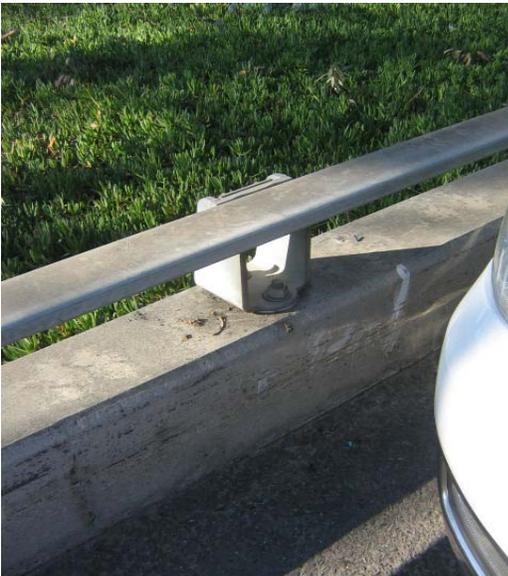
- **Bridge #55-0510 at I-5 / Camino Las Ramblas Undercrossing** - the Black / Grayish shim material found at the interface of the metal guardrail and the concrete bridge was found to contain 40% Chrysotile asbestos. This asbestos material is expected to be disturbed during the partial demolition work. There are approximately 40 shims on this bridge.

Sample Number	Material Description	Sample Location	Material Condition	Approx. Quantity	Asbestos Content	Friable/ Non-Friable
07	Black/Grayish fibrous spacer material	At interface of metal guardrail and concrete bridge	Good	40 Ea.	40% Chrysotile	Friable
08	Grayish fibrous spacer material	At interface of metal guardrail and concrete bridge	Good		40% Chrysotile	Friable

Photo 8 - Bridge #55-0510, Camino Las Ramblas Undercrossing. Sample 07 of shim/spacer material - close up view

Photo 9 - Bridge #55-0510, Camino Las Ramblas Undercrossing. Sample 07 of shim/spacer material - wide view

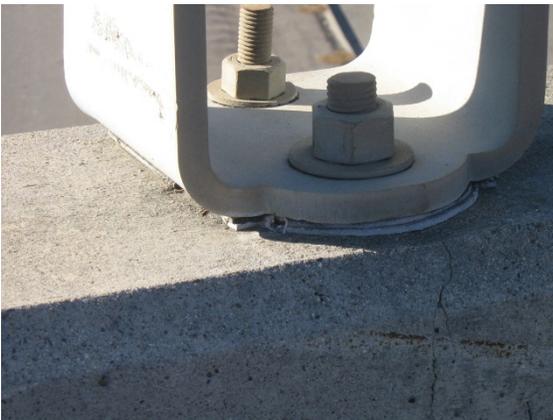
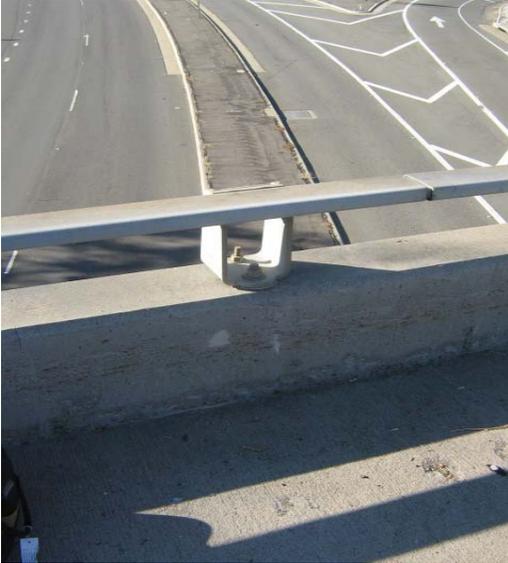
Photo 12 - Bridge #55-0510, Camino Las Ramblas Undercrossing. Sample 08 of shim/spacer material - close up view

Photo 13 - Bridge #55-0510, Camino Las Ramblas Undercrossing. Sample 08 of shim/spacer material - wide view

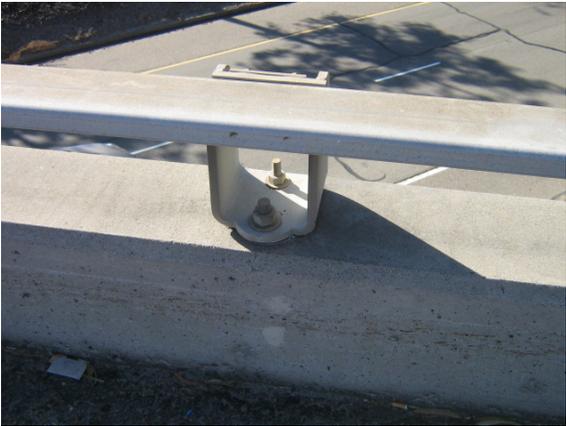
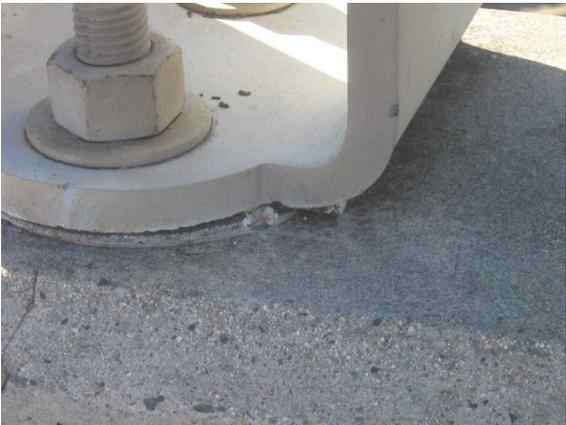
- **Bridge #55-0226 at NB I-5 to NB Pacific Coast Highway Connector** - the Grayish shim material found at the interface of the metal guardrail and the concrete bridge was found to contain 70% Chrysotile asbestos. This asbestos material is expected to be disturbed during the partial demolition work. There are approximately 55 shims on this bridge.

Sample Number	Material Description	Sample Location	Material Condition	Approx. Quantity	Asbestos Content	Friable/ Non-Friable
15	White/Grayish fibrous spacer material	At interface of metal guardrail	Good	55 Ea.	40% Chrysotile	Friable

Photo 20 - Bridge #55-0226, Northbound PCH Connector. Sample 15 of shim/spacer material – wide view

Photo 21 - Bridge #55-0226, Northbound PCH Connector. Sample 15 of shim/spacer material – close-up view

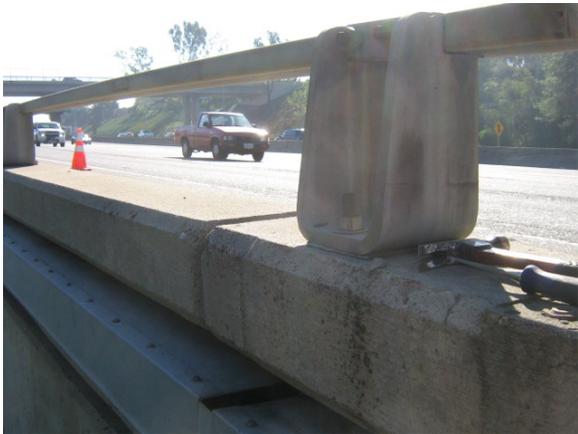
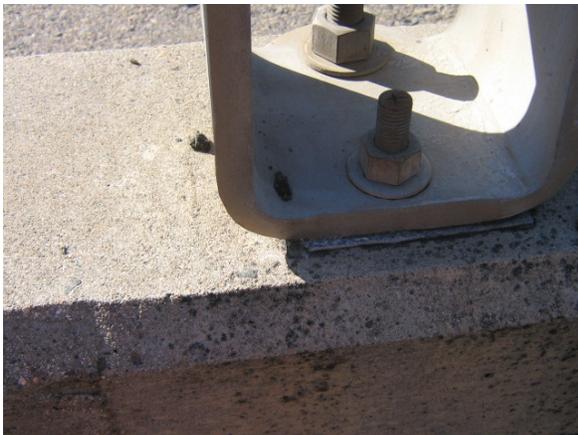
Photo 32 - Bridge #55-0226, Northbound PCH Connector. Sample 16 of shim/spacer material – wide view

Photo 33 - Bridge #55-0226, Northbound PCH Connector. Sample 16 of shim/spacer material – close-up view
