**AERIALY DEPOSITED LEAD AND NATURALLY OCCURRING ASBESTOS SITE
INVESTIGATION REPORT**

**State Route 36
Post Mile 36.7 to 37.1
Trinity County, California**

**GEOCON PROJECT NO. S9300-06-97
TASK ORDER NO. 97, EA NO. 02-2E0600**

AUGUST 2009

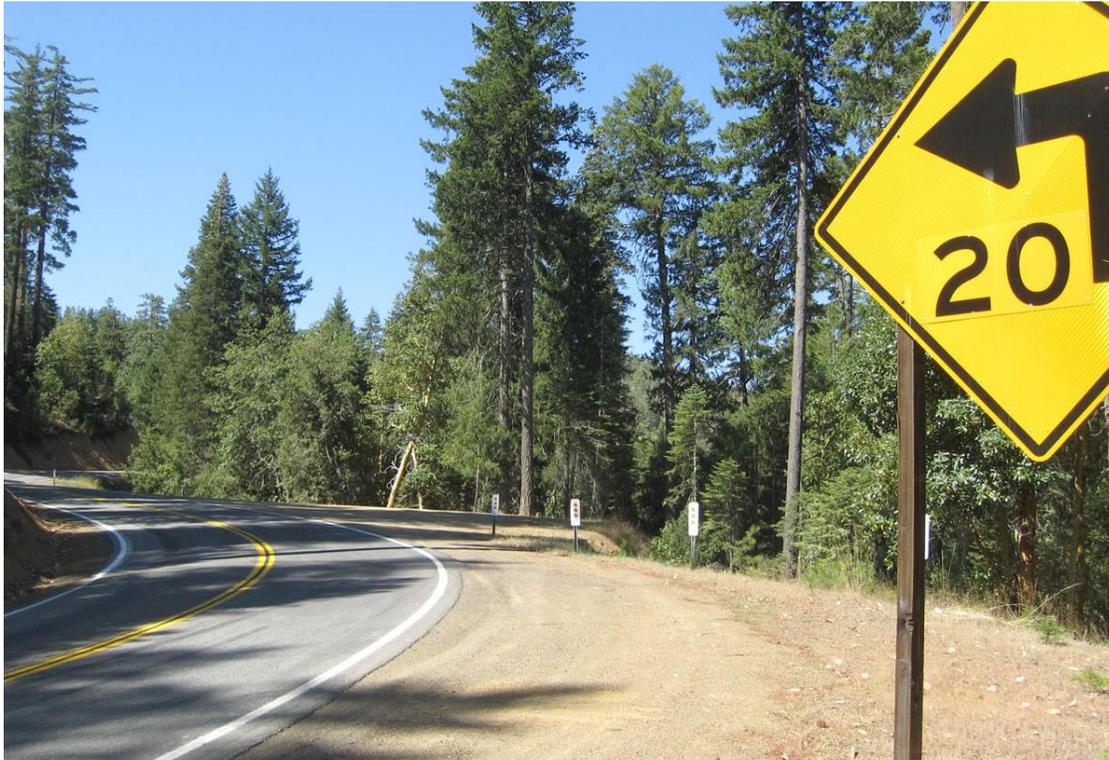
The soils encountered during the advancement of the hand-auger borings were generally composed of dark brown clayey silt with gravel. Rock types observed within the existing roadway cut slopes consisting of blocky, highly weathered metavolcanics did not appear to have characteristic features indicative of a rock-type in which NOA is likely to be present. Stained/odorous soil or groundwater was not encountered during the field sampling activities.

Photo No. 1 View of General Site Conditions
