INFORMATION HANDOUT

AERIALY DEPOSITED LEAD,
TRAFFIC STRIPE PAINT AND
NATURALLY OCCURRING ASBESTOS SITE INVESTIGATION
AND BRIDGE SURVEY REPORT

CALIFORNIA DEPARTMENT OF TRANSPORTATION AND MR. STEVE ROGERS
BIG FRENCH CREEK BRIDGE WIDENING PROJECT
(ONE ENCROACHMENT)

SR-299 Big French Creek Bridge Improvement Project
S9300-06-159

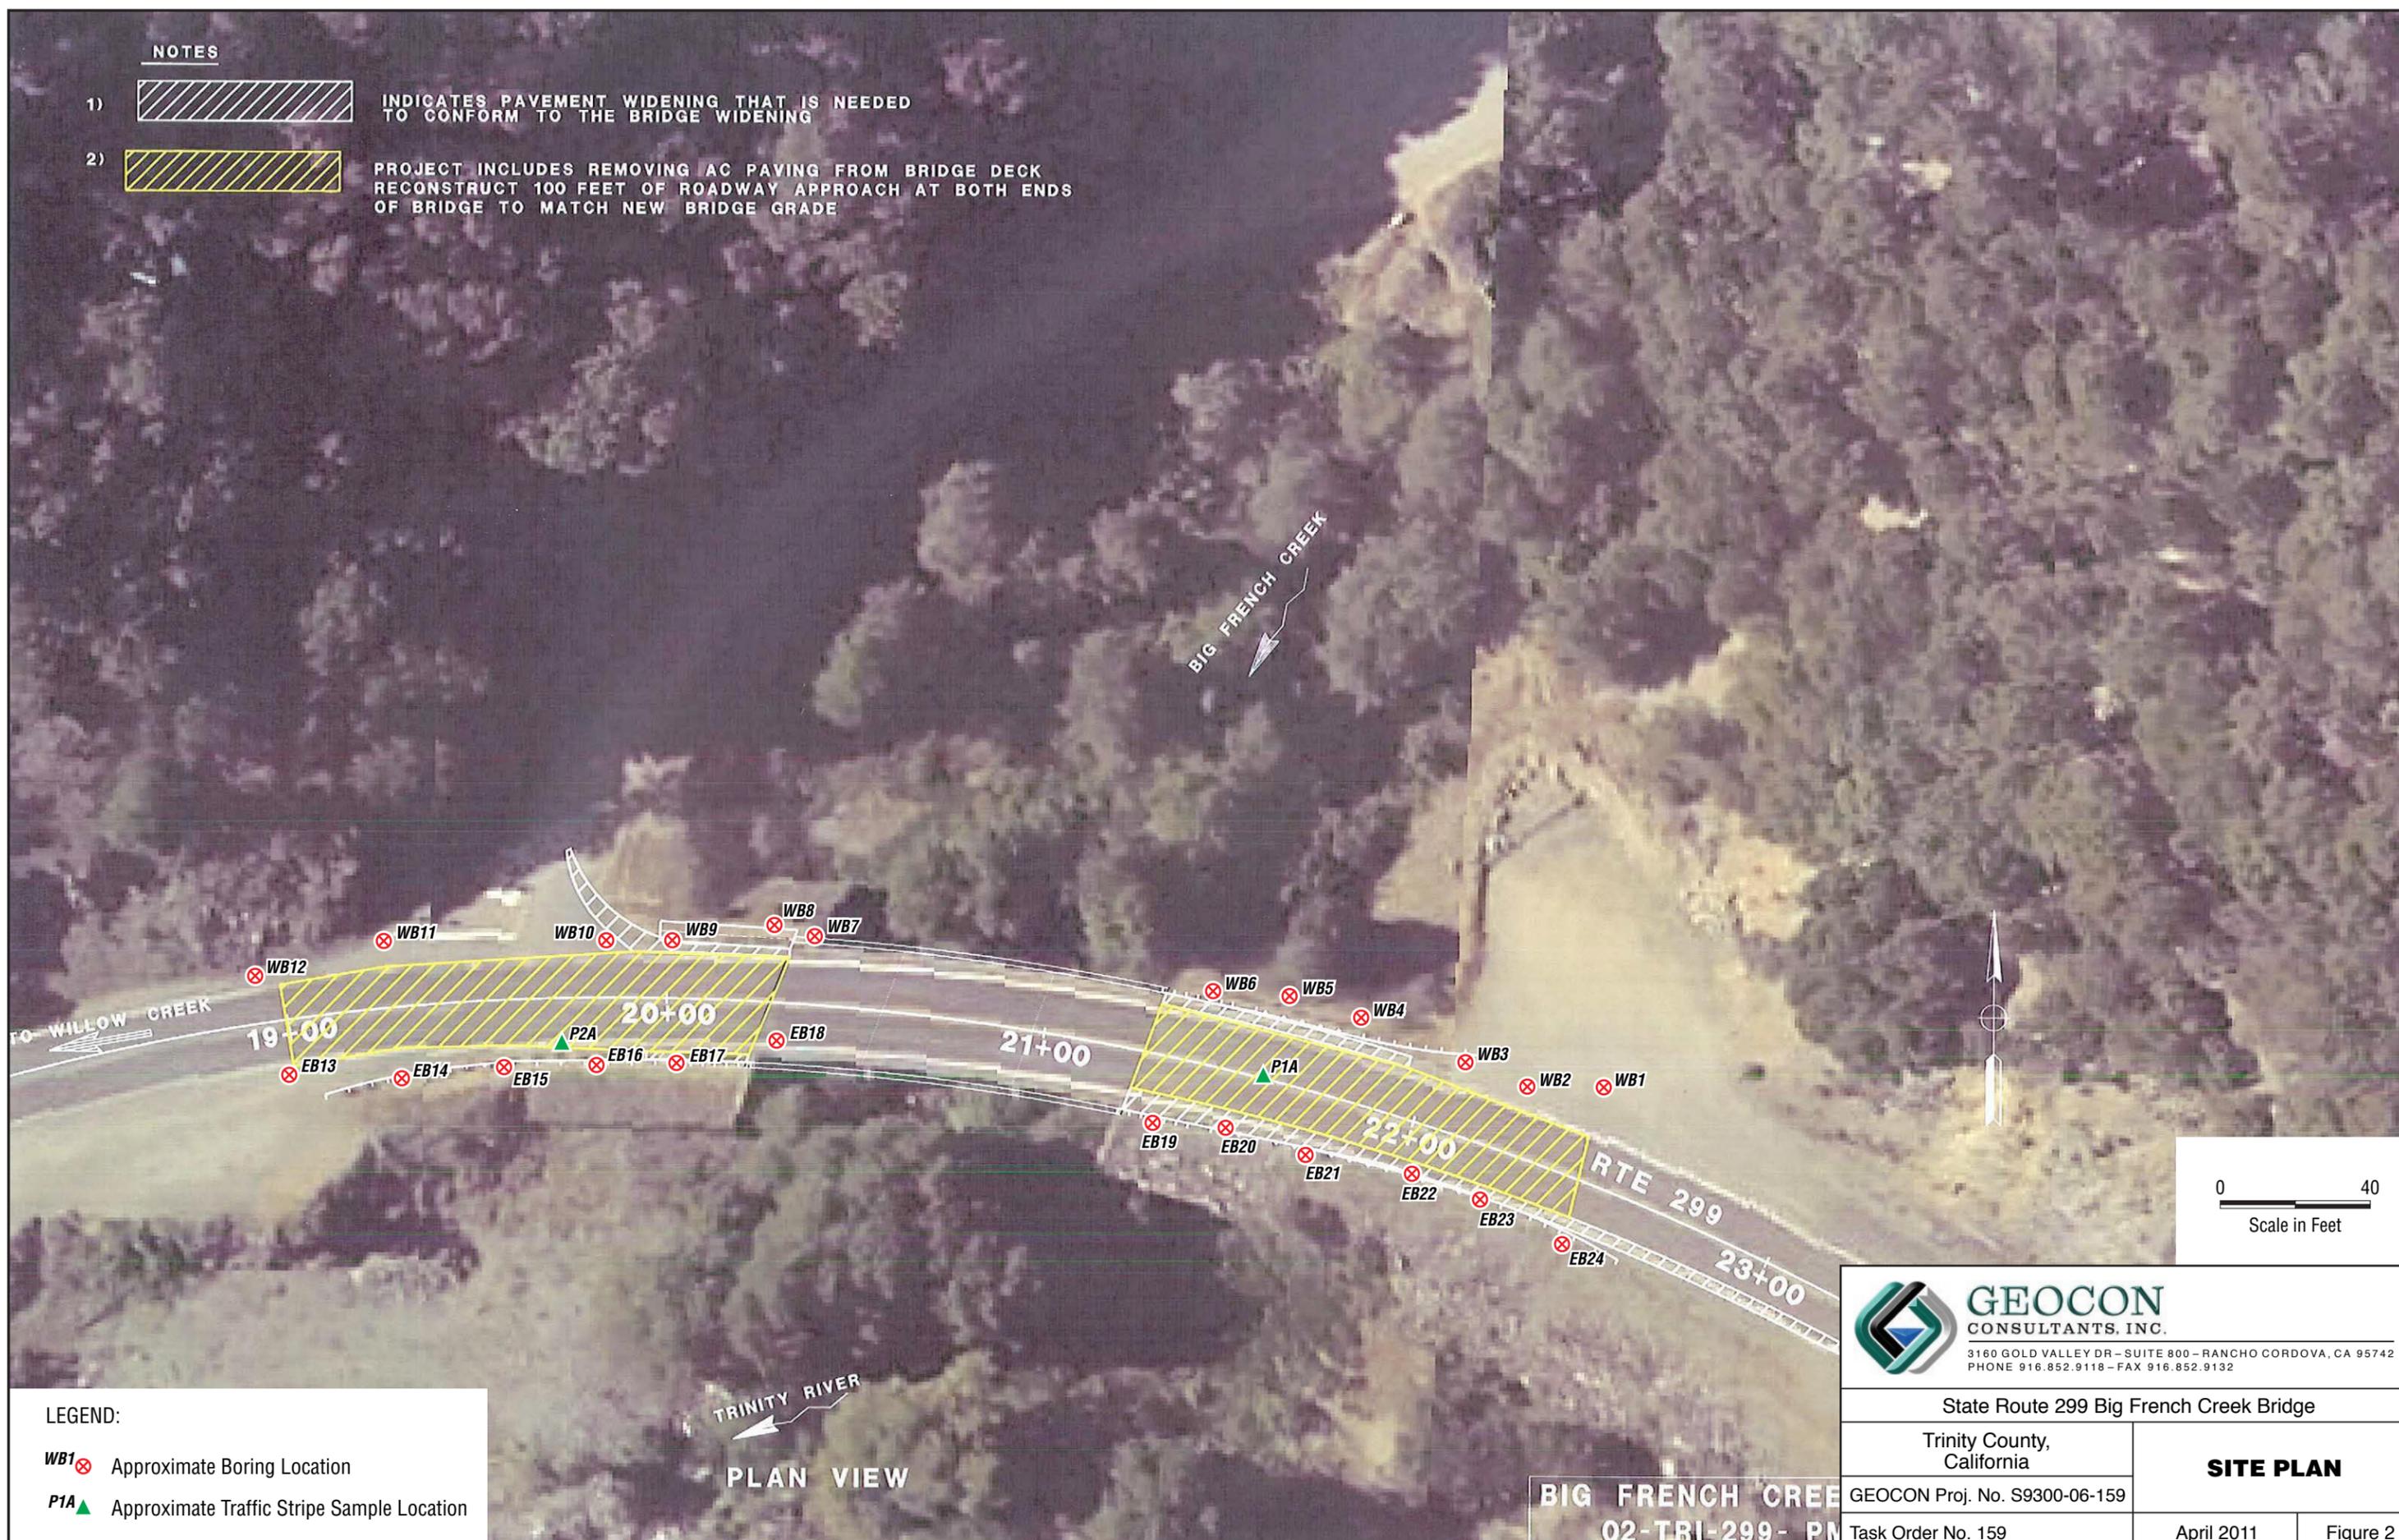
TRINITY RIVER
PLAN VIEW

PROJECT INCLUDES REMOVING AC PAVING FROM BRIDGE DECK RECONSTRUCT 100 FEET OF ROADWAY APPROACH AT BOTH ENDS OF BRIDGE TO MATCH NEW BRIDGE GRADE

LEGEND:
 WB1 ⊗ Approximate Boring Location
 P1A ▲ Approximate Traffic Stripe Sample Location

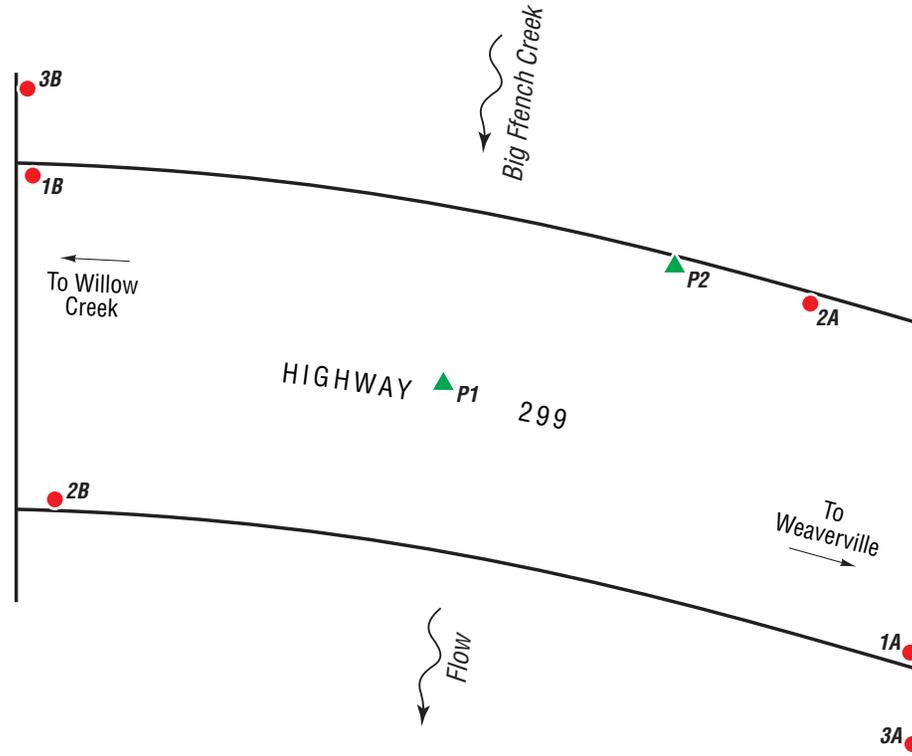
Trinity County, California		SITE PLAN
GEOCON Proj. No. S9300-06-159		
Task Order No. 159	April 2011	Figure 2

BRIDGE 05-0008

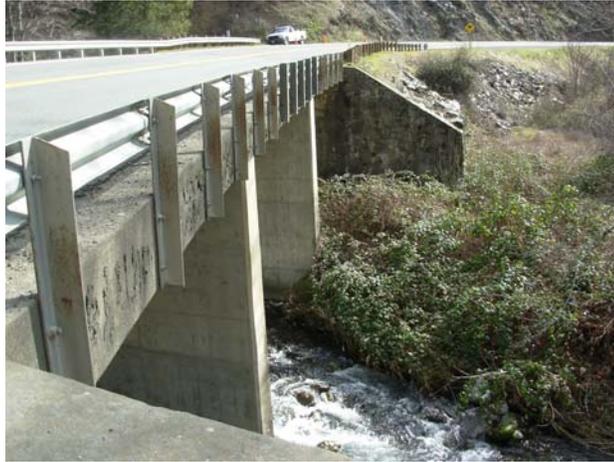
Photo 1 – Big French Creek Bridge (05-0008) on Highway 299 (PM 23.3) in Trinity County, California

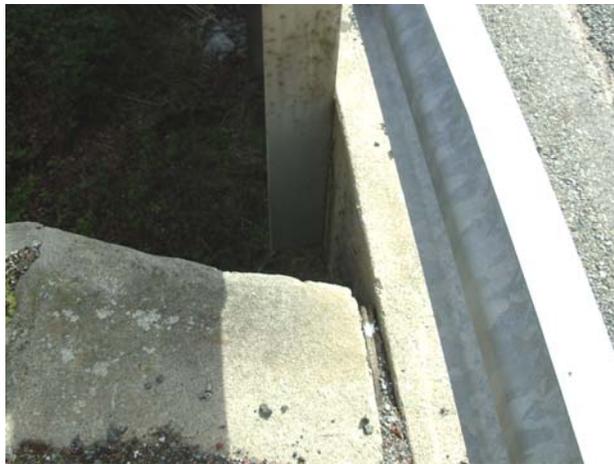
Photo 2 – Expansion joint

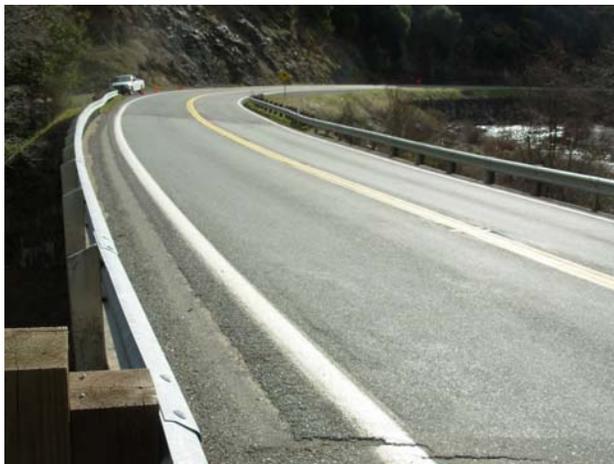
Photo 3 – Bridge deck

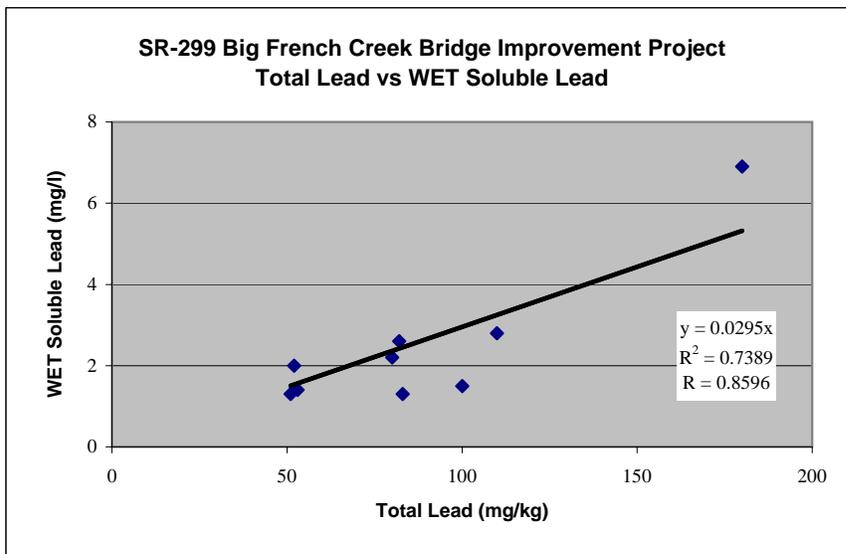
Sample ID	Total Lead	WET Lead
WB4-0	83	1.3
EB21-0.5	51	1.3
EB23-2	53	1.4
EB17-0	100	1.5
WB9-0	52	2.0
EB23-0	80	2.2
EB23-0.5	82	2.6
EB21-0	110	2.8
EB19-0	180	6.9

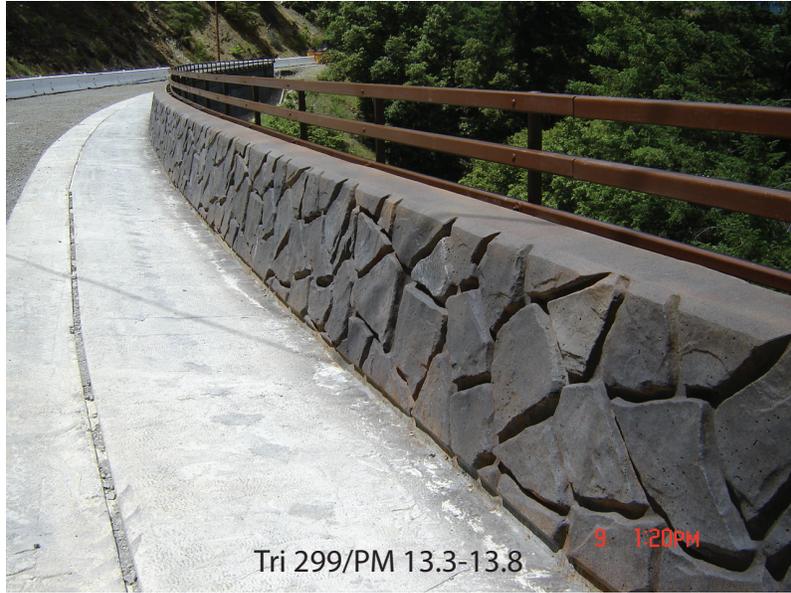
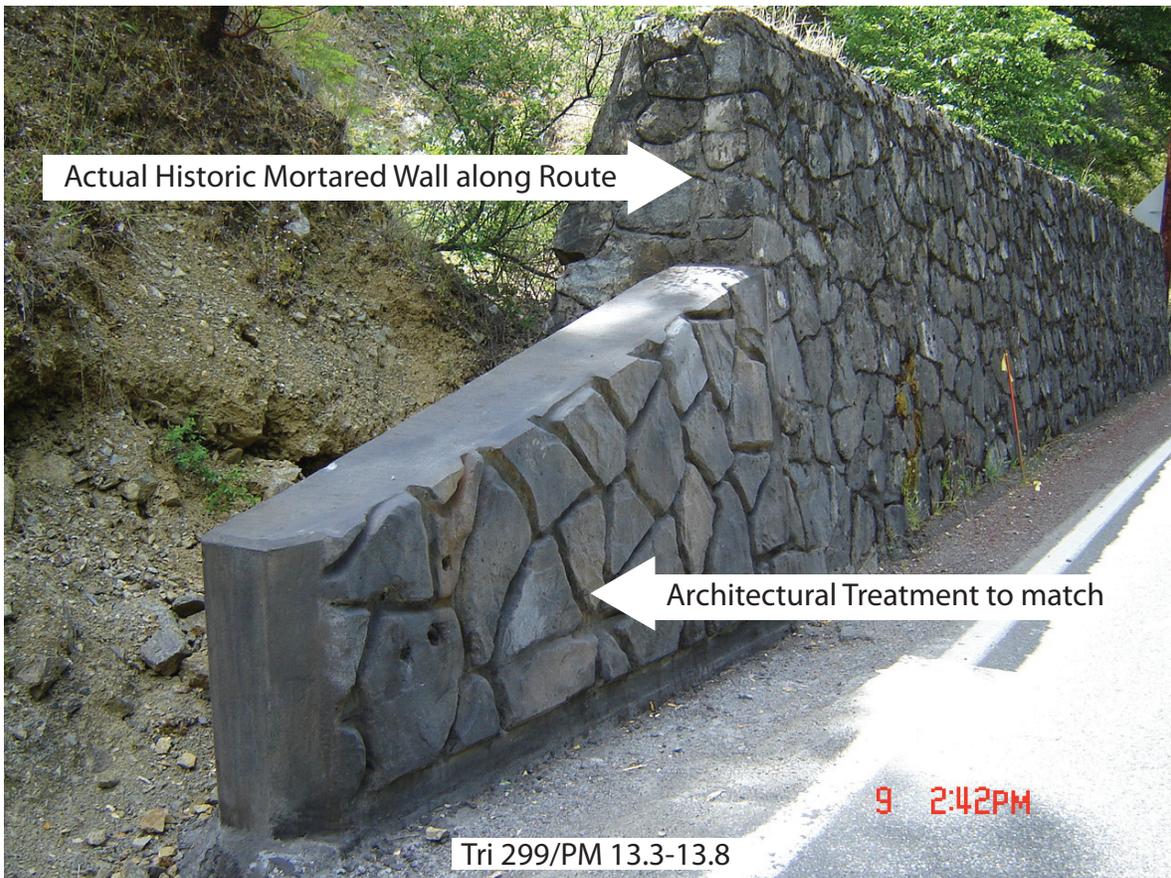
REFERENCE PHOTOS ARCHITECTURAL SURFACE (TEXTURED CONCRETE)

Photographs of Referee Samples for Architectural Surface (Textured Concrete) with Colored Concrete and Stain
