INFORMATION HANDOUT

**For Contract No. 08-0Q7904
At 08-SBd-40-R93.1/R
Project ID 0800020481**

**Hoff Wash Bridge (Replace)
Bridge No. 54-0889 L/R (Existing)
Bridge No. 54-1299 L/R (Proposed)**

STRUCTURE HYDRAULICS & HYROLOGY FINAL HYDRAULIC REPORT

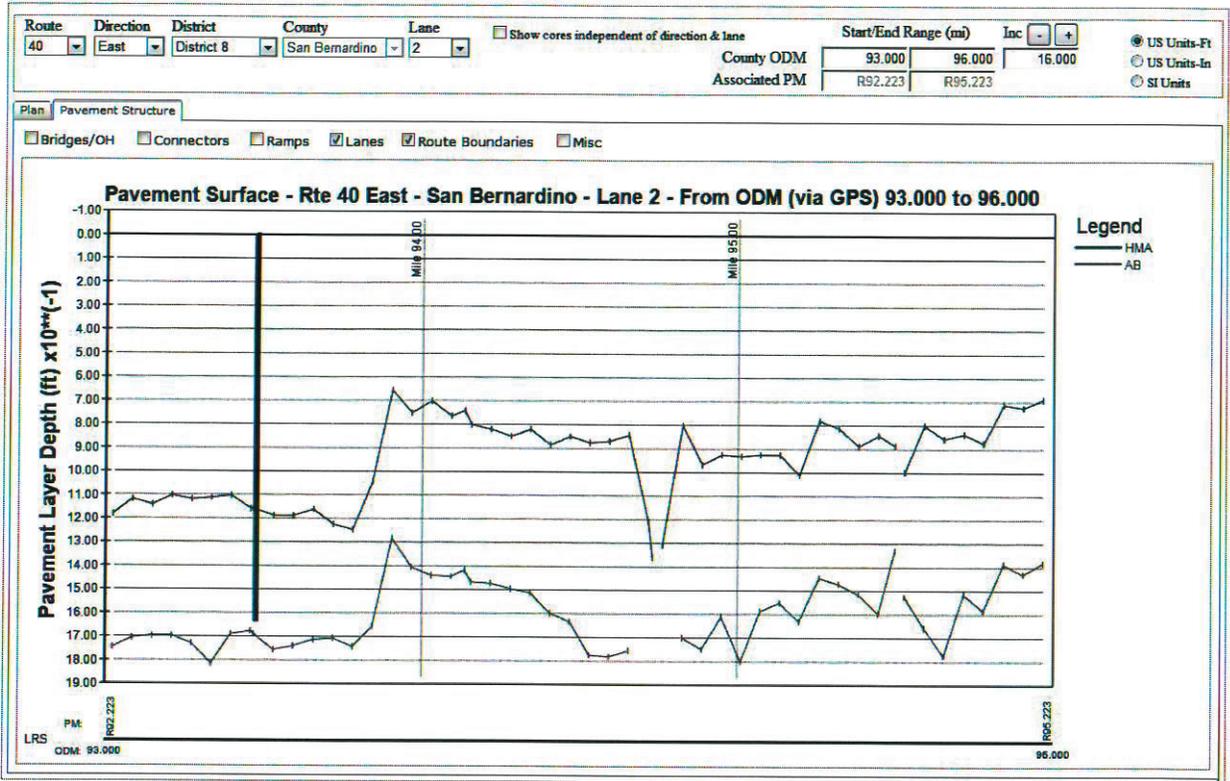
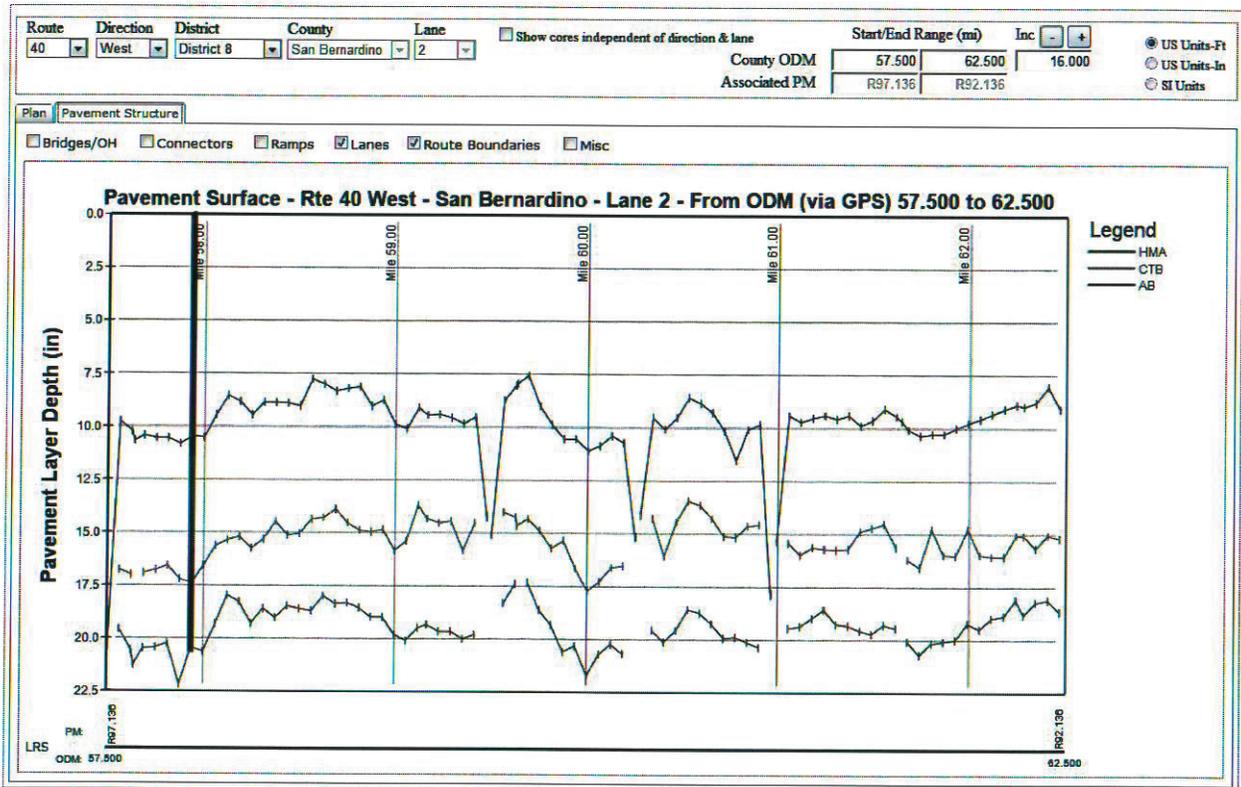
The Caltrans Pavement Program has recently developed a web application called internet Ground Penetrating Radar (iGPR), that allows the user to access a pavement structure inventory of most of California's pavement network layer thicknesses and materials type, including information on pavement cores. The iGPR graphs below obtained from this web application show the indication of the existing HMA pavement (thin blue line) within this project limit, and the locations of two pavement cores which are slightly outside of this project limit, one at PM 92.35 in lane no. 2 (bold blue and red line) in eastbound direction and the other at PM 96.67 in lane no. 2 (bold blue and red line) in westbound direction.

The graphs above do not provide information on the year the GPR data was performed, but we can consider Year 2010 since the pavement cores were taken on 2010. According to these graphs, the existing asphalt pavement thickness can be summarized as follow:

- In lane 2, eastbound direction, from PM R93.1 to PM R94.2, the existing AC thickness is at least 0.70'
- In lane 2, westbound direction, from PM R93.1 to PM R94.2, the existing AC thickness is at least 0.70'

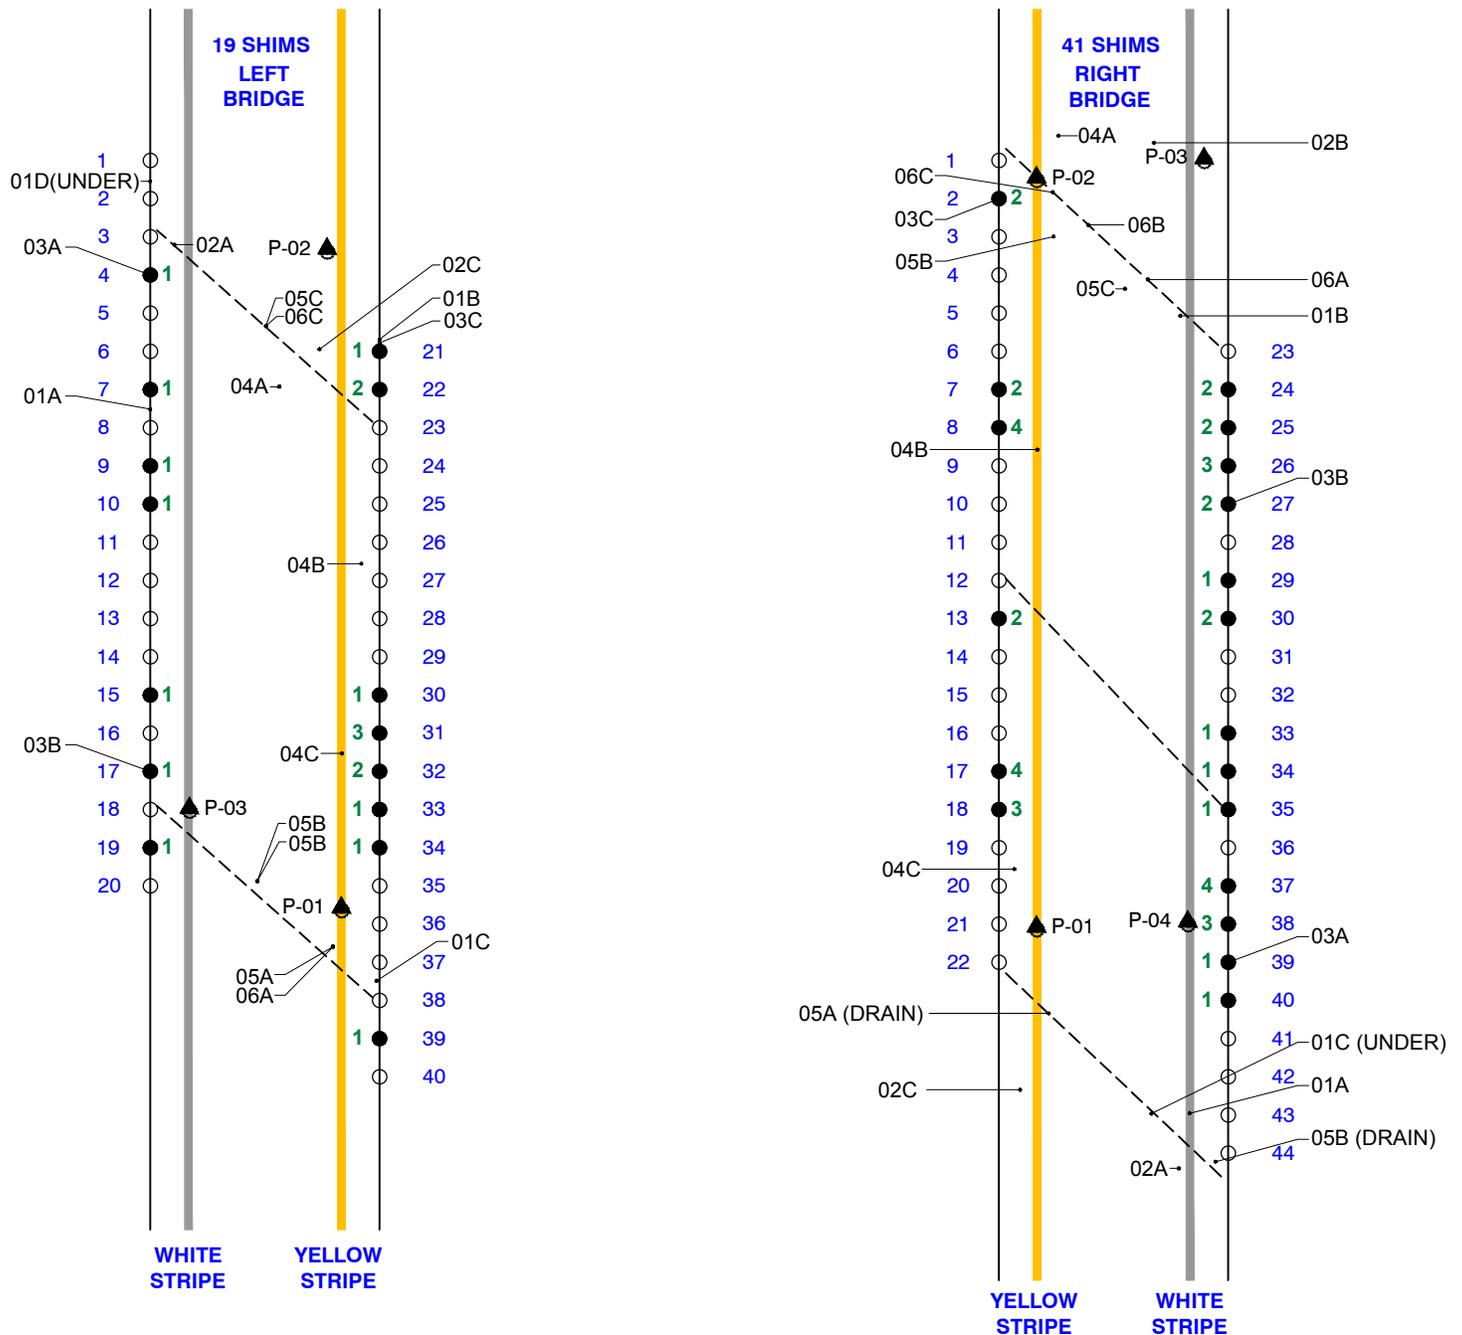
ACM/LBP SURVEY Task Order No. 20 HOFF WASH BRIDGES BRIDGE No. 54-0889 L & R SAN BERNARDINO COUNTY, CALIFORNIA PN# 185802876			FIGURE: <h1 style="text-align: center;">1</h1>	
	JOB NUMBER: 185802876	DRAWN BY: STA	CHECKED BY: AP	APPROVED BY: AP	DATE: 05/20/14

- 01 = CONCRETE
- 02 = ASPHALT
- 03 = SHIMS
- 04 = REFLECTOR MARKER
- 05 = CONCRETE (VERTICAL DRAIN)
- 06 = DRAIN LINING
- P = PAINTCHIP SAMPLE
- 2** ● GUARDRAIL POST OBSERVED WITH SHIMS
(ESTIMATED NUMBER OF SHIMS NOTED IN GREEN)
- 25** ○ GUARDRAIL POST OBSERVED
(NUMBER OF POSTS INDICATED IN BLUE)

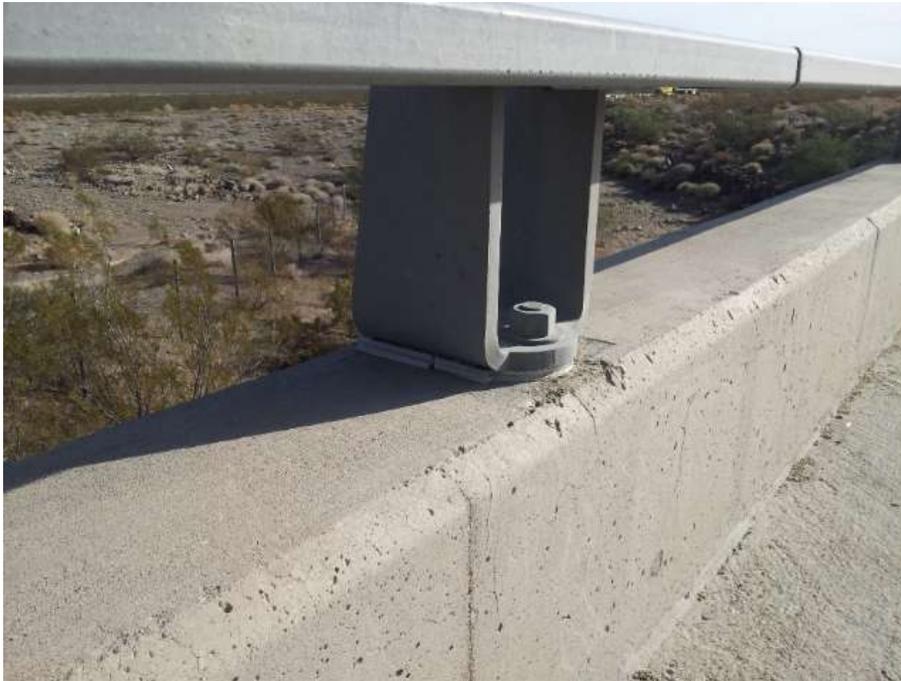
Photograph No. 3

Hoff Wash bridge guardrail post containing leveling shims.

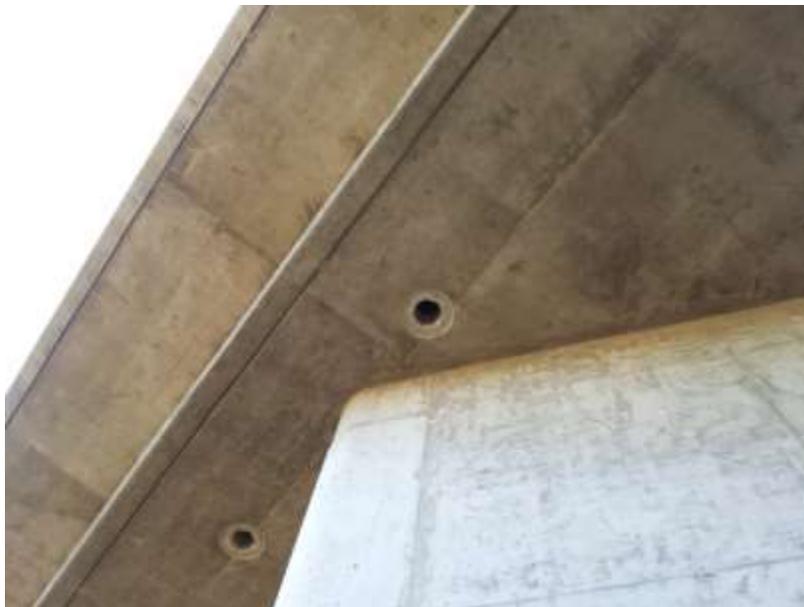
Photograph No. 4

Hoff Wash bridge view of several drain lines.

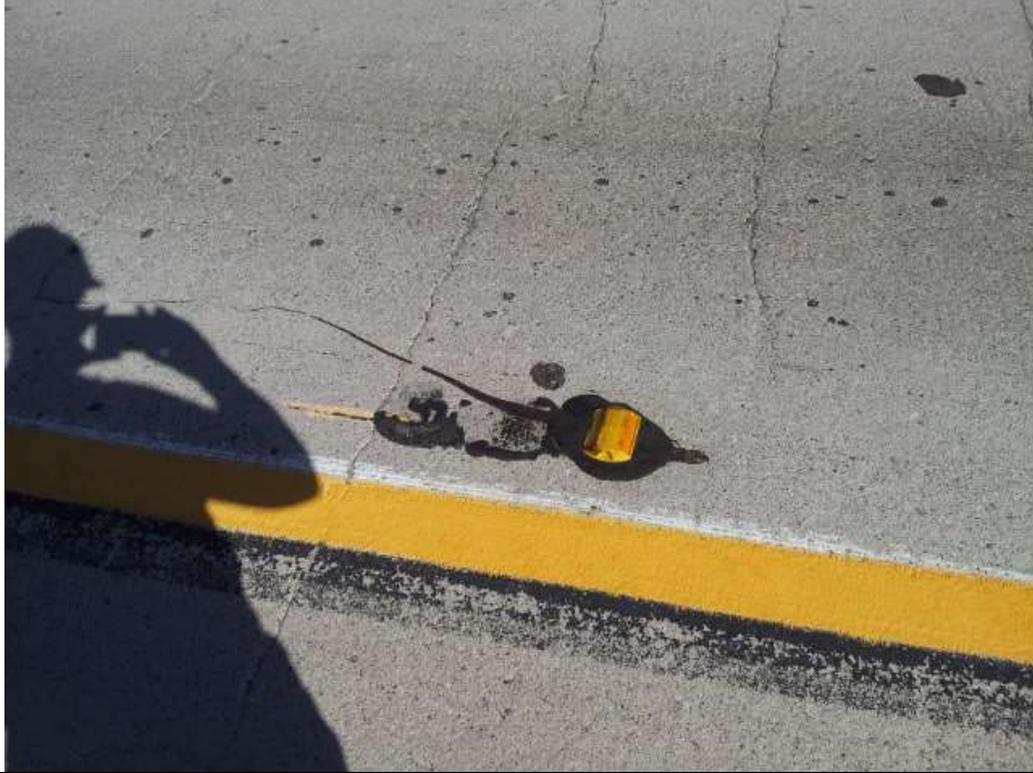
Photograph No. 5

Hoff Wash bridge yellow striping and reflective dot mastics.

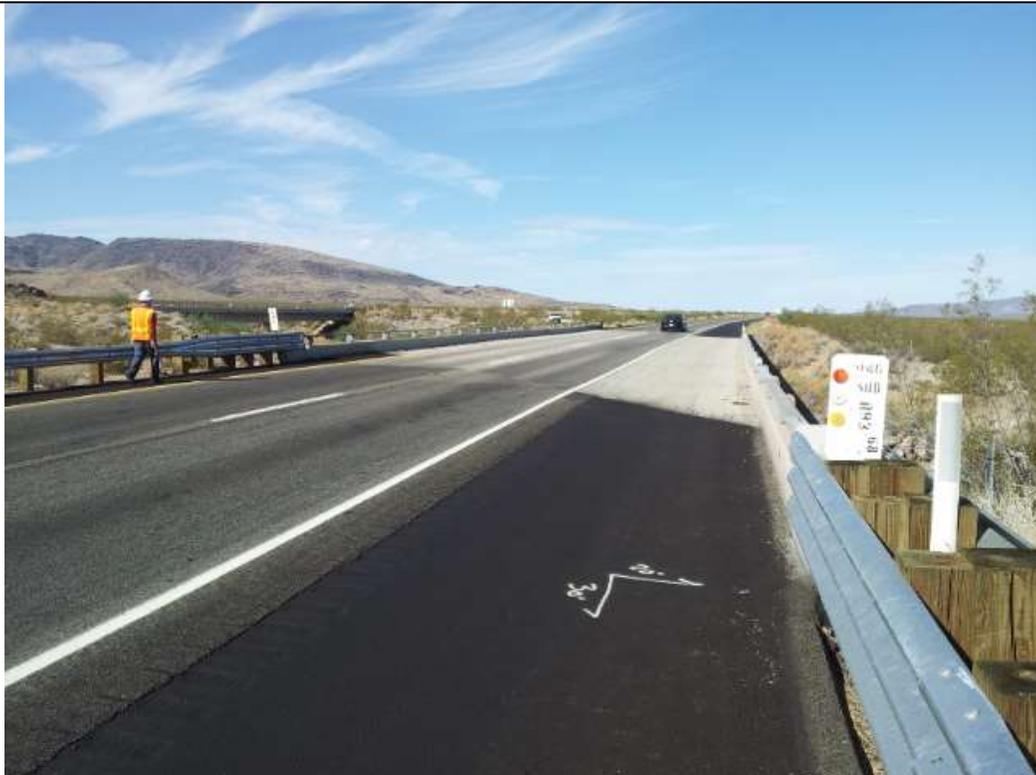
Photograph No. 6

Hoff Wash bridge white roadway striping.
