Foundation Report for Log Fill Repair Wall dated October 2, 2014

Date: October 2, 2014
File: 01-DN-101-PM 17.5
EFIS ID: 0112000112
Retaining Wall No.: 01E0016

Subject: Foundation Report for Log Fill Repair Wall

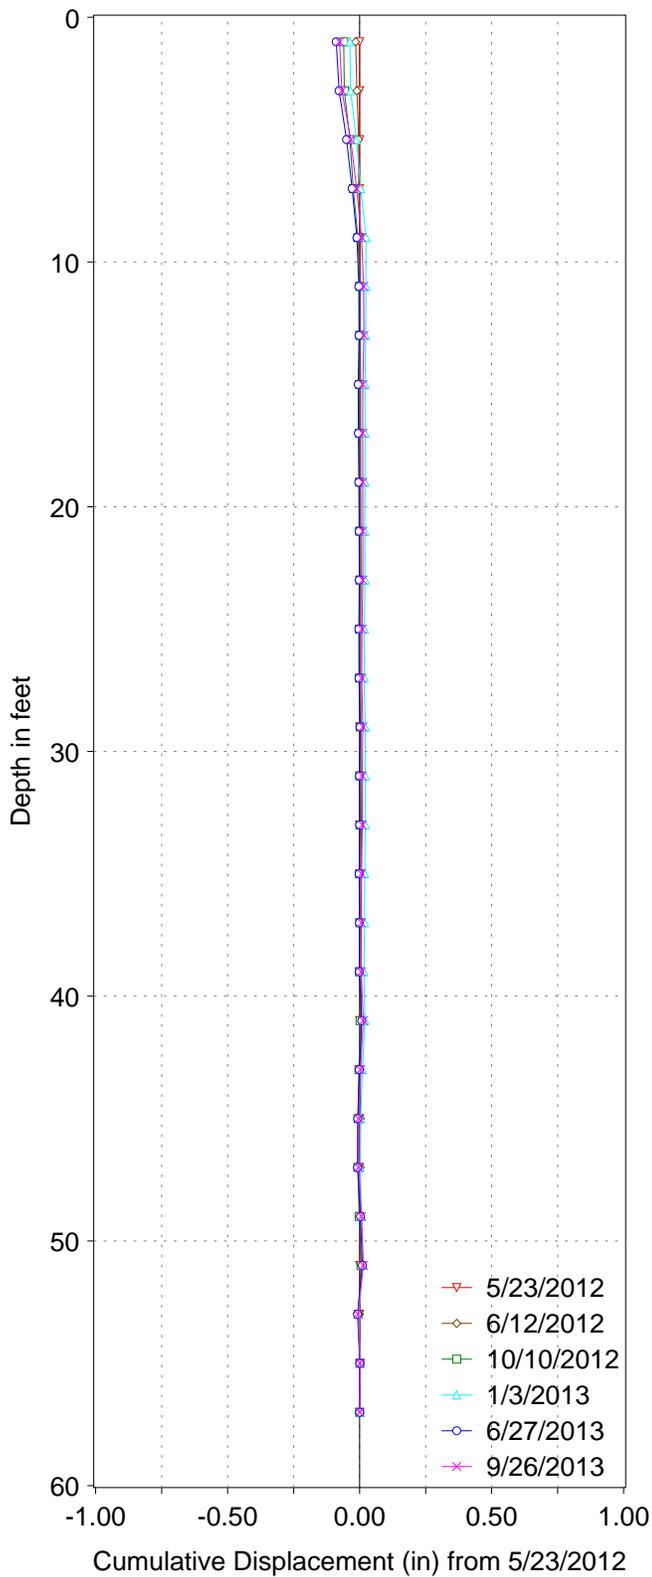
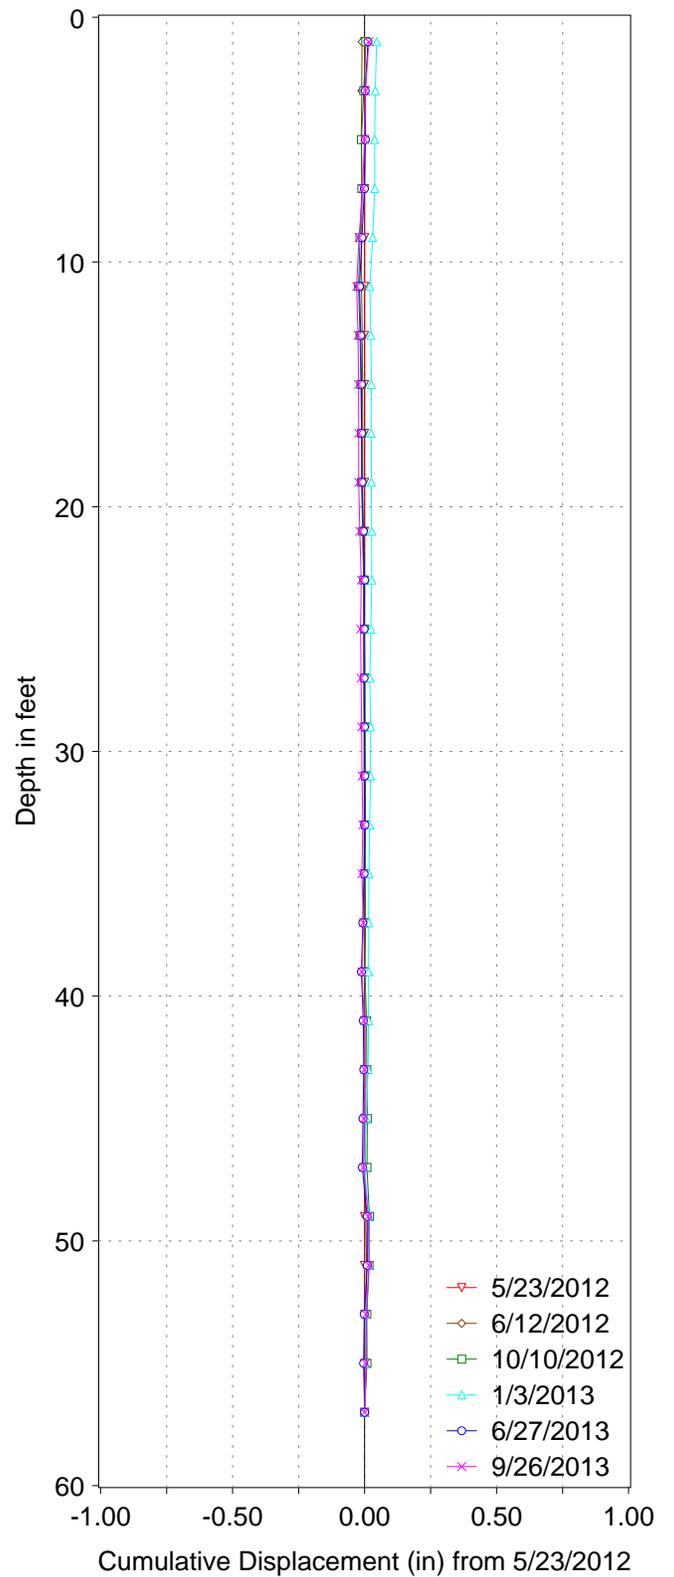
RC-12-003, A-Axis

Depth of casing: 39.0 ft
 A0 direction (magnetic north): 250 deg.
 Location: N41°40'05.7", W124°06'47.1"

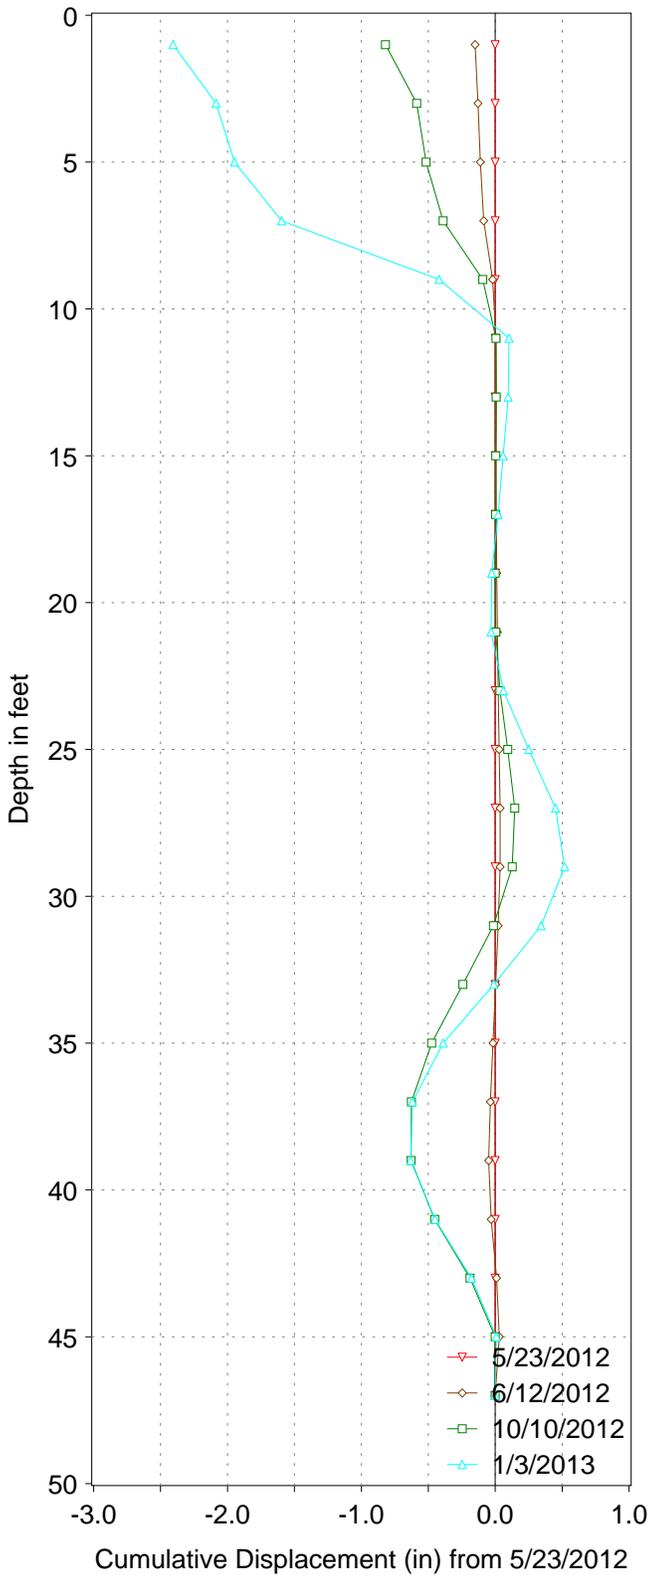
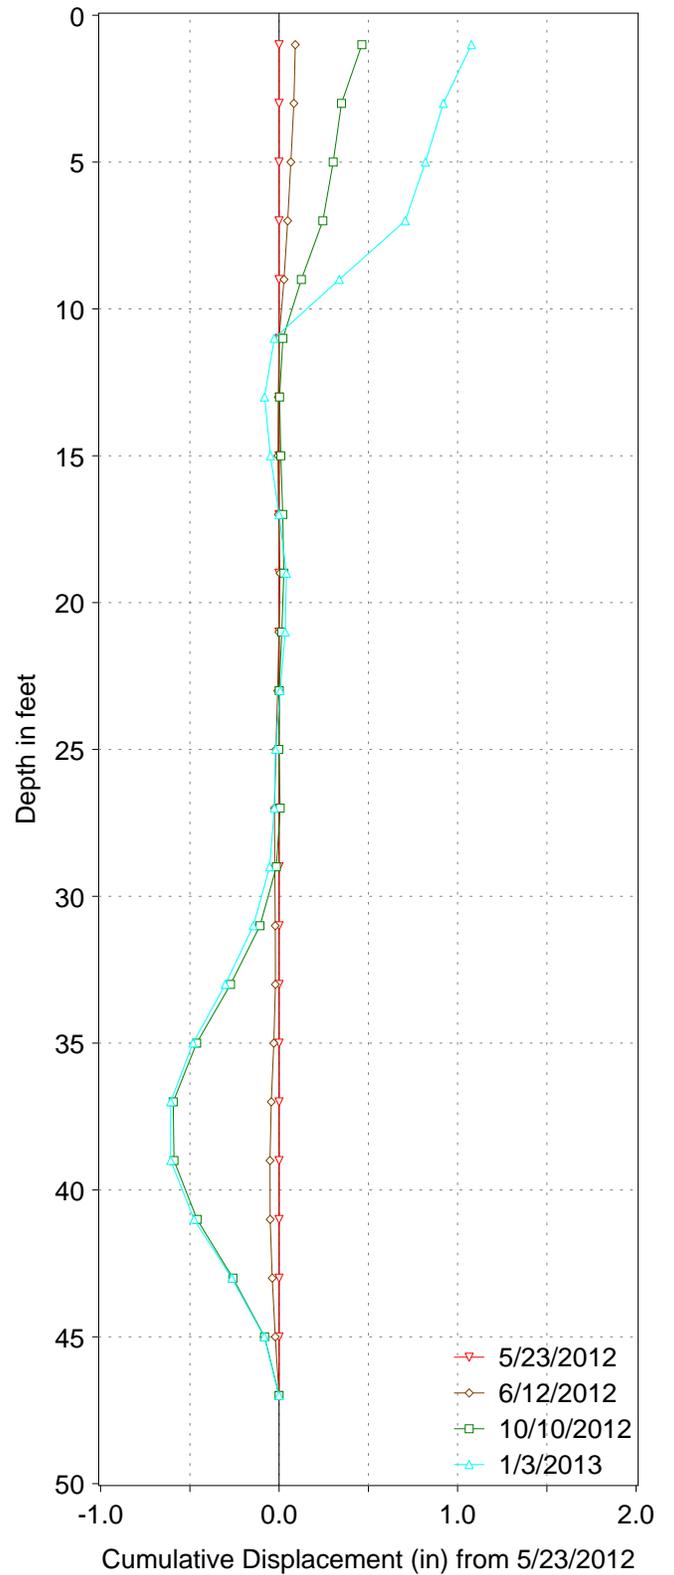
RC-12-004, A-Axis

Depth of casing: 60 ft
 A0 direction (magnetic north): 262 deg.
 Location: N41°40'05.9", W124°06'47.6"

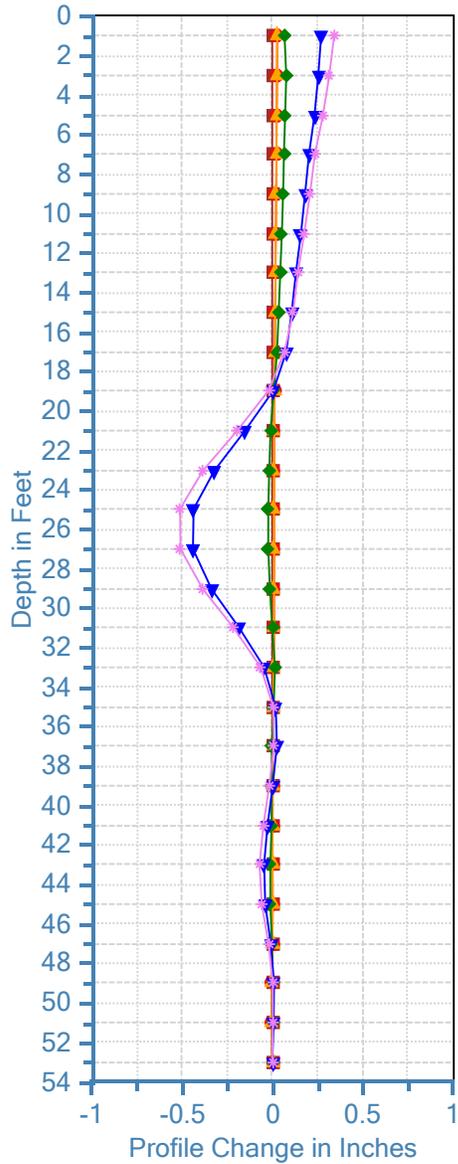
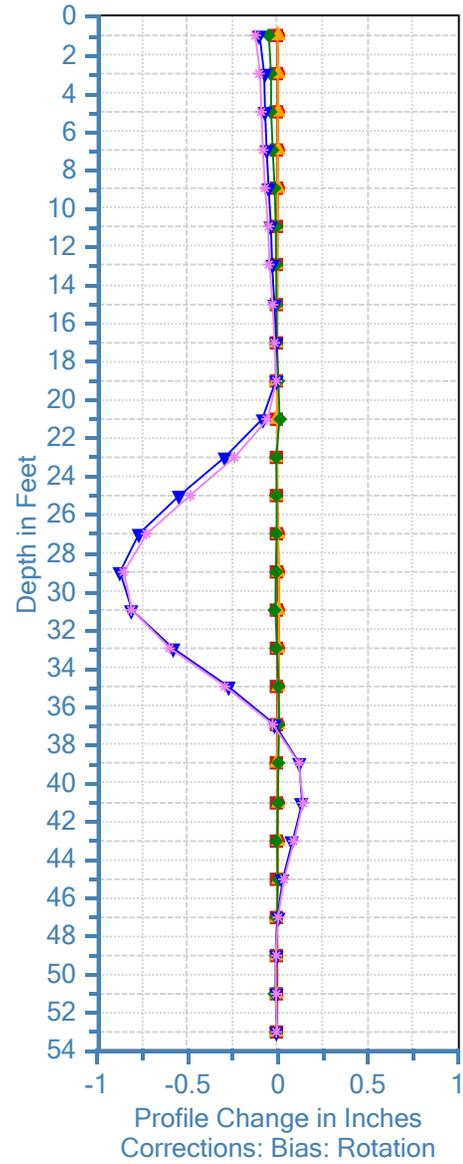
RC-13-008, A-Axis

Depth of Casing: 56 ft
 A0 direction (magnetic north): 254 deg.
 Location: N41°40'06.6", W124°06'50.0"
