INFORMATION HANDOUT

At Paradise Valley Maintenance Station in San Bernardino County

**ASBESTOS AND DETERIORATED LEAD-CONTAINING PAINT SURVAY
REPORT**

Subject: ASBESTOS AND DETERIORATED LEAD-CONTAINING PAINT SURVEY
REPORT
CALTRANS MAINTENANCE YARD
6690 LA CONTENNA ROAD
YUCCA VALLEY, CALIFORNIA

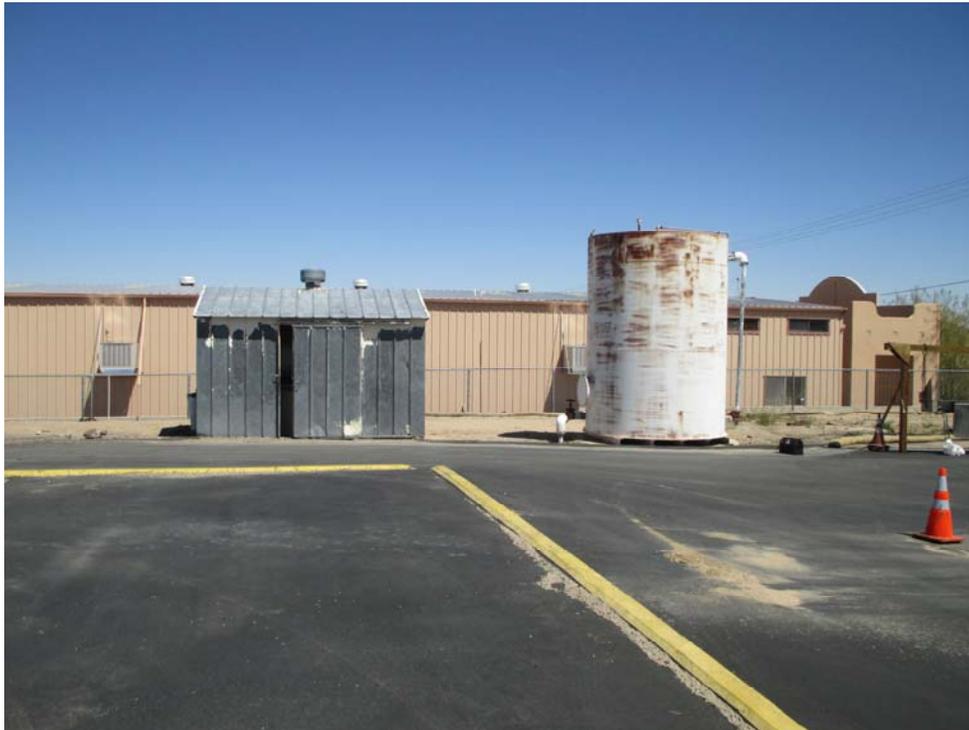
Mojave Desert Air Quality Management District (MDAQMD) regulations require that the asbestos-containing sealant on the water tank and white/gray sealant on the emulsion tank, (NESHAP Category I nonfriable/nonhazardous material) identified during our asbestos survey be removed and disposed of prior to renovation or demolition activities that would disturb the material. This material can be disposed of as non-hazardous waste. However, *disturbance* of the material is still covered by the Cal/OSHA asbestos standard (Title 8, CCR Section 1529).

Photo 1 – View looking north at the water pump shed and water tank.

We recommend the notification of contractors (that will be conducting demolition, renovation, or related activities) and/or facility occupants of the presence of asbestos in their work areas (i.e., provide the occupants and contractor[s] with a copy of this report and a list of asbestos removed by asbestos abatement contractor[s] during subsequent abatement activities). Contractors should be instructed not to disturb asbestos during their work.

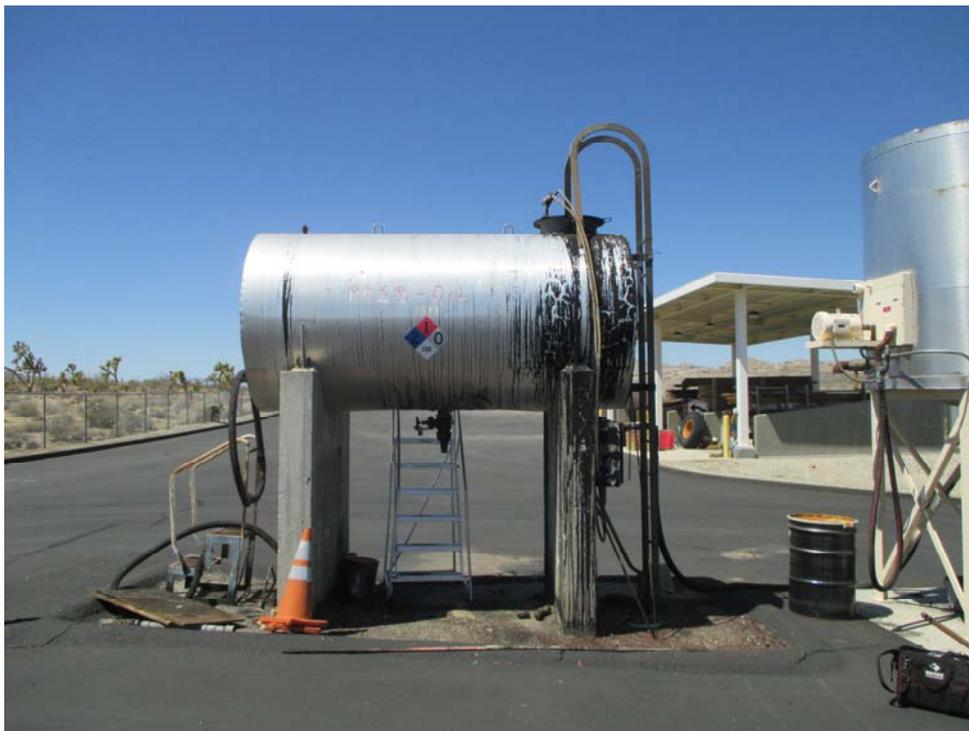
Photo 2 – View looking west at the emulsion tank.
