INFORMATION HANDOUT

ASBESTOS AND LEAD-CONTAINING PAINT SURVEY REPORT

**Tuolumne River Bridge (32-0018)
Tuolumne County, California**

FEBRUARY 2013

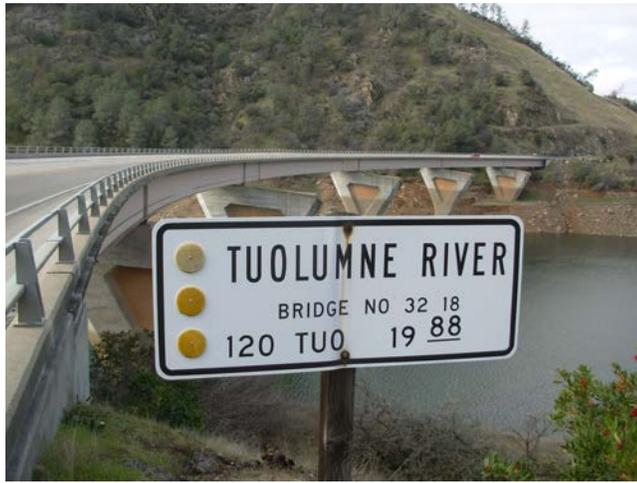
Photo 1 – Tuolumne River Bridge (32-0018) on Highway 120 in Tuolumne County, California
