**PRELIMINARY RECOMMENDATIONS FOR RIPPABILITY FOR MANZANITA
CHUTE CURVE IMPROVEMENT**

ROUTE: 02-Sha-44-46.6/48.3

File: 02-SHA-44-PM46.9/48.3
Manzanita Chute
02-4C9401

Subject: Preliminary Recommendations for Rippability for Manzanita Chute Curve Improvement

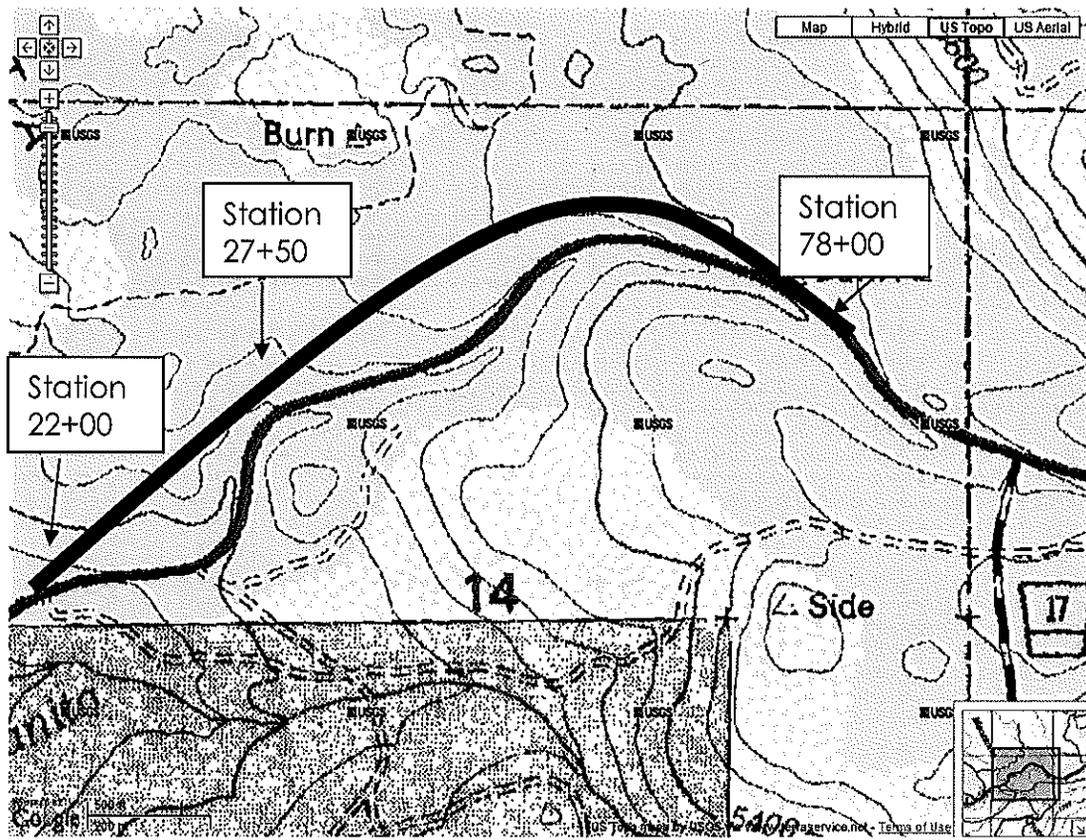
Figure 1. Sketch of the proposed re-alignment indicating approximate locations of the seismic lines

This memo documents the results of a refraction seismic survey to assist in the design of roadway improvements for Highway 44 between PM 46.9 to 48.3. The seismic refraction survey was employed determine the rippability of the material proposed to be removed to accommodate the new alignment. Three refraction profiles were surveyed over two visits. Snow cover restricted access to some degree. The deepest cuts were prioritized. Figure 1 shows the approximate locations of the seismic lines.

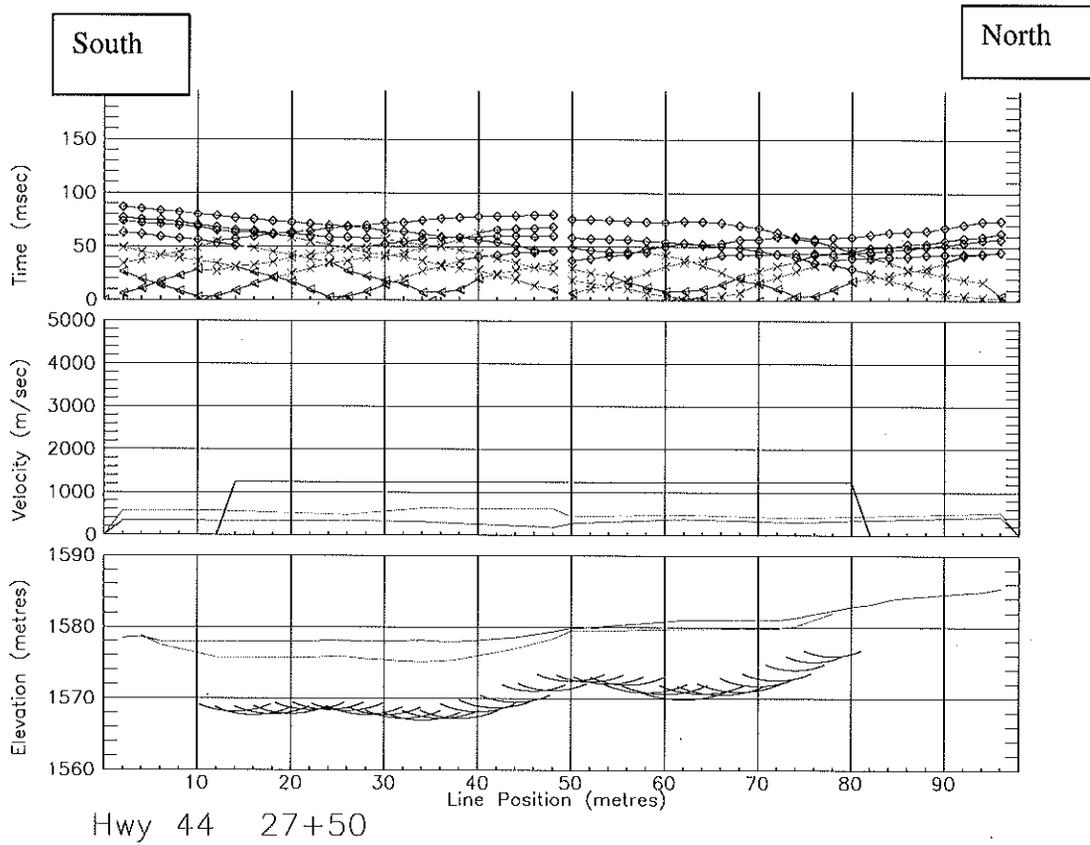
Figure 2. Travel-time curve, velocity model and depth section for seismic line @ 27+50. Cut here is expected to be 30 feet (9.14 meters). Model indicates material at that depth has a seismic velocity of 1200meters/ second

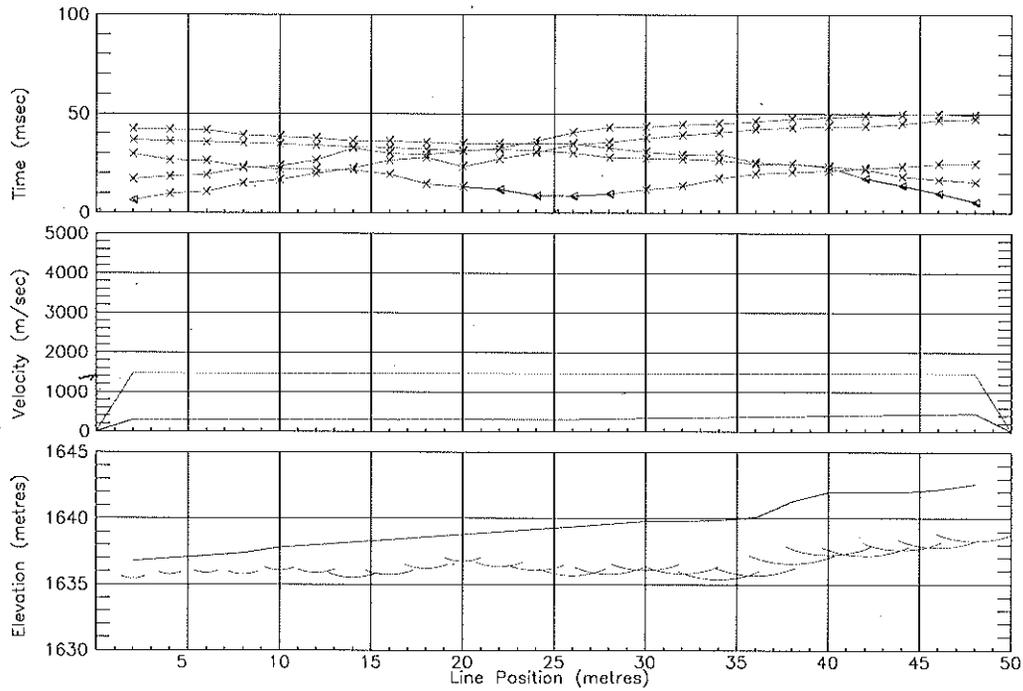
HWY44 STATION 78+00

Figure 3. Travel time curve, velocity model and depth section for seismic line at 78+00 where cuts are expected to be 28 feet (8.53 meters). This model indicates material at that depth has a seismic velocity of 1420 meters per second.

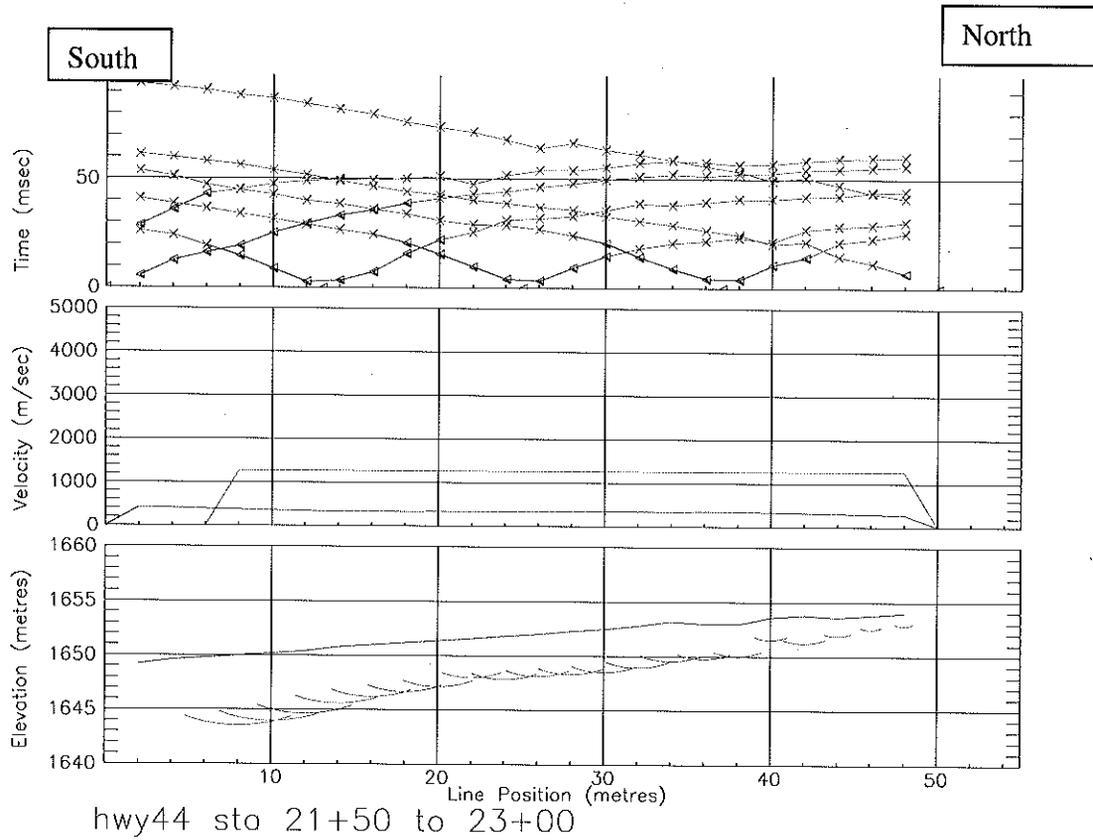
Figure 4 Travel-time curve, velocity model and depth section for seismic line @ station 22+00
