# INFORMATION HANDOUT

For Contract No. 10-0X2104

# LIMITED ASBESTOS AND DETERIORATED LEAD-CONTAINING PAINT SURVEY REPORT

District 10 Maintenance Stations  
Camp Connell, Peddler Hill,  
and Woodfords, California

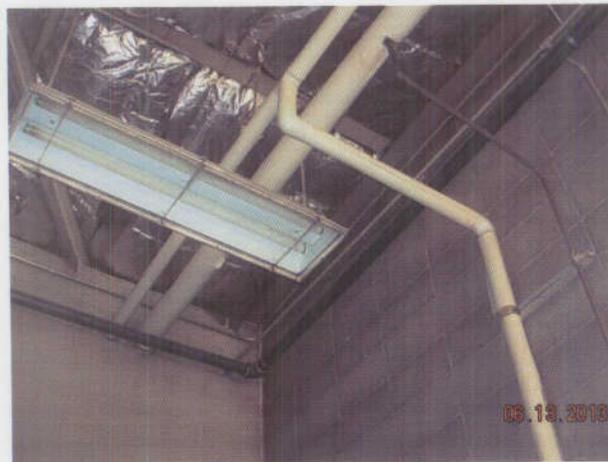
**Photo 5 – Fiberglass pipe insulation at site of proposed brine water treatment system, Camp Connell MS**

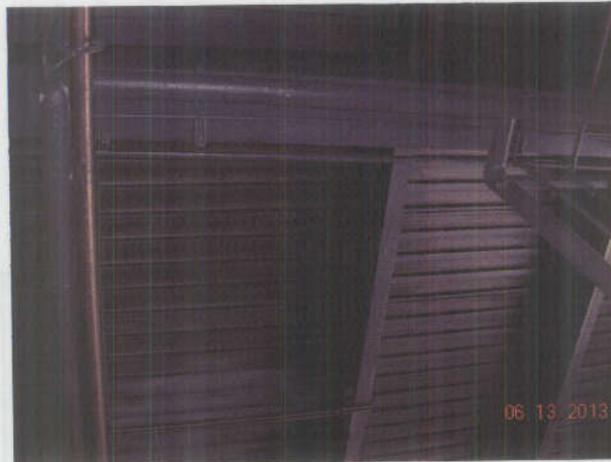
**Photo 11 – Asbestos pipe insulation at site of proposed brine water treatment system, Peddler Hill MS**

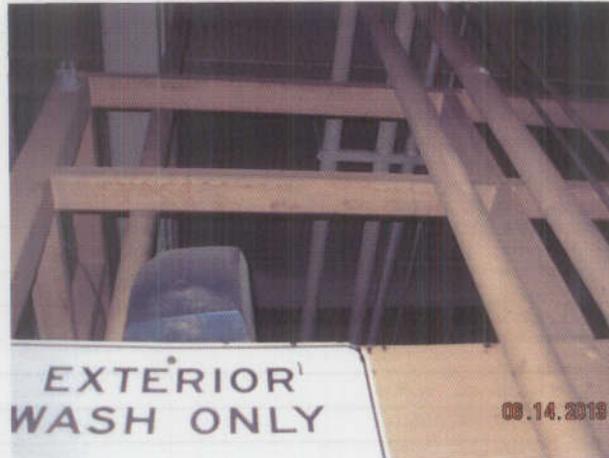
Photo 16 – Asbestos pipe insulation at site of proposed brine water treatment system, Woodfords MS

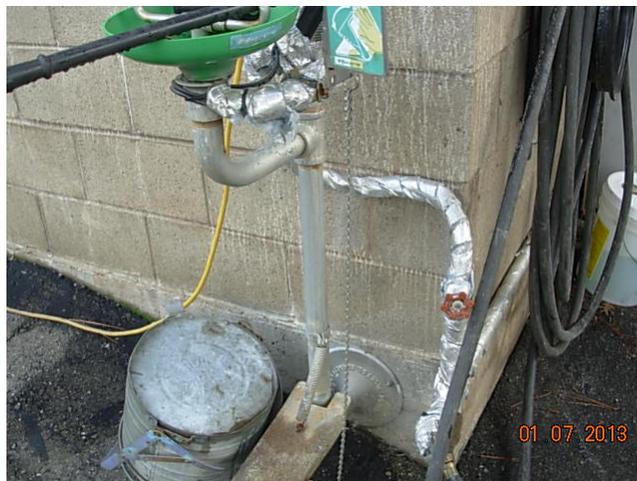
**Photo 2 – Pipe insulation**

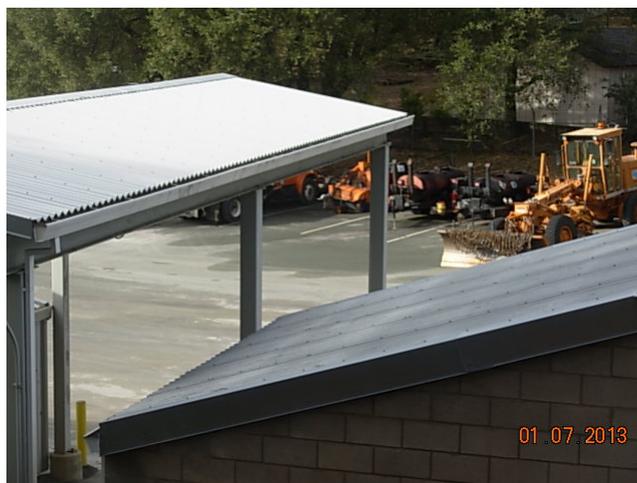
**Photo 6 – Corrugated metal roofing (non-suspect)**

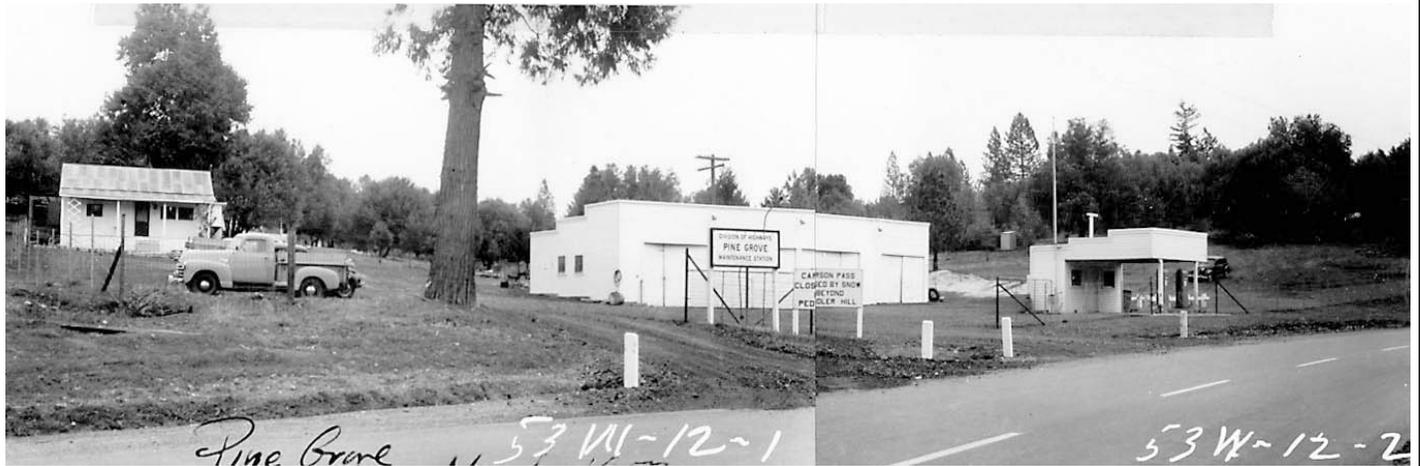
Photo No. 1 Former Garage and Service Station - 1953

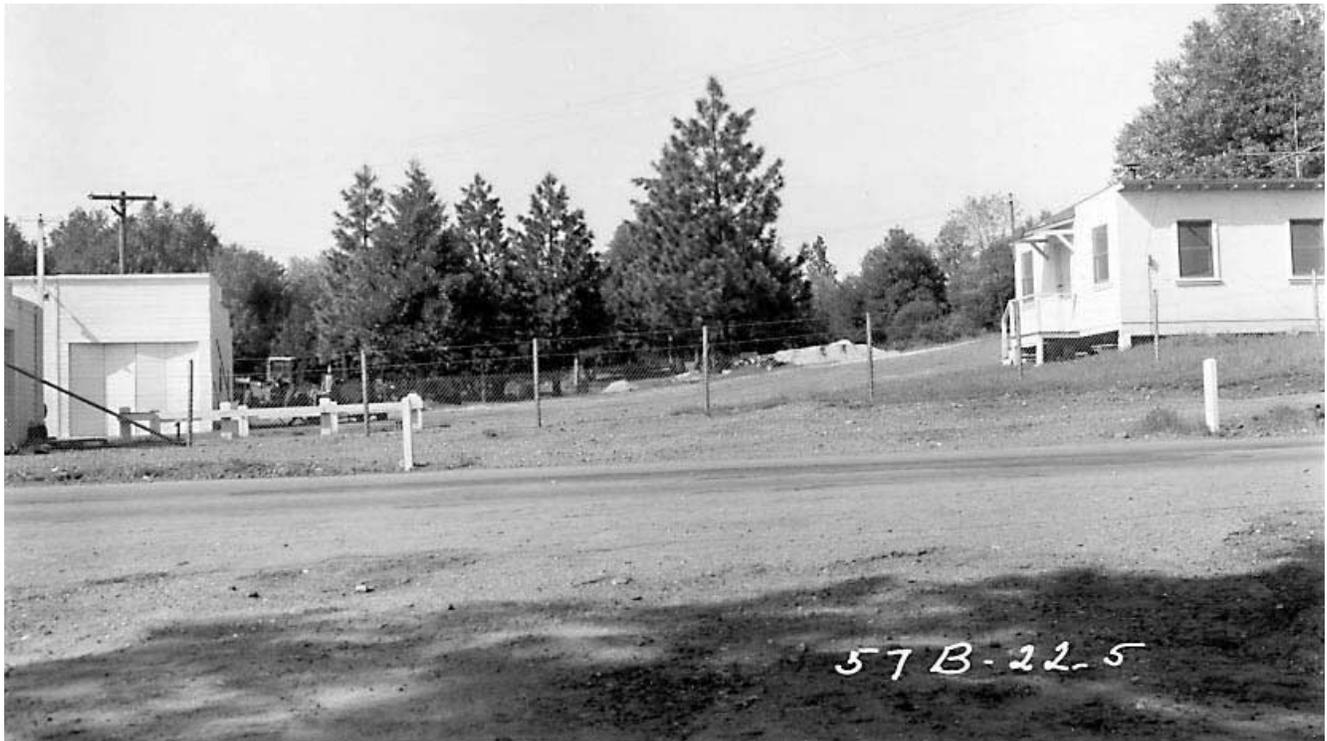
Photo No. 2 Former Service Station and Former Office on the Southern Site Boundary - 1957

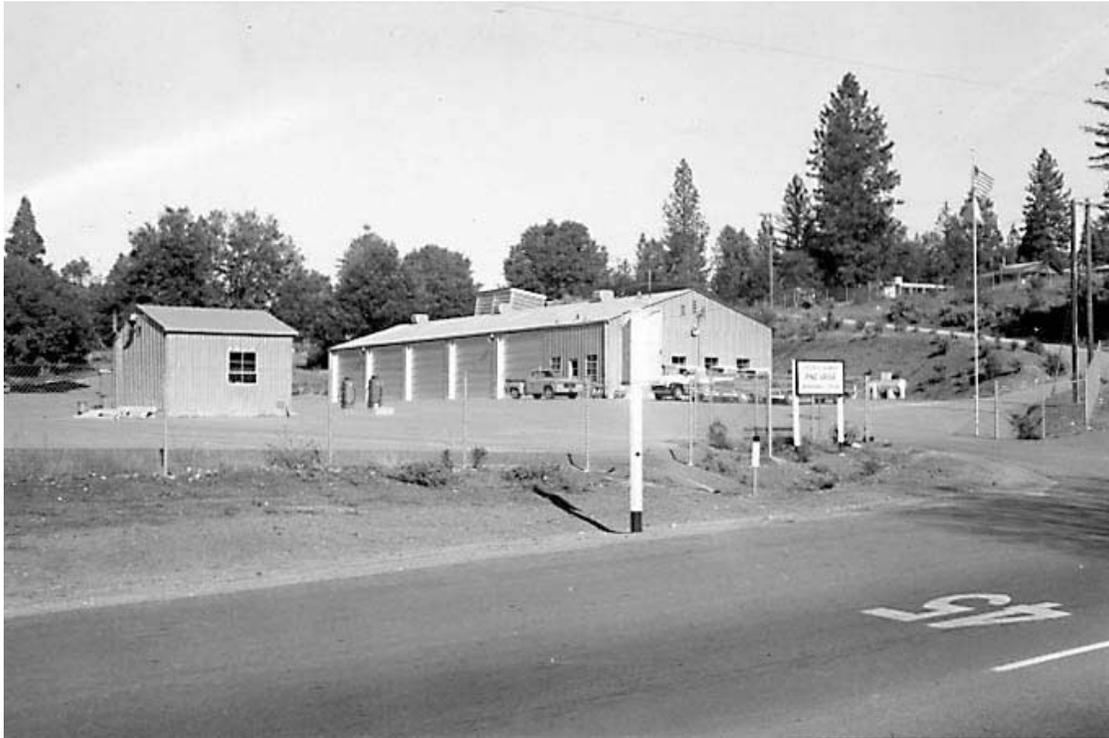
Photo No. 3 Southern Gas House and Equipment Building

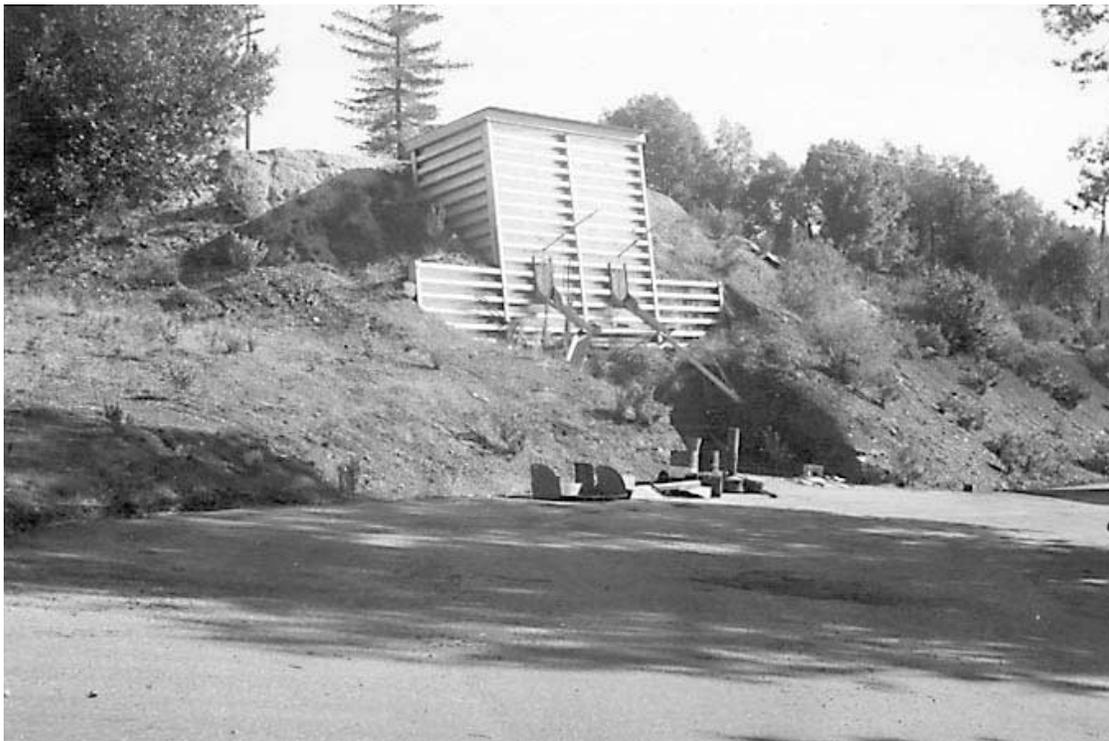
Photo No. 4 Former Sand Bunker Located Northeast of the Equipment Building

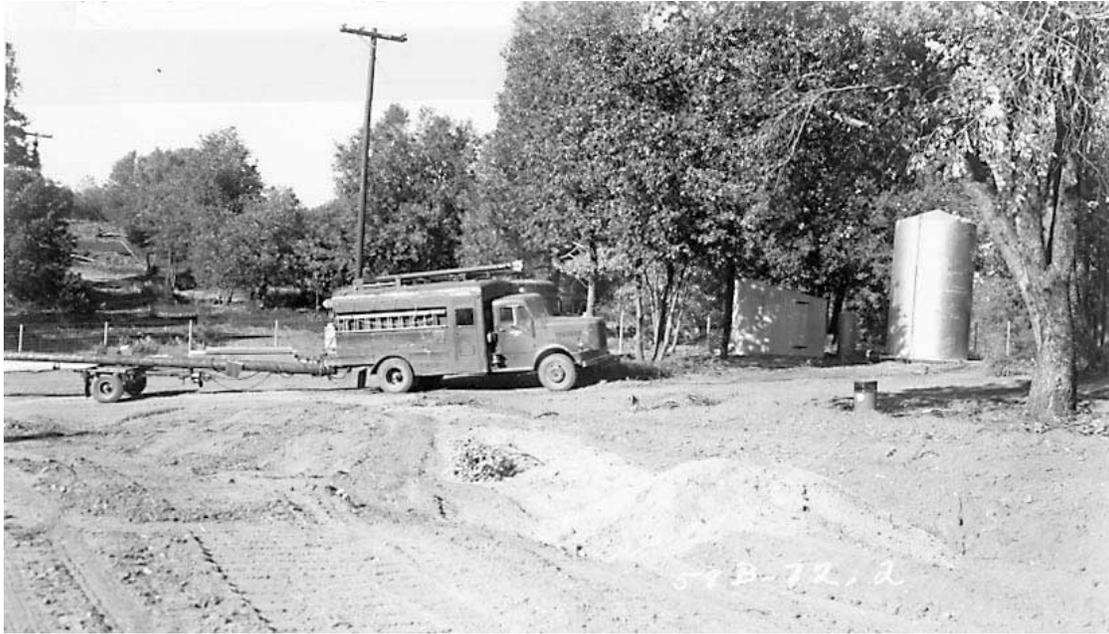
Photo No. 5 Well House and Water Tank Noted at the CDF Facility - 1959

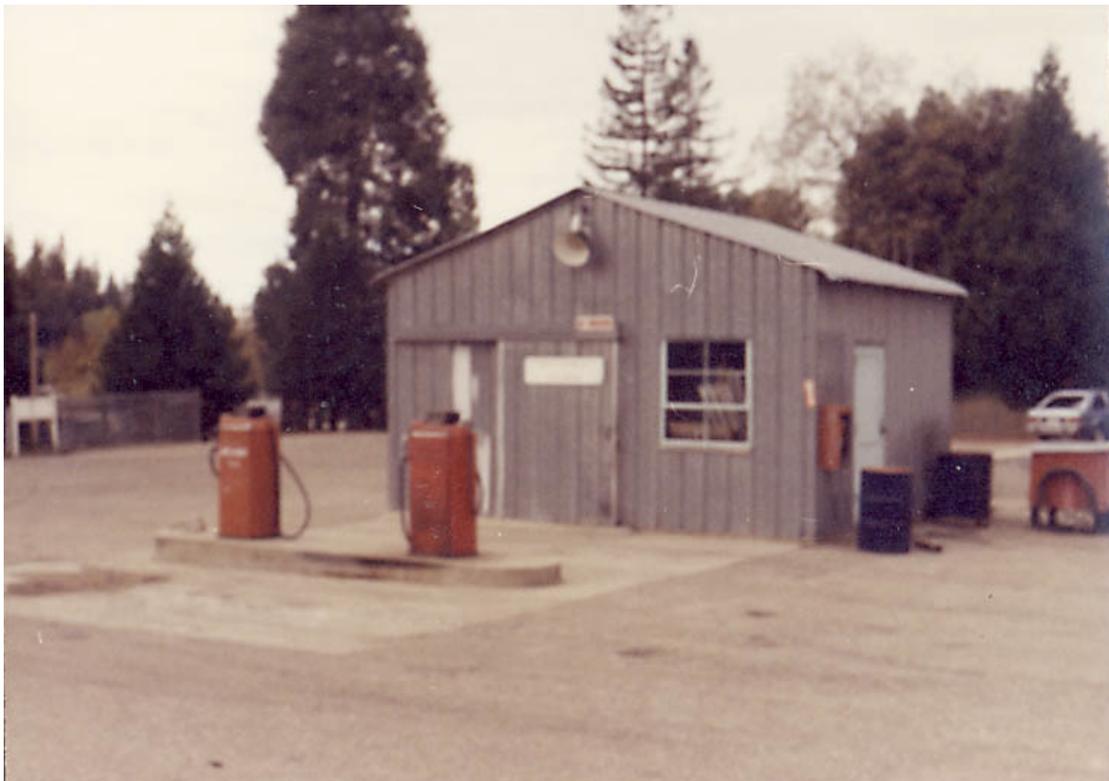
Photo No. 6 Southern Gas House - 1982

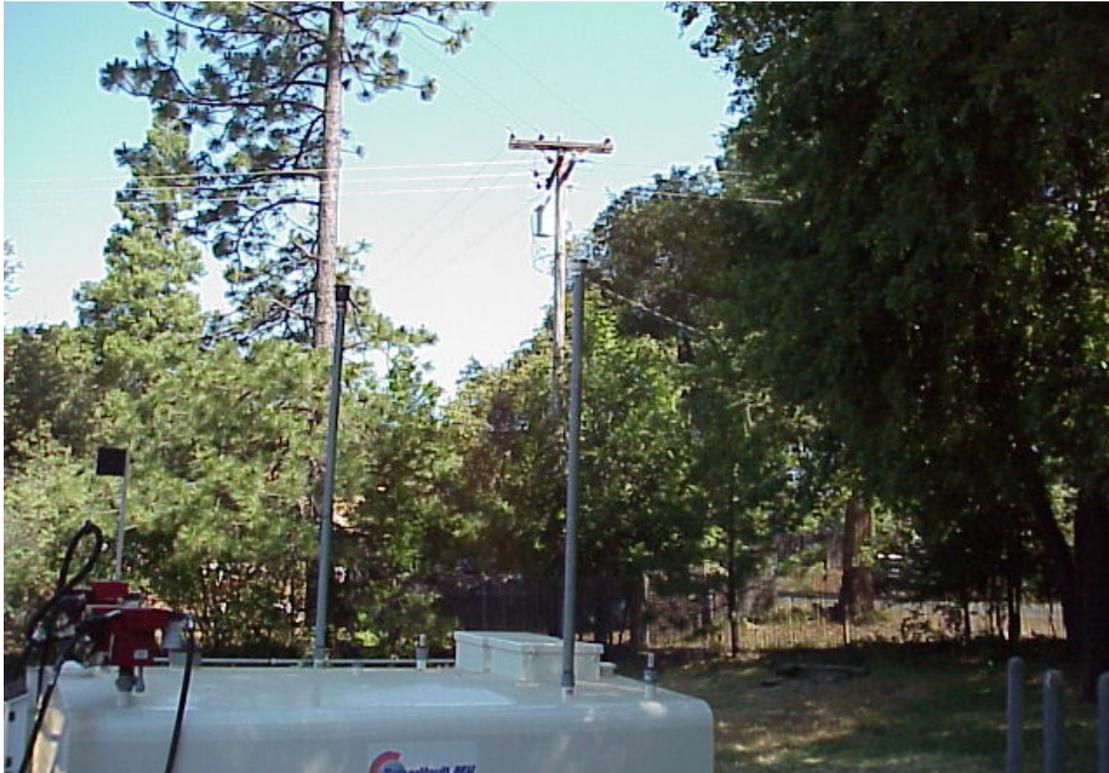
Photo No. 5 Pole-Mounted Transformer Located in the Northeast Corner of the CDF Facility

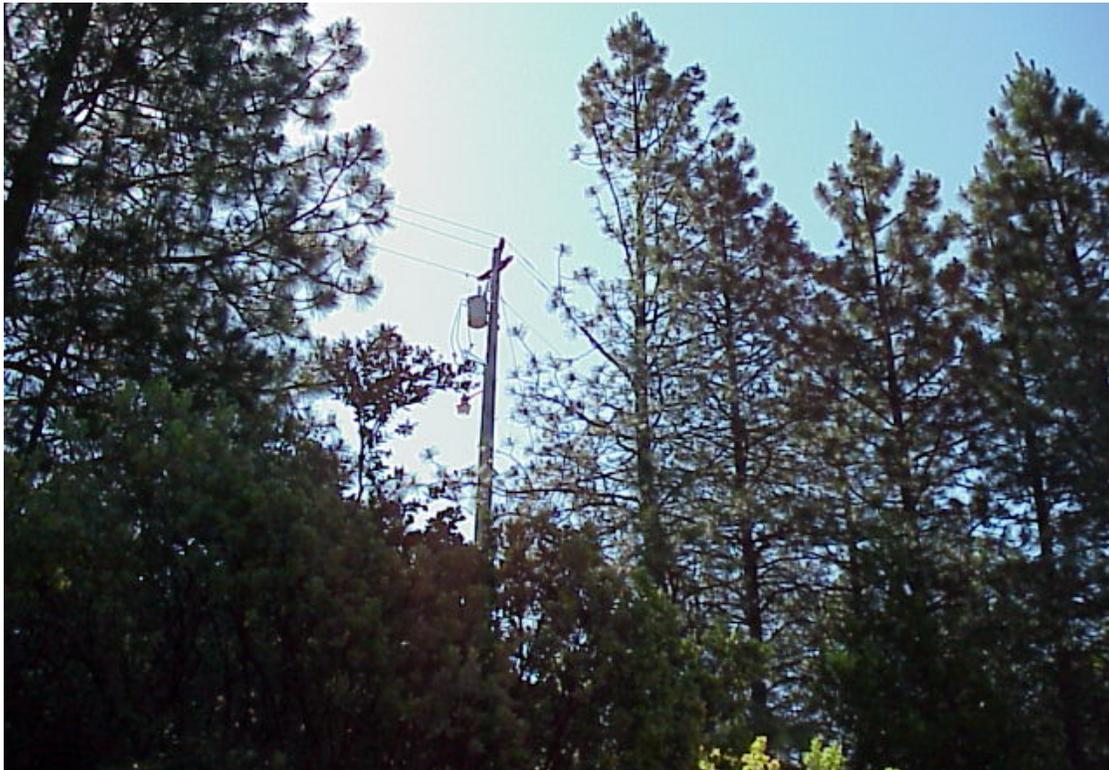
Photo No. 6 Pole-Mounted Transformer Located North of the Former Sand Bunker at the CDF Facility (Map ID No. 2)

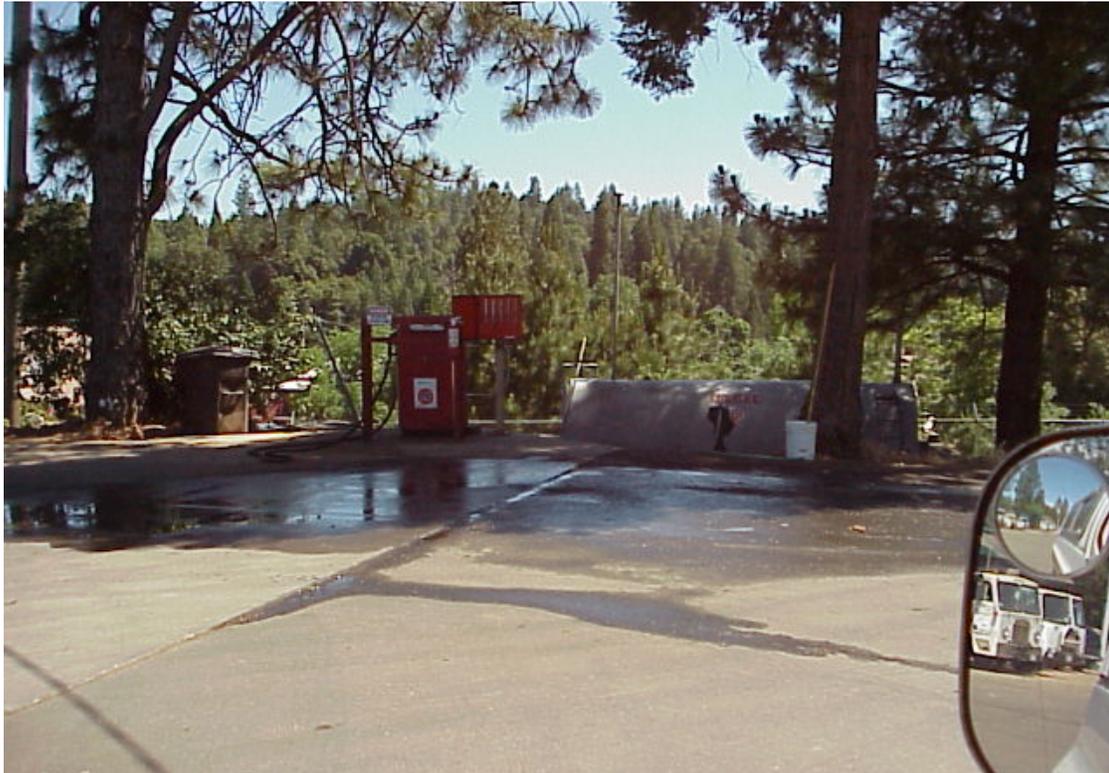
Photo No. 11 ASTs Located at Amador County Environmental (Pine Grove Public Refuse Transfer Station) (Map ID No. 5)

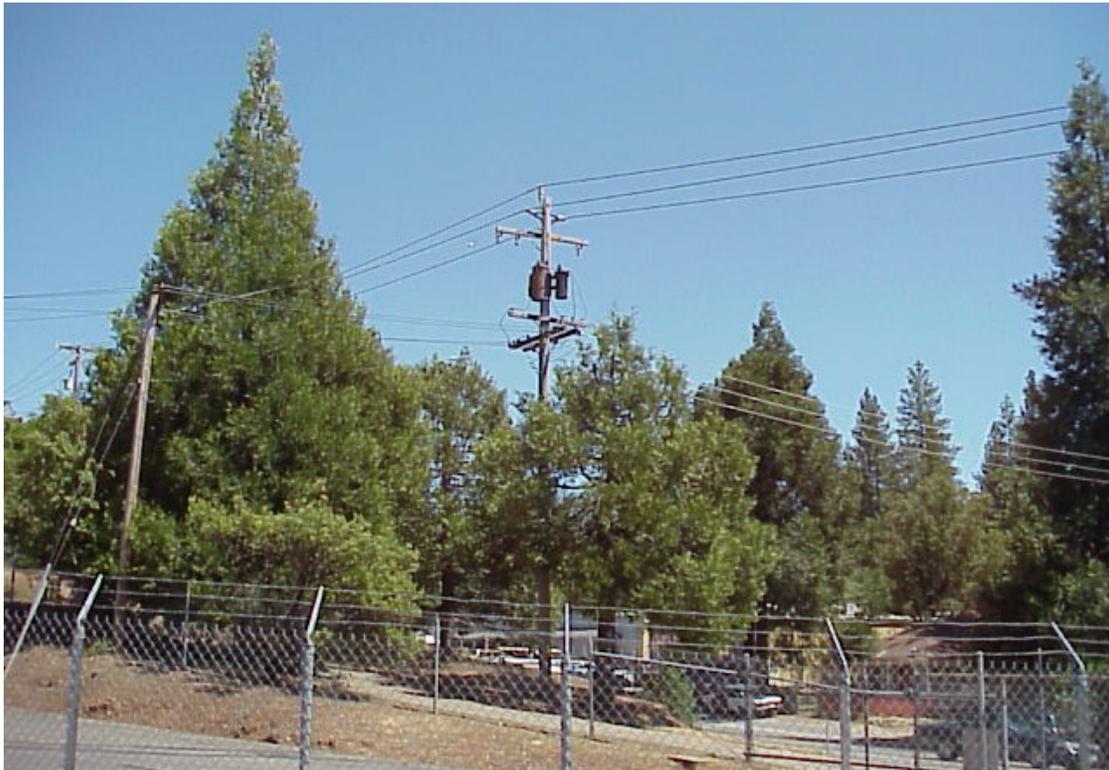
Photo No. 12 Two Pole-Mounted Transformers Located South of the Site

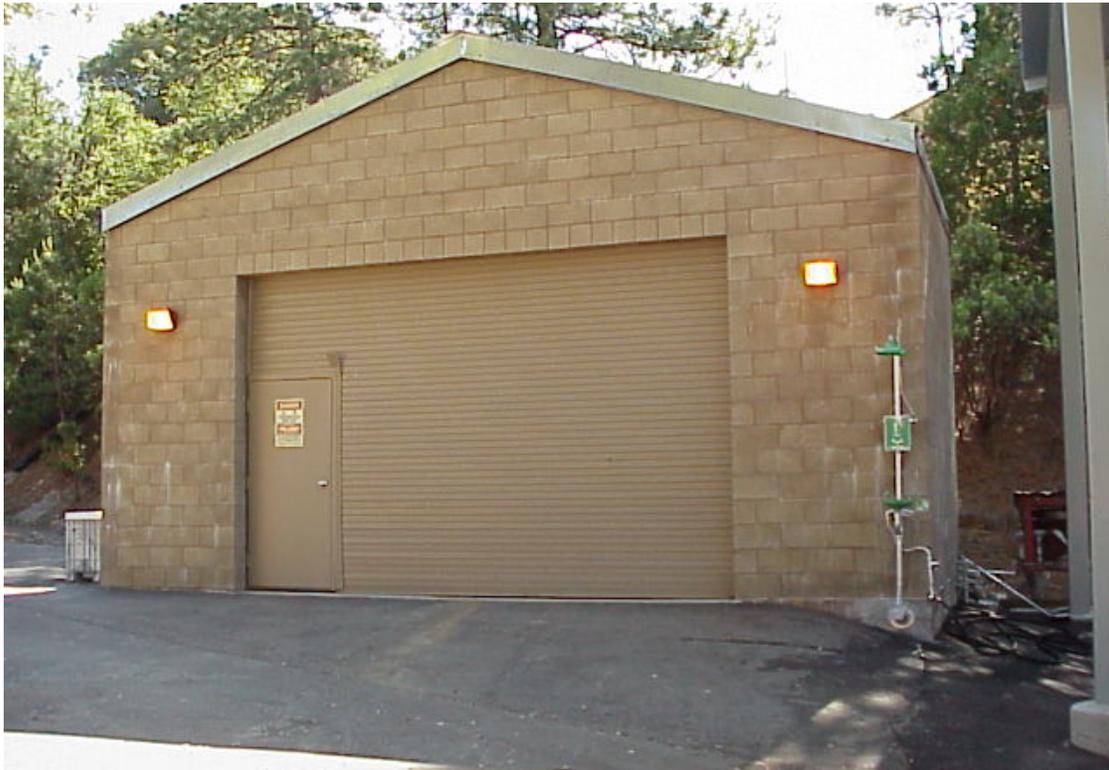
Photo No. 6 Chemical Storage Building Located North of the Wash Rack

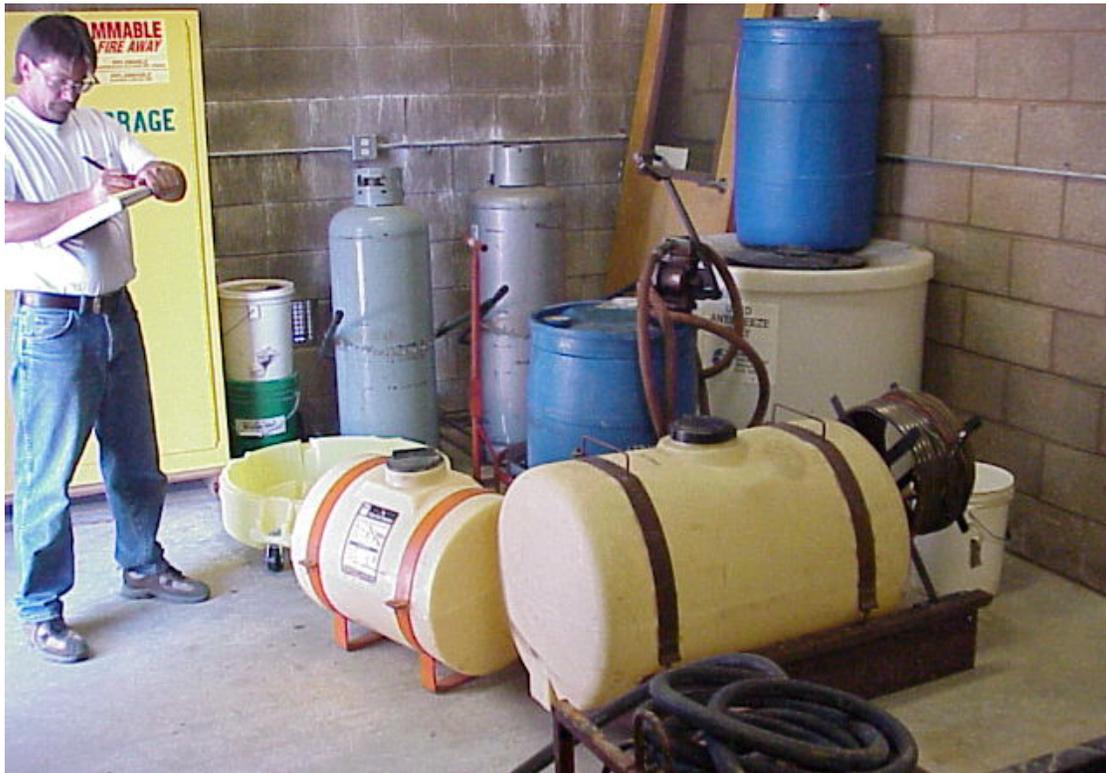
Photo No. 7 Herbicide ASTs, Propane, Antifreeze AST and Flammable Storage Locker in the Chemical Storage Building

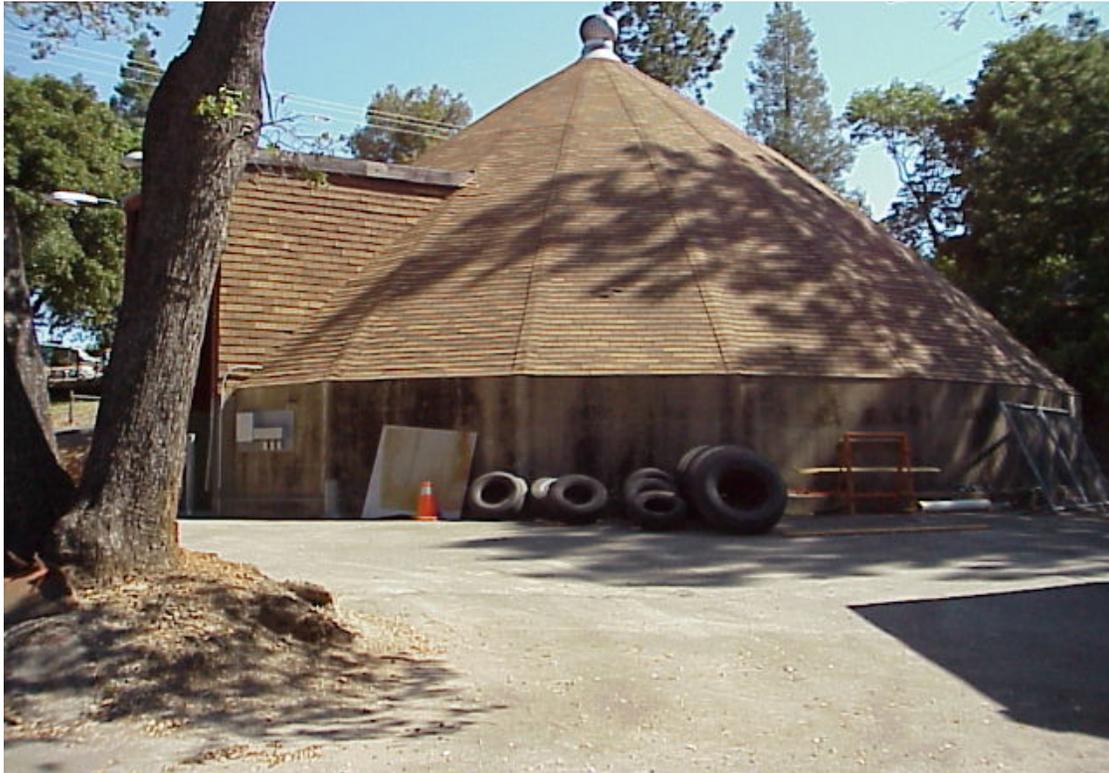
Photo No. 9 Sand House

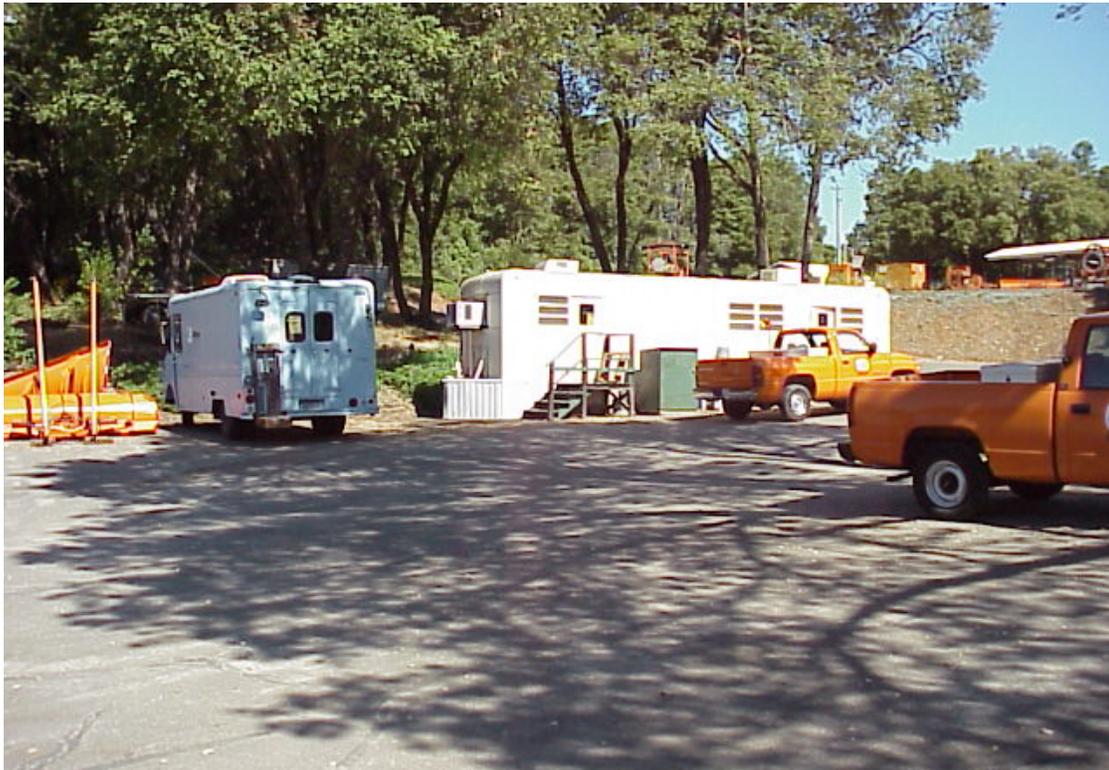
Photo No. 10 Resident Engineer Trailer and Van Used for Soils Laboratory and Nuclear Gauge Storage

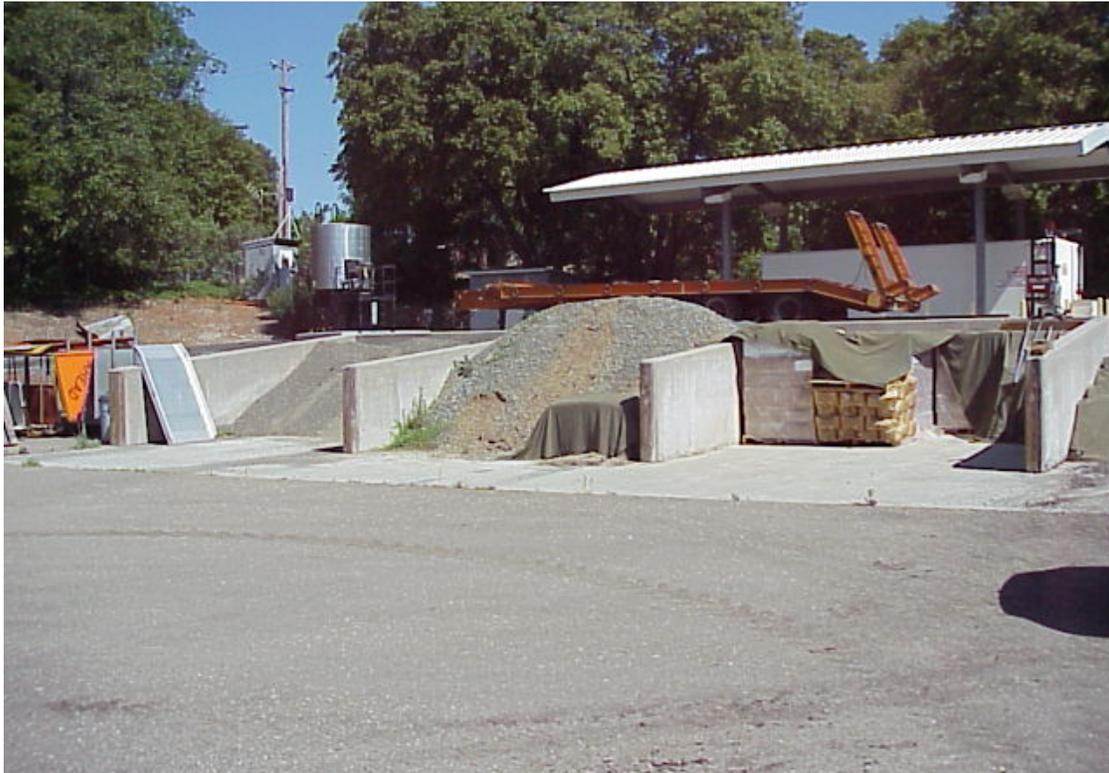
Photo No. 11 Looking Northwest at Material Storage Bins

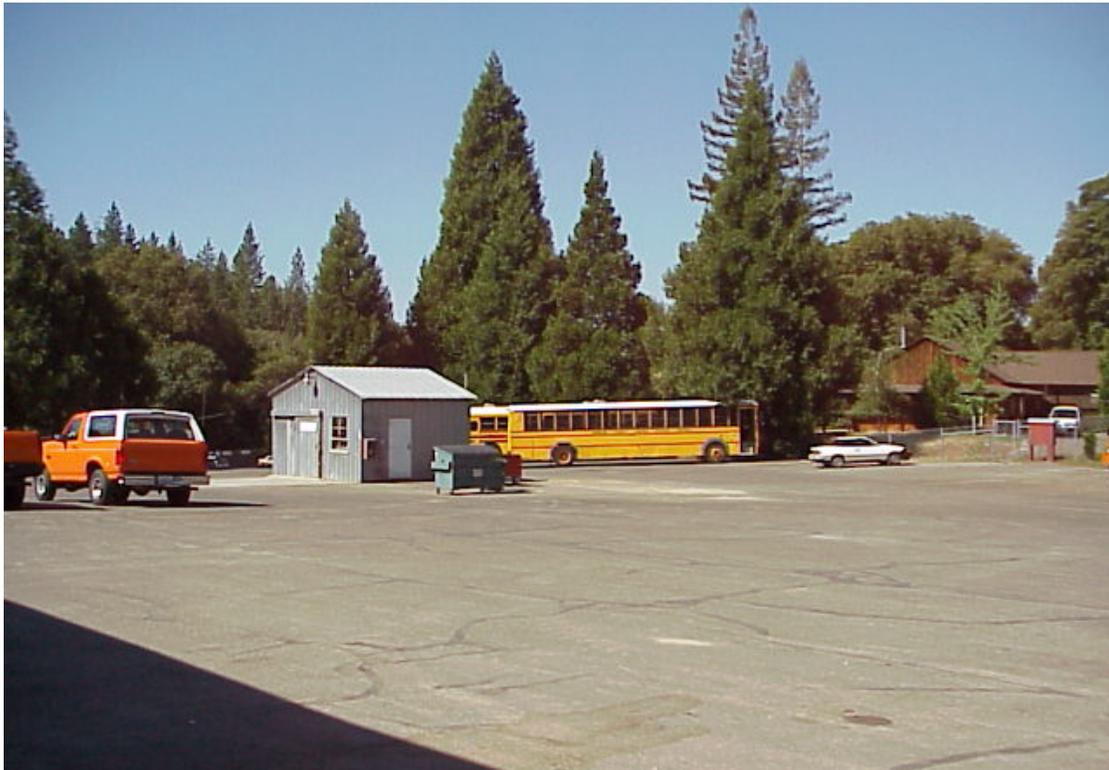
Photo No. 12 Looking Southwest at the Southern Gas House and School Bus Parking Area

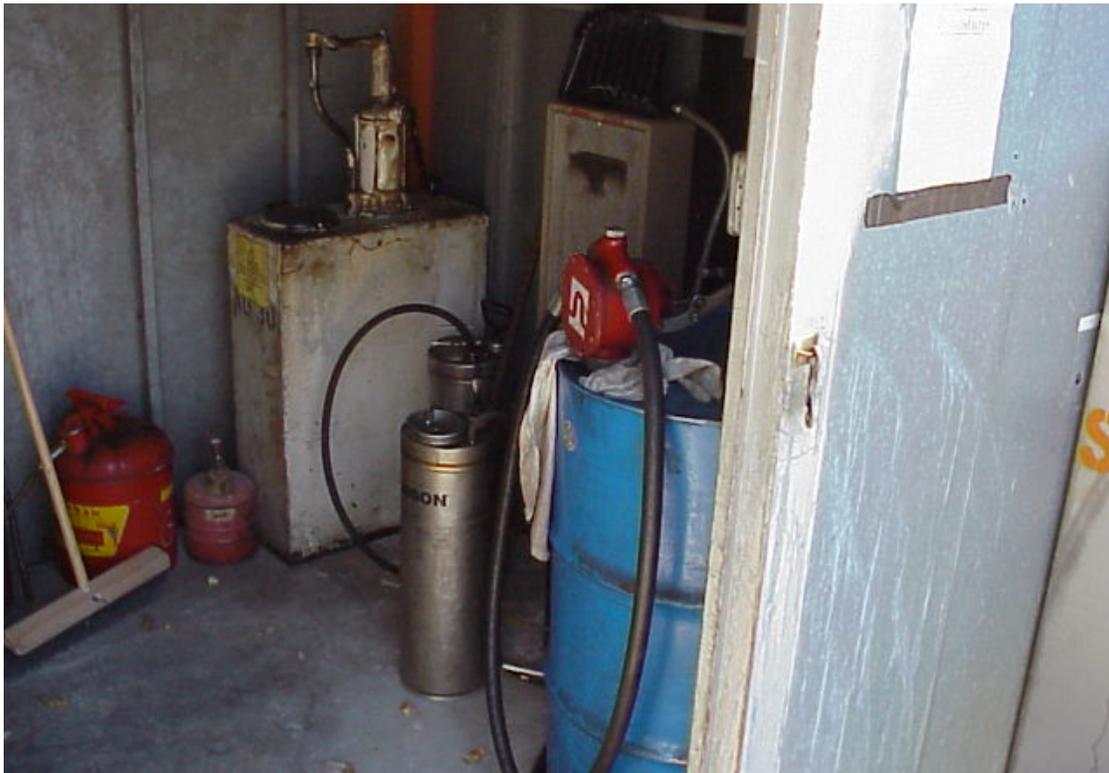
Photo No. 13 Materials Stored Inside the Southern Gas House

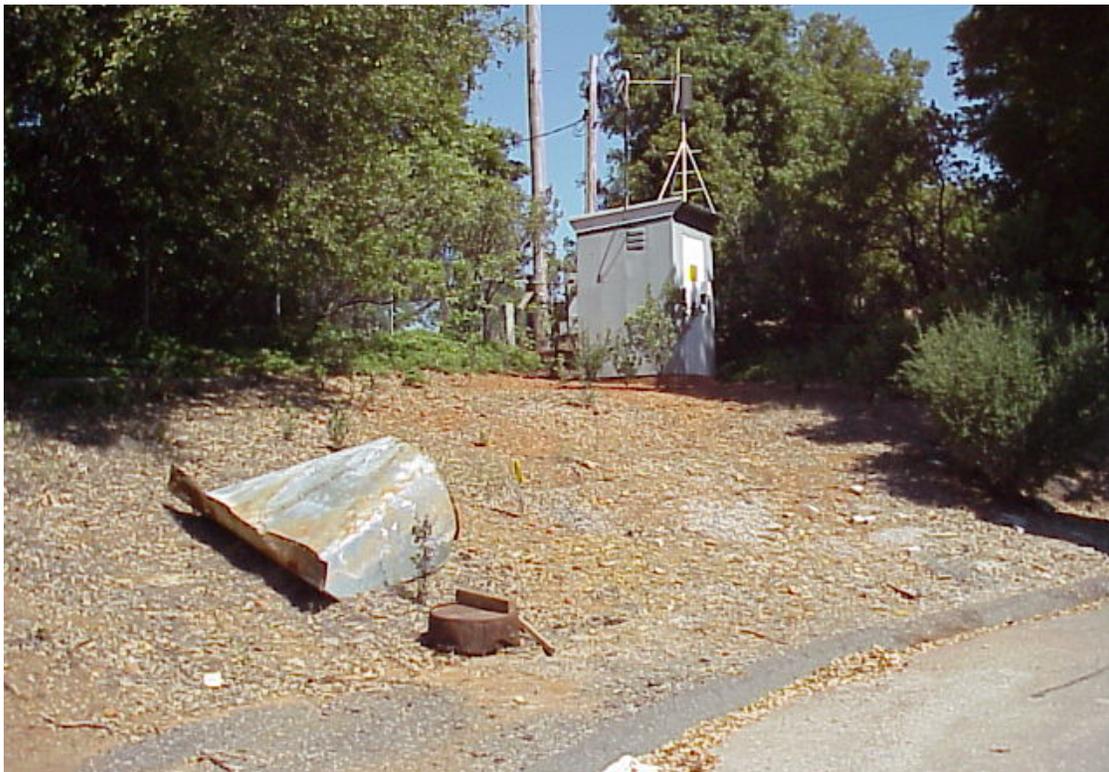
Photo No. 14 Meteorological Shed Located in the Northwest Corner of the Site

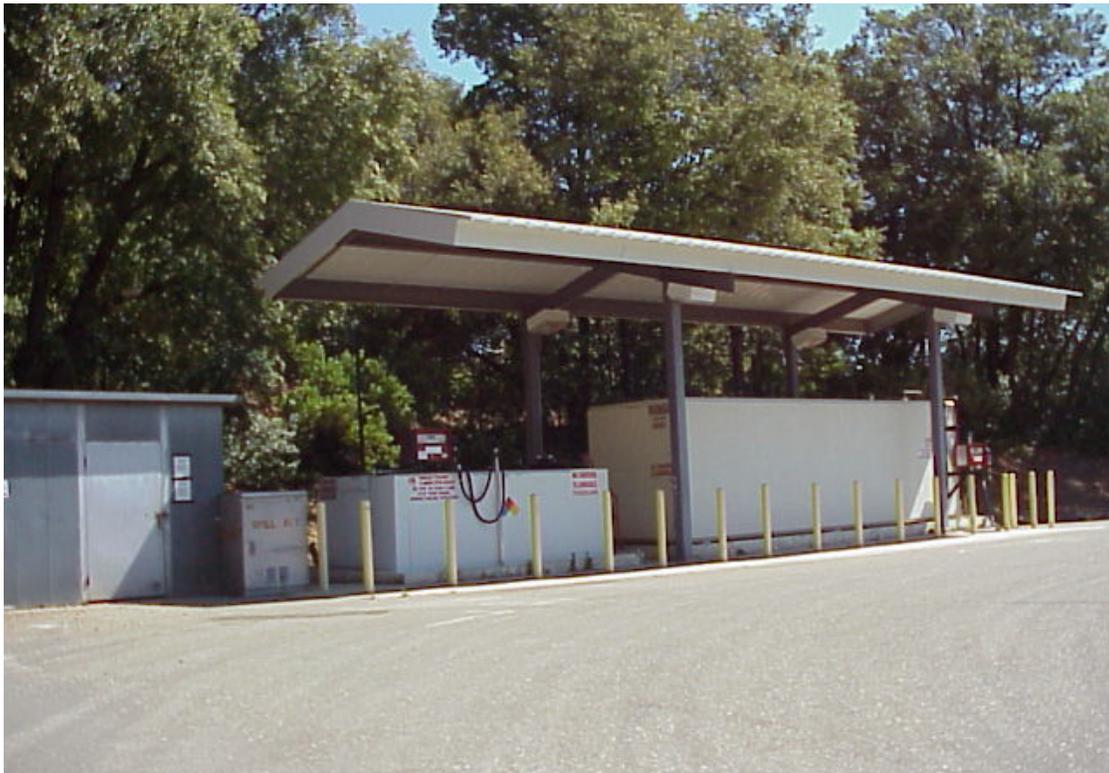
Photo No. 15 (Left to Right) Northern Gas House, Gasoline AST and Diesel AST

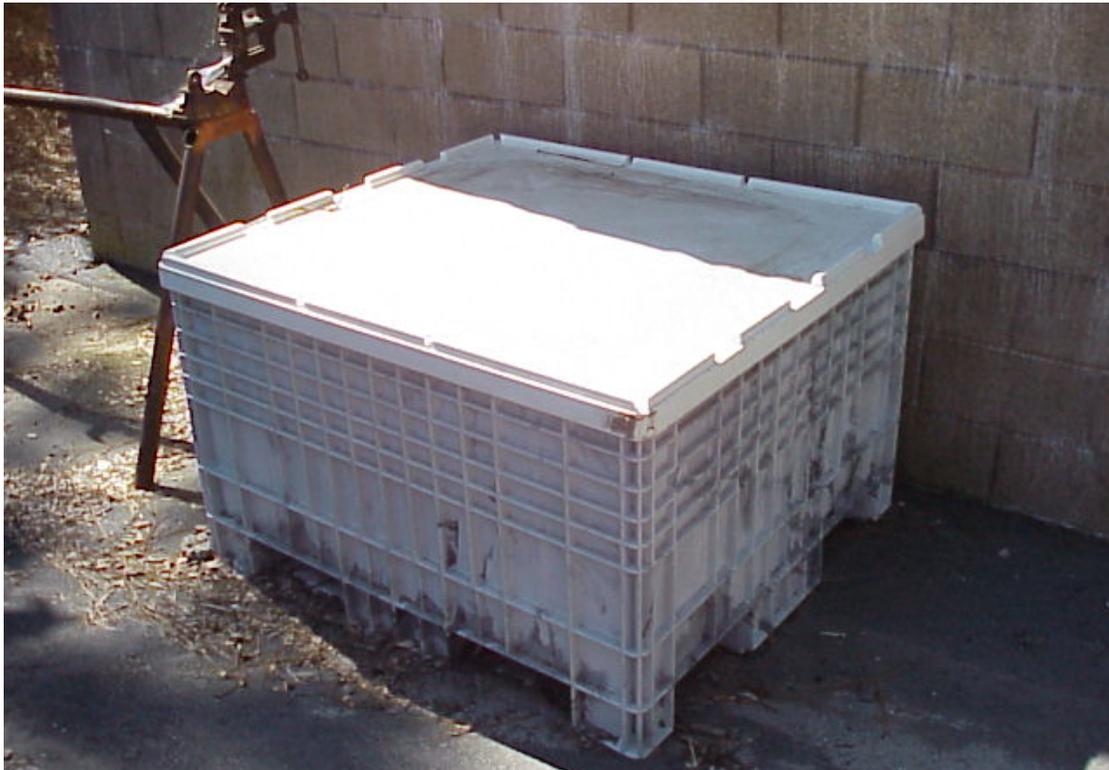
Photo No. 18 Battery Storage Box Located North of the Chemical Storage Building

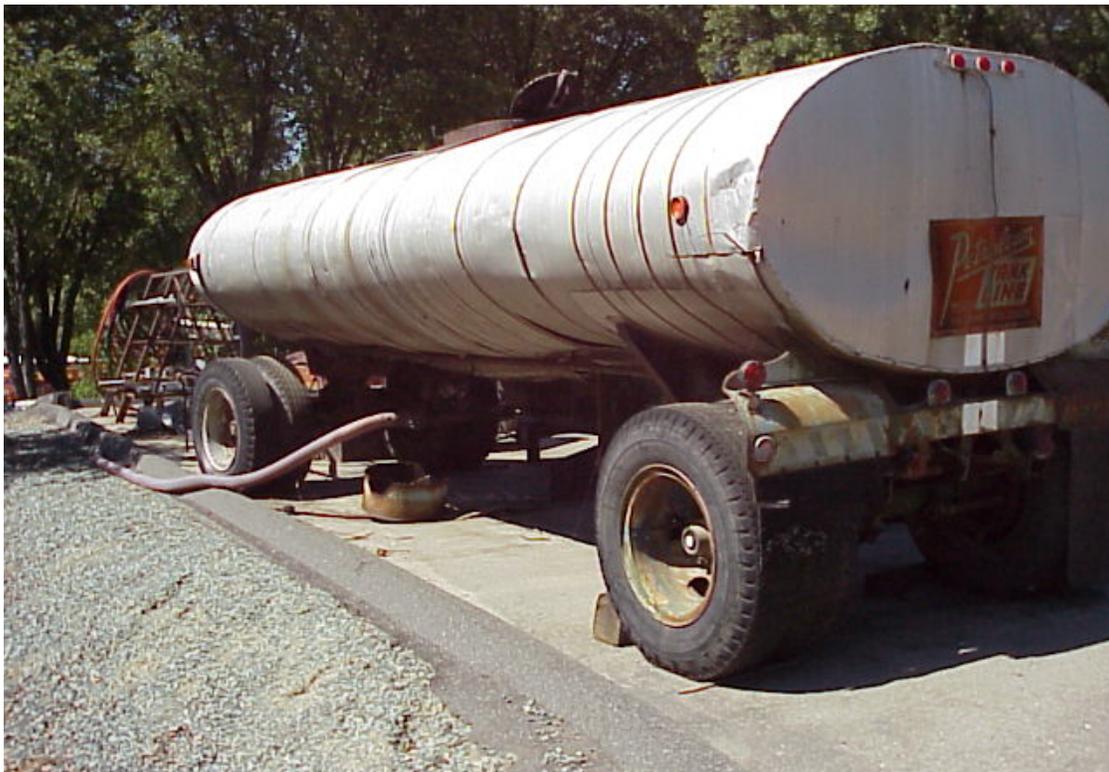
Photo No. 20 Asphalt Crack Sealer Trailer and Hose

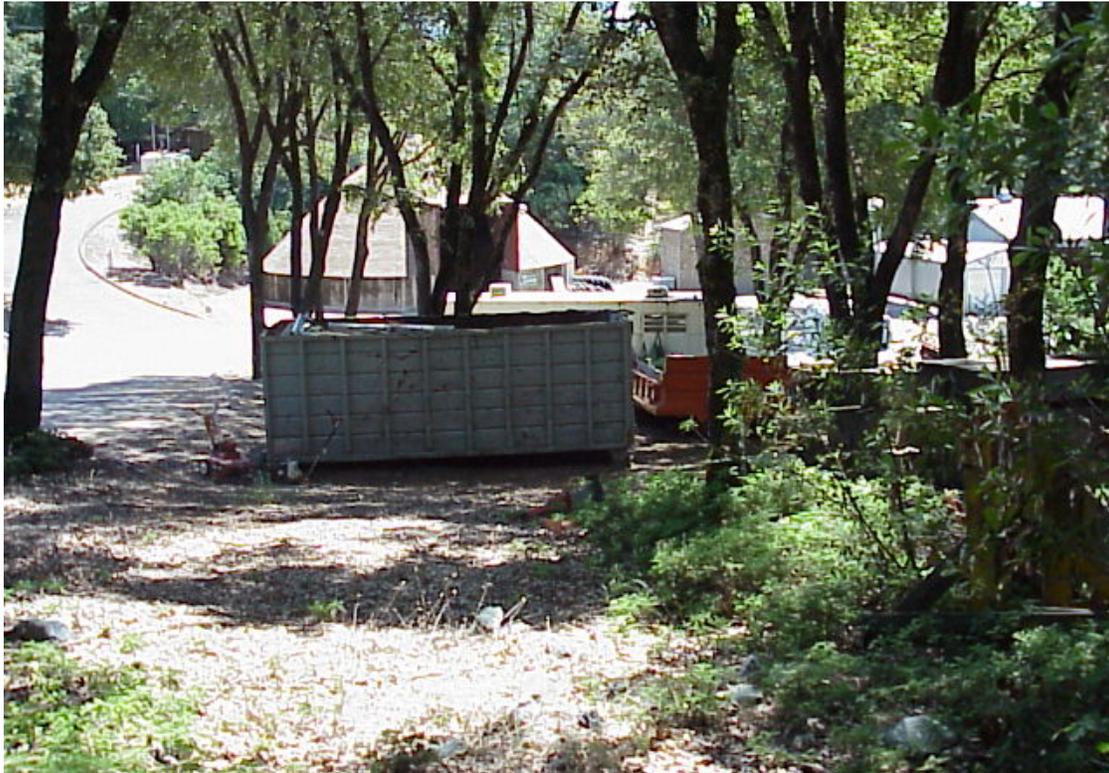
Photo No. 21 Looking East at the Scrap Steel Trash Bin and Wood Timber Storage Area

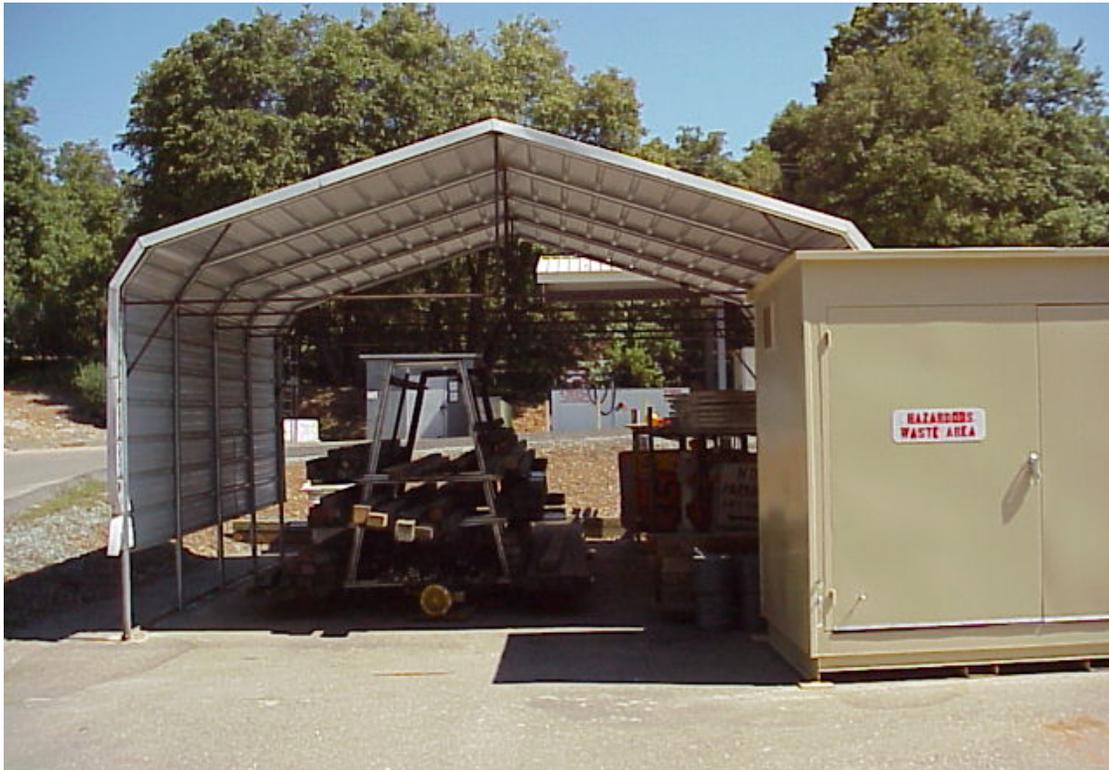
Photo No. 22 Treated Wood Storage Canopy

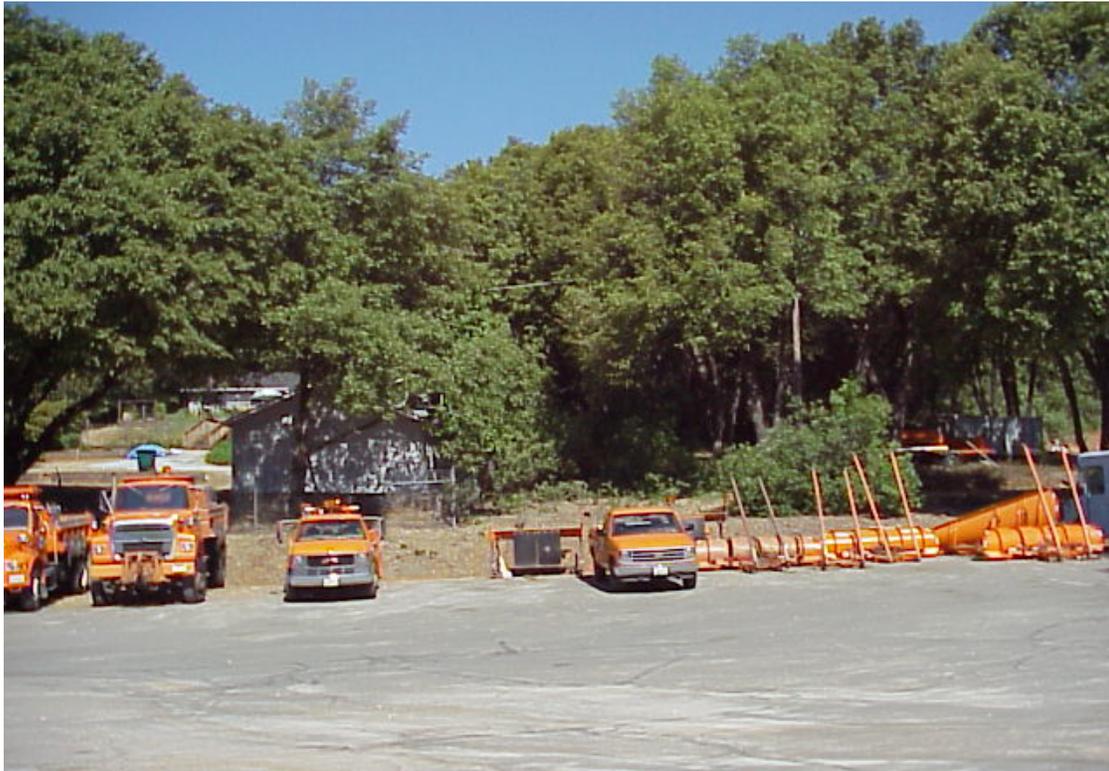
Photo No. 23 Looking West at Vehicle Parking and Material Storage Area

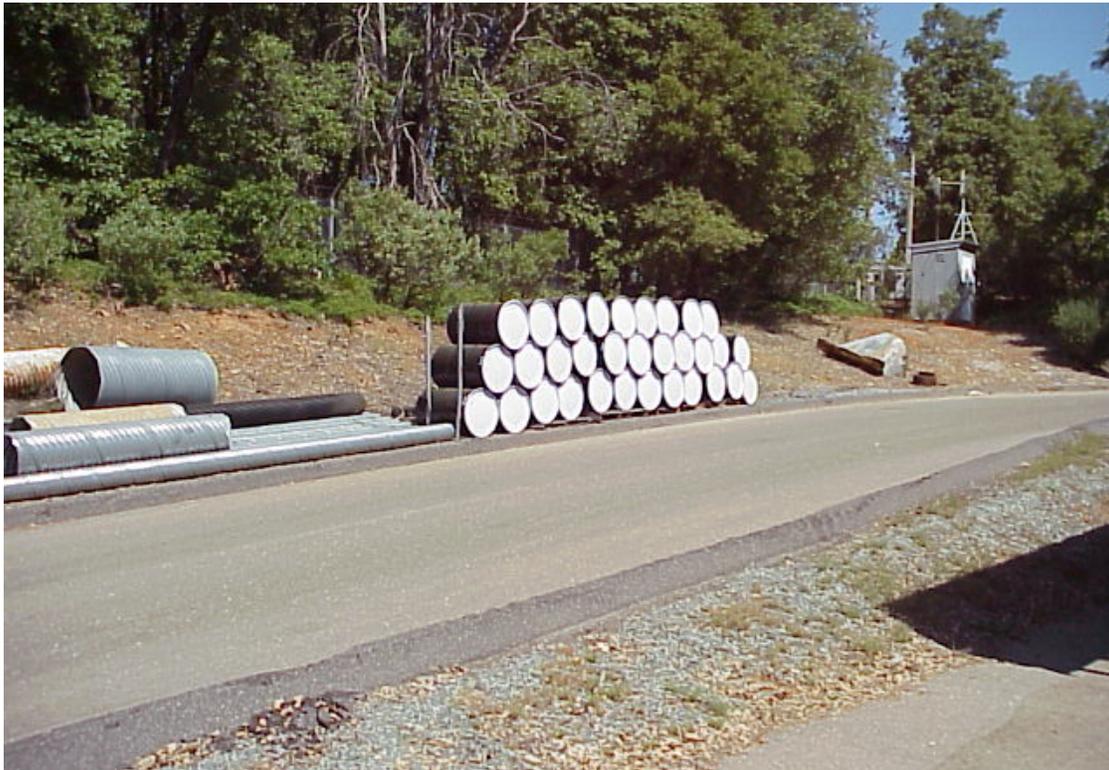
Photo No. 24 Empty Drum and Pipe Storage Areas in the Northwest Corner of the Site
