# INFORMATION HANDOUT

For Contract No. 10-0X2104

# LIMITED ASBESTOS AND DETERIORATED LEAD-CONTAINING PAINT SURVEY REPORT

District 10 Maintenance Stations  
Camp Connell, Peddler Hill,  
and Woodfords, California

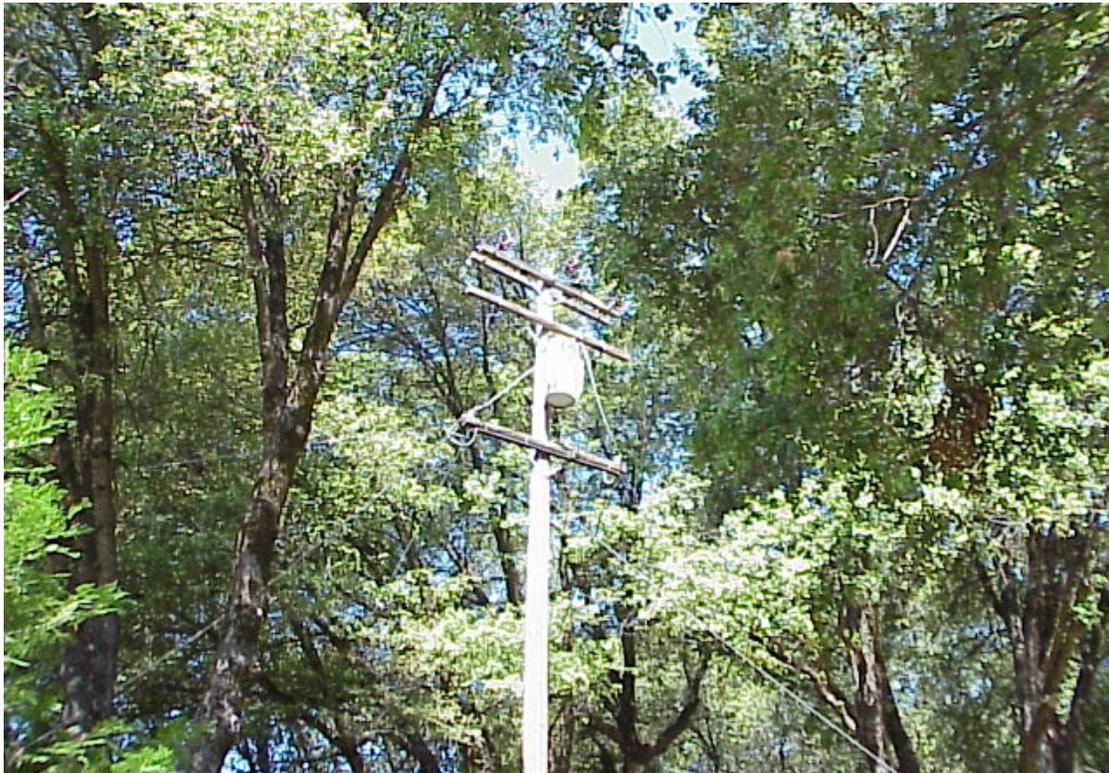
Photo No. 26 Pole-Mounted Transformer Located on the Western Site Boundary

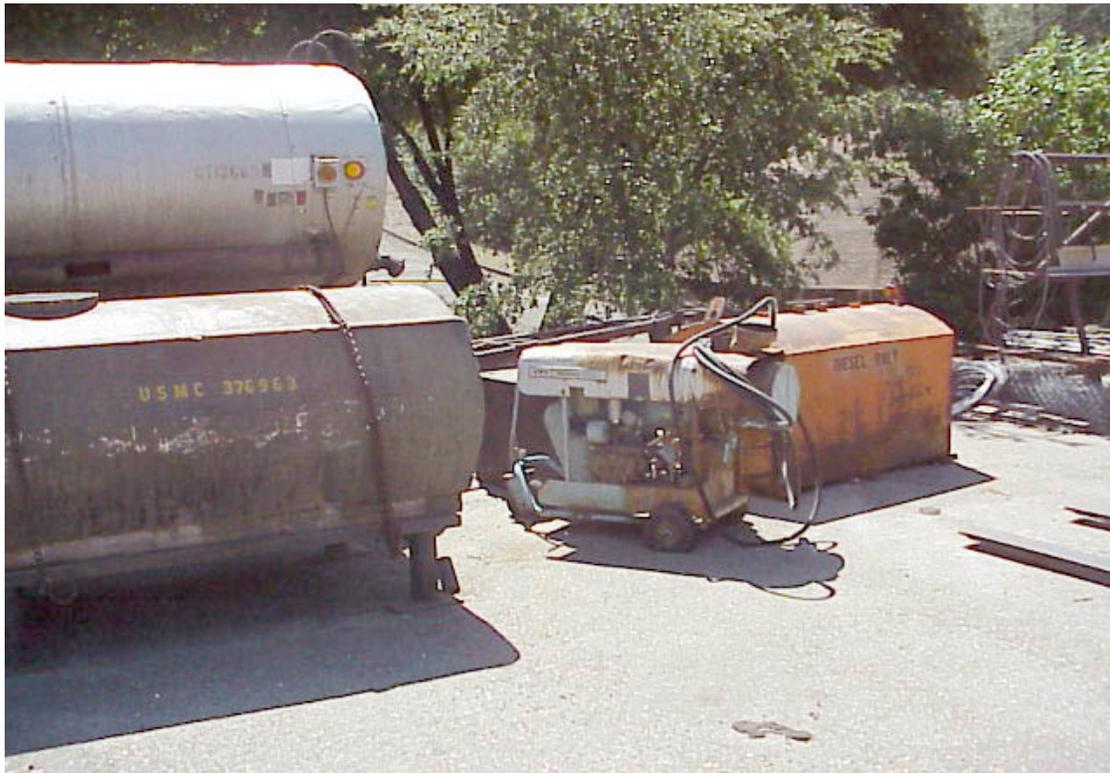
Photo No. 27 Water AST, Hydraulic Oil AST and Diesel AST Located South of the Asphalt Crack Sealer Trailer

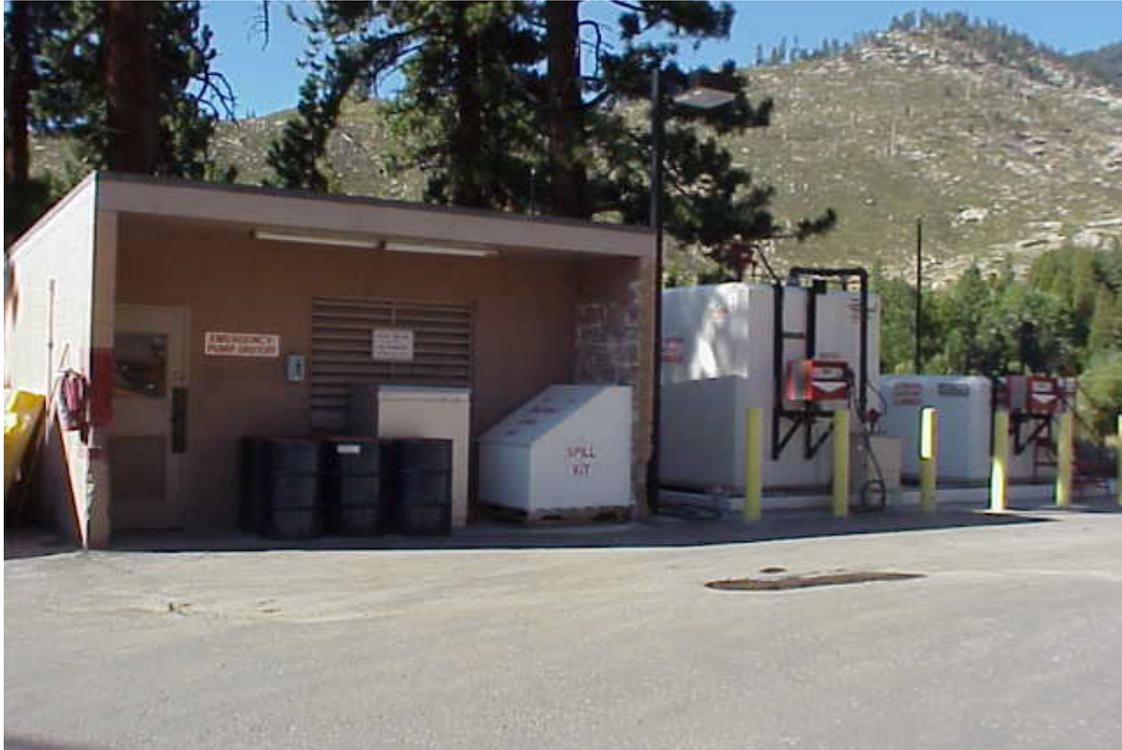
Photo No. 13 Looking South at the Gas House and Diesel (Left) and Gasoline (Right) ASTs

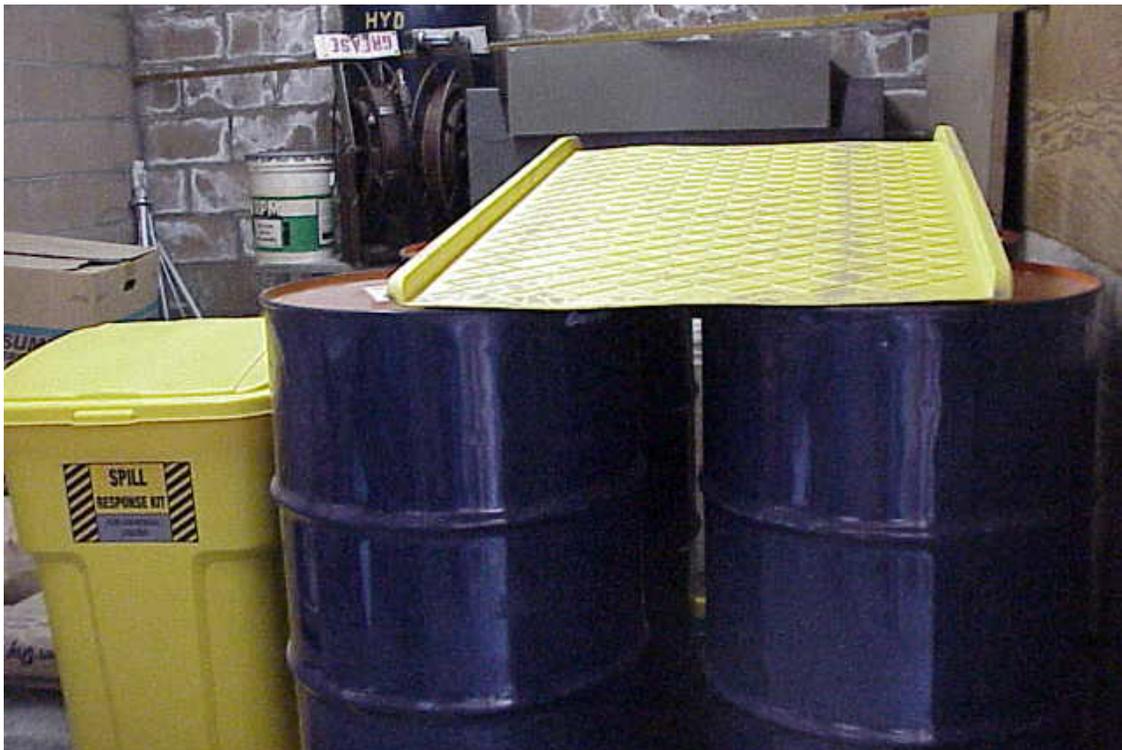
Photo No. 14 Spill Kit, Petroleum Drums and Equipment in the Gas House

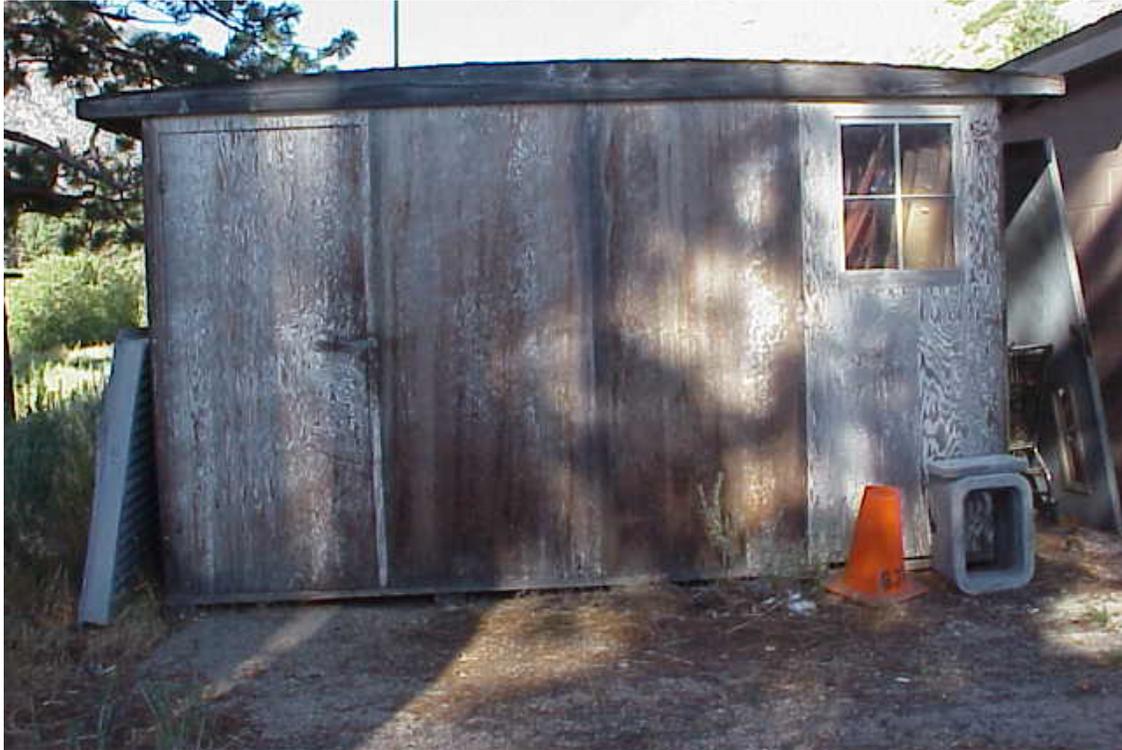
Photo No. 15 Engineers Building Located South of the Gas House

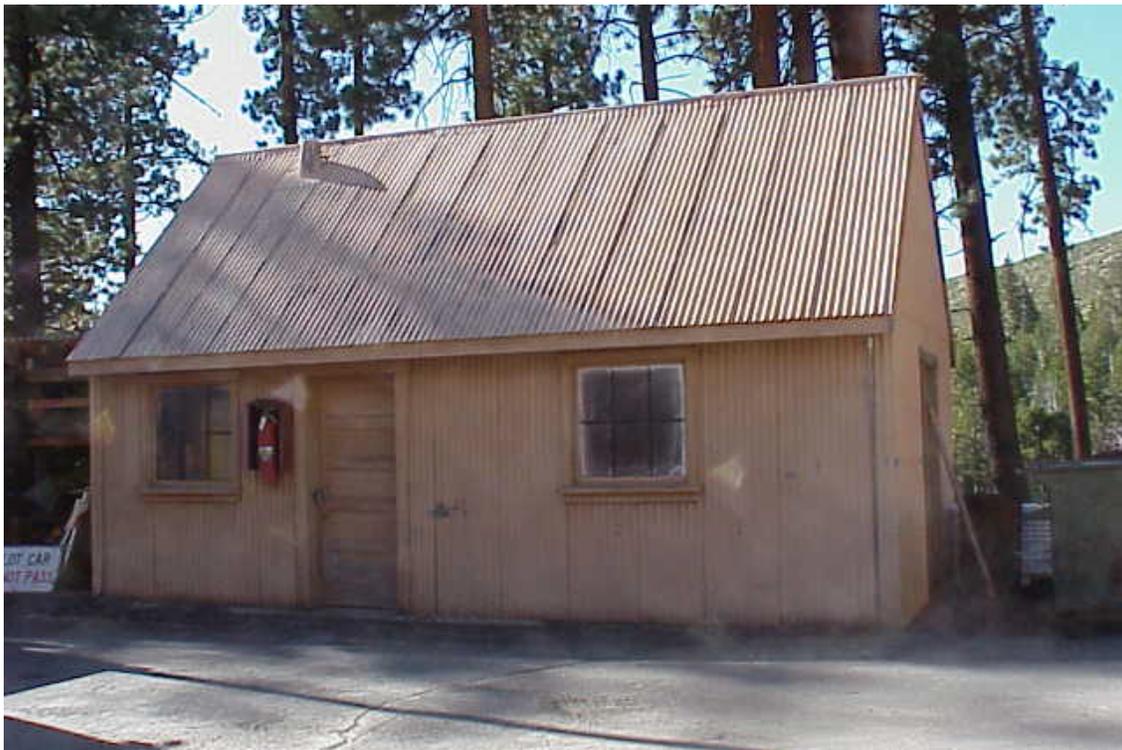
Photo No. 16 Sign House

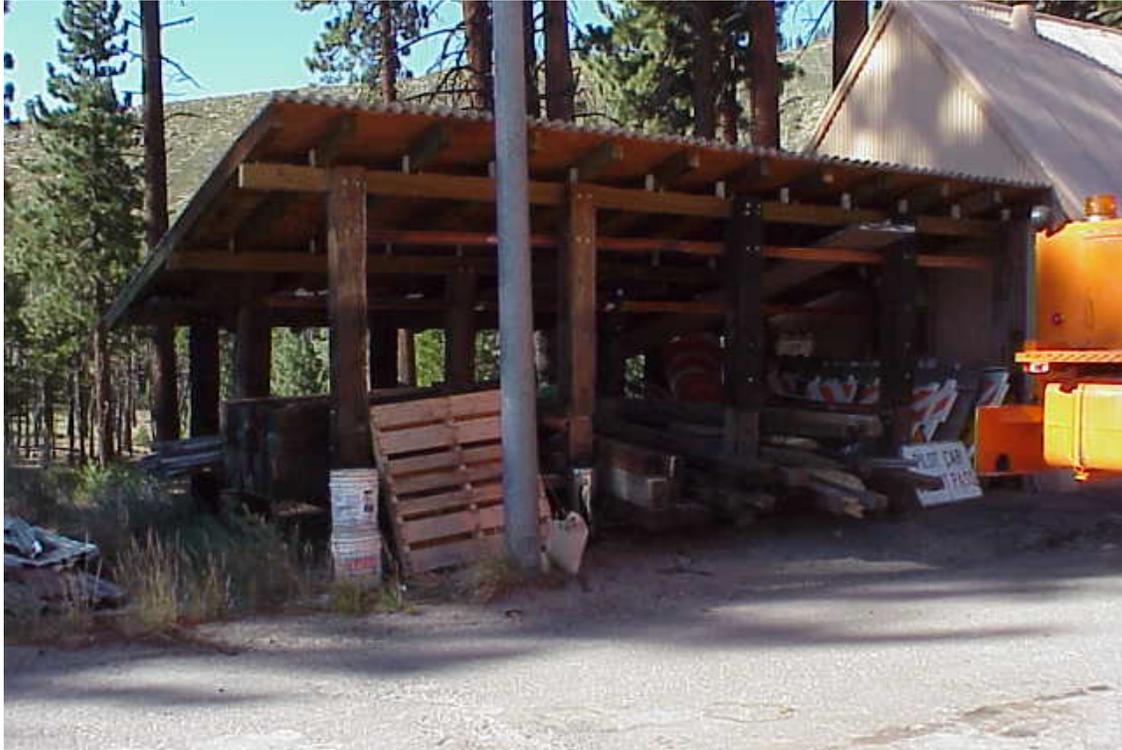
Photo No. 17 Looking South at the Treated Wood Storage Located Adjacent and East of the Sign House

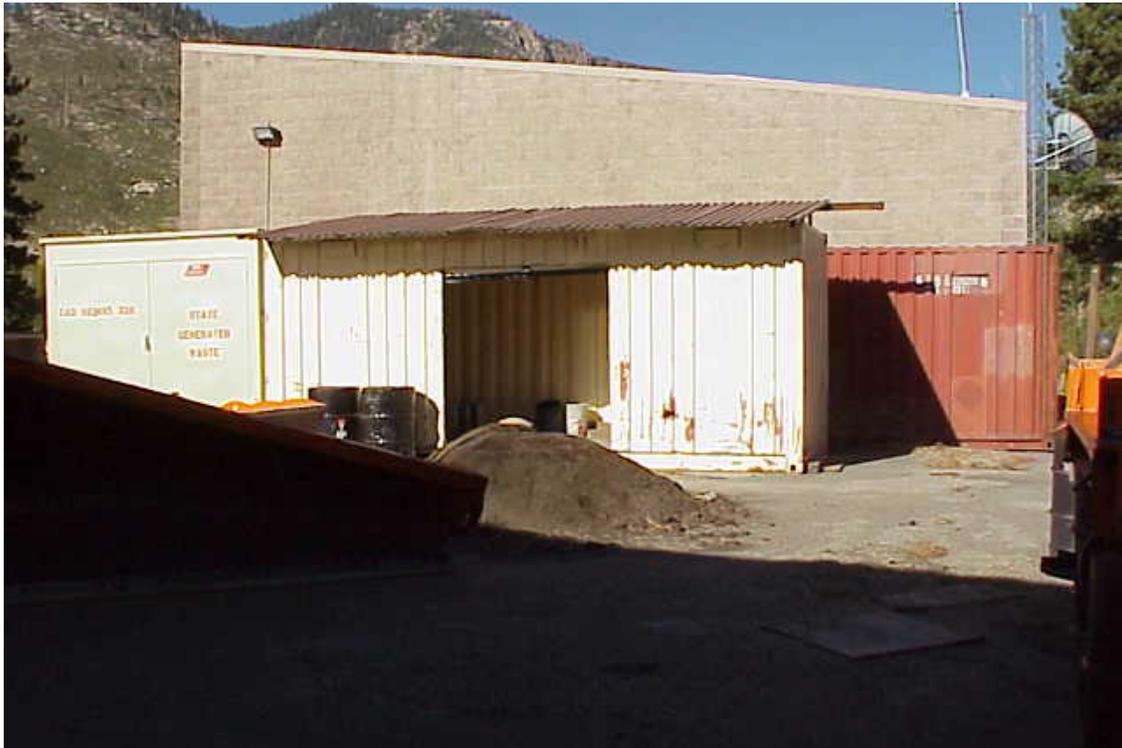
Photo No. 18 Hazardous Materials Storage Container, Sign Storage Container and Sealand Container (Left to Right), Located Northeast of the Equipment Building

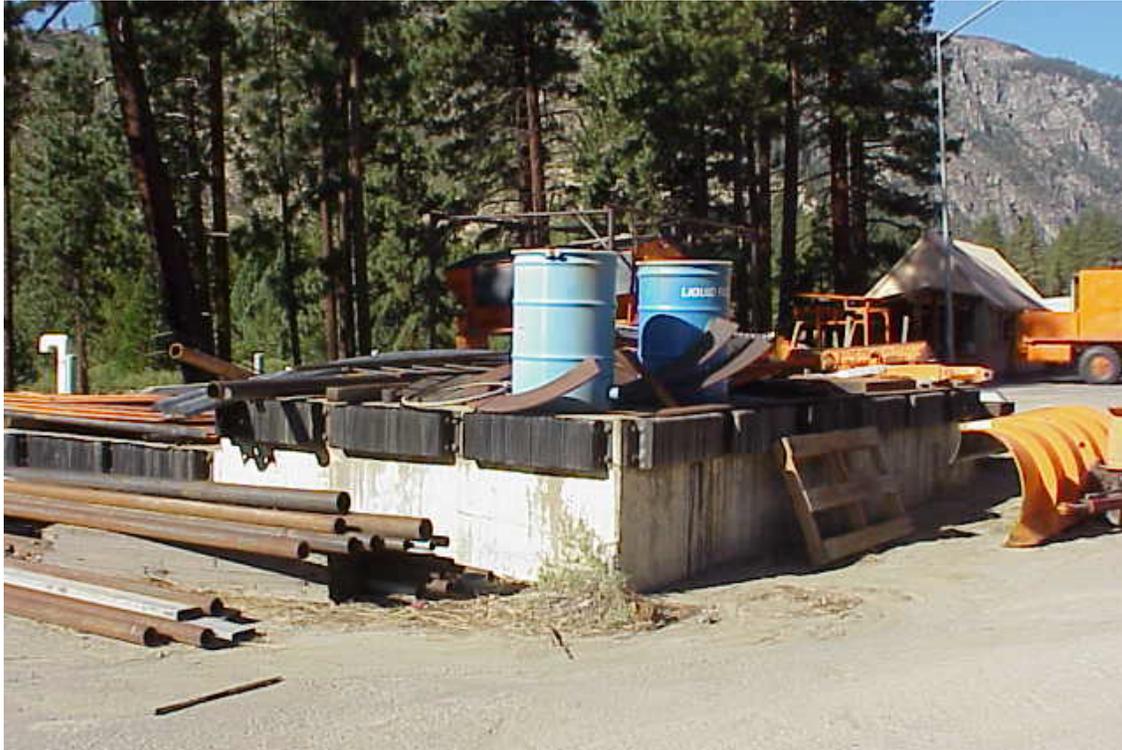
Photo No. 19 Looking South at the Loading Dock and Steel Piping

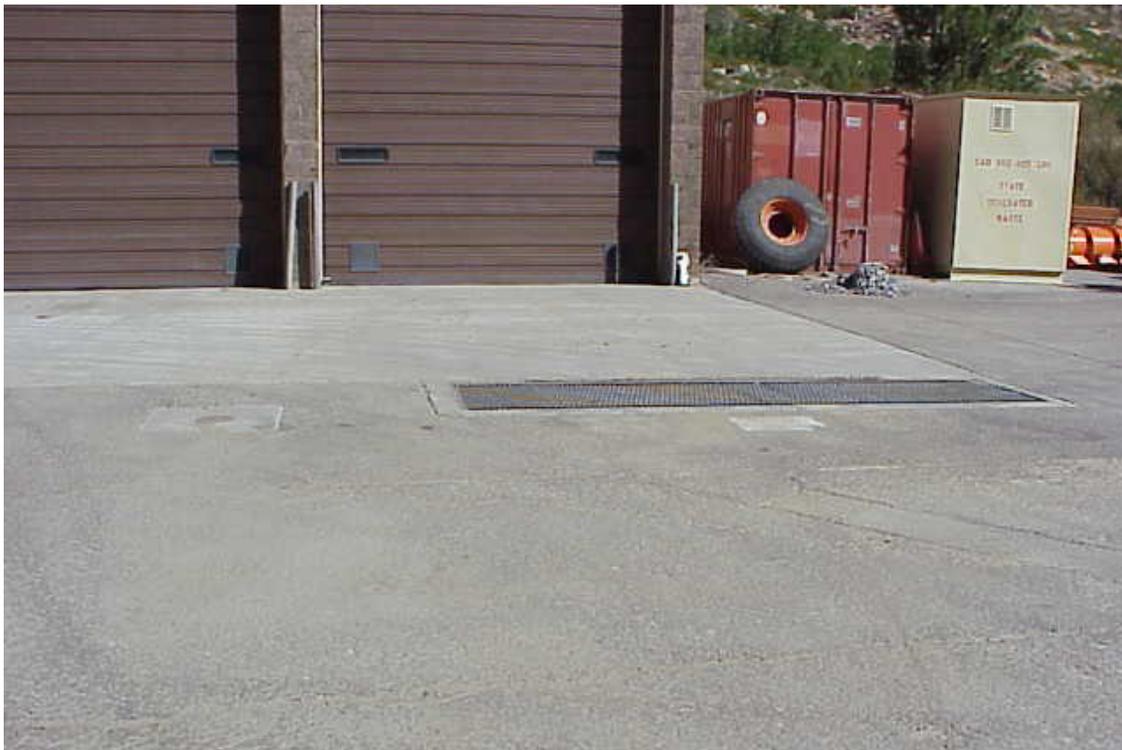
Photo No. 20 Looking North at the Mud Rinse Slab, Equipment Building and Storage Container

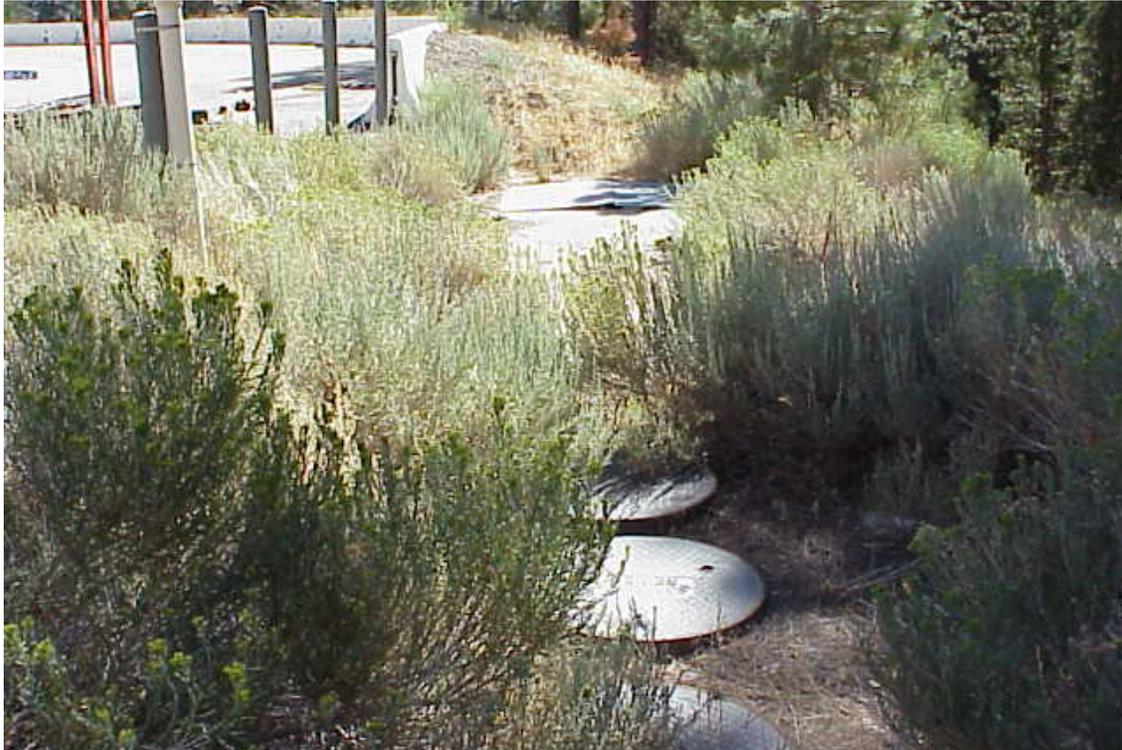
Photo No. 21 Looking East at the Water Treatment System Location

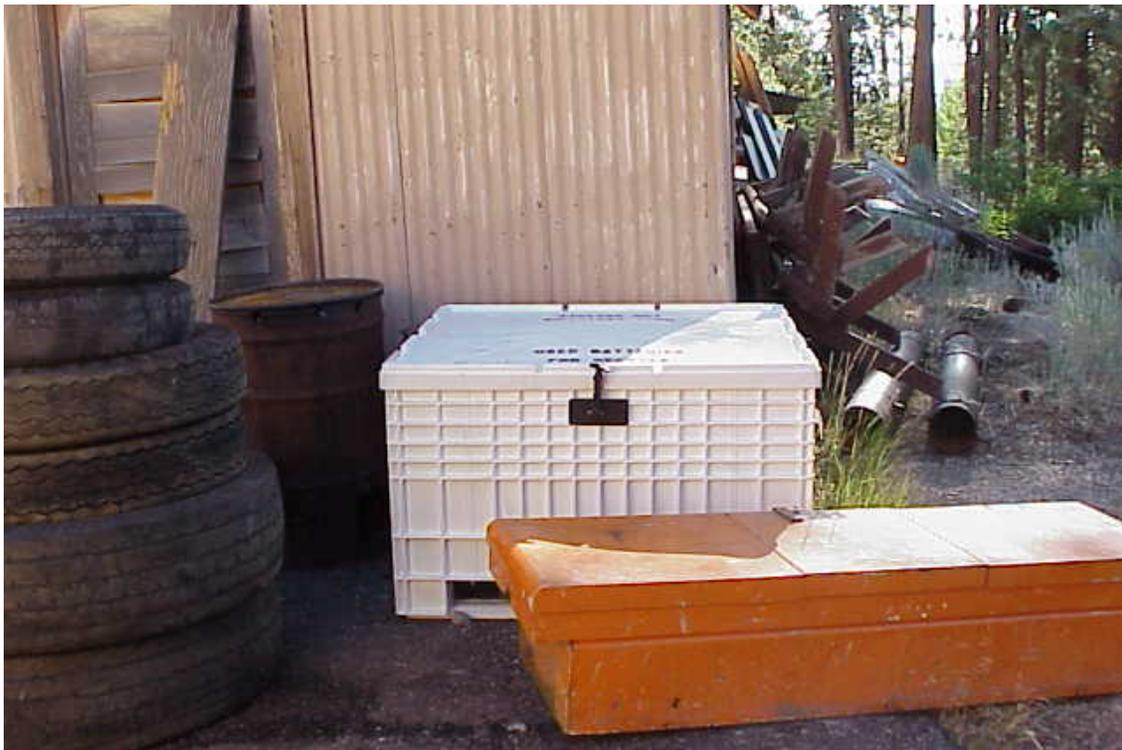
Photo No. 22 Tires, Debris and Battery Storage Container Located Southwest of the Sign House

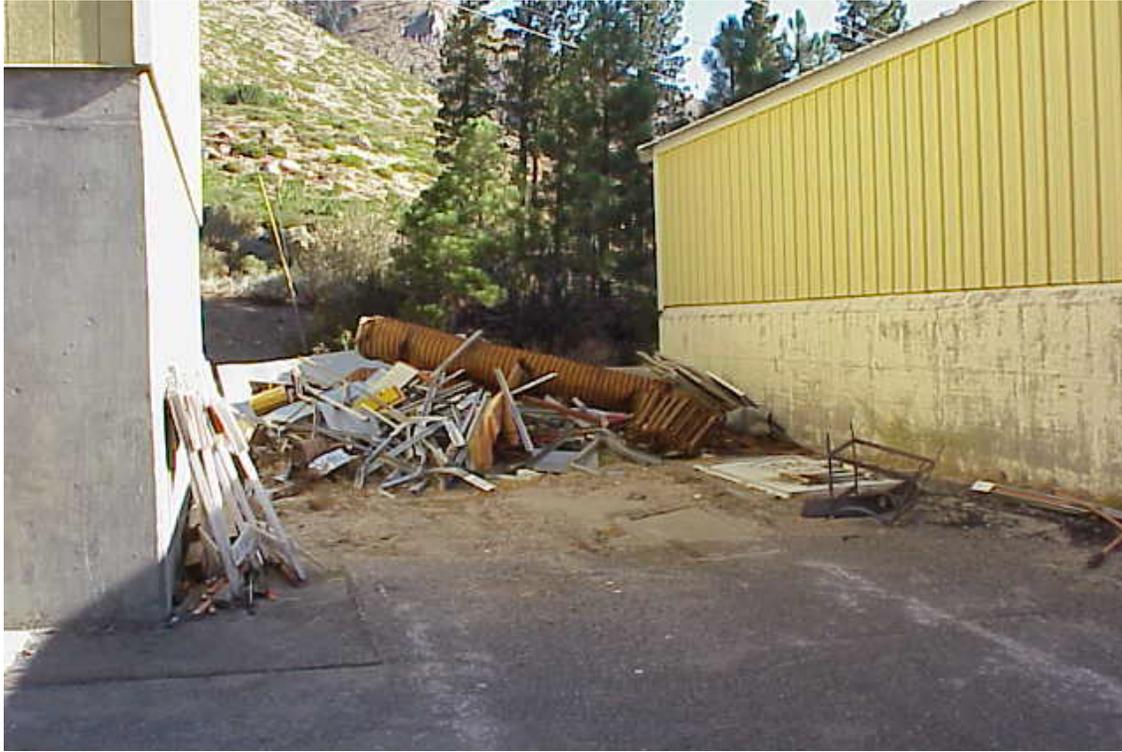
Photo No. 23 Looking North at Plastic Piping and Wood Debris Located Between the Salt and Sand Storage Buildings

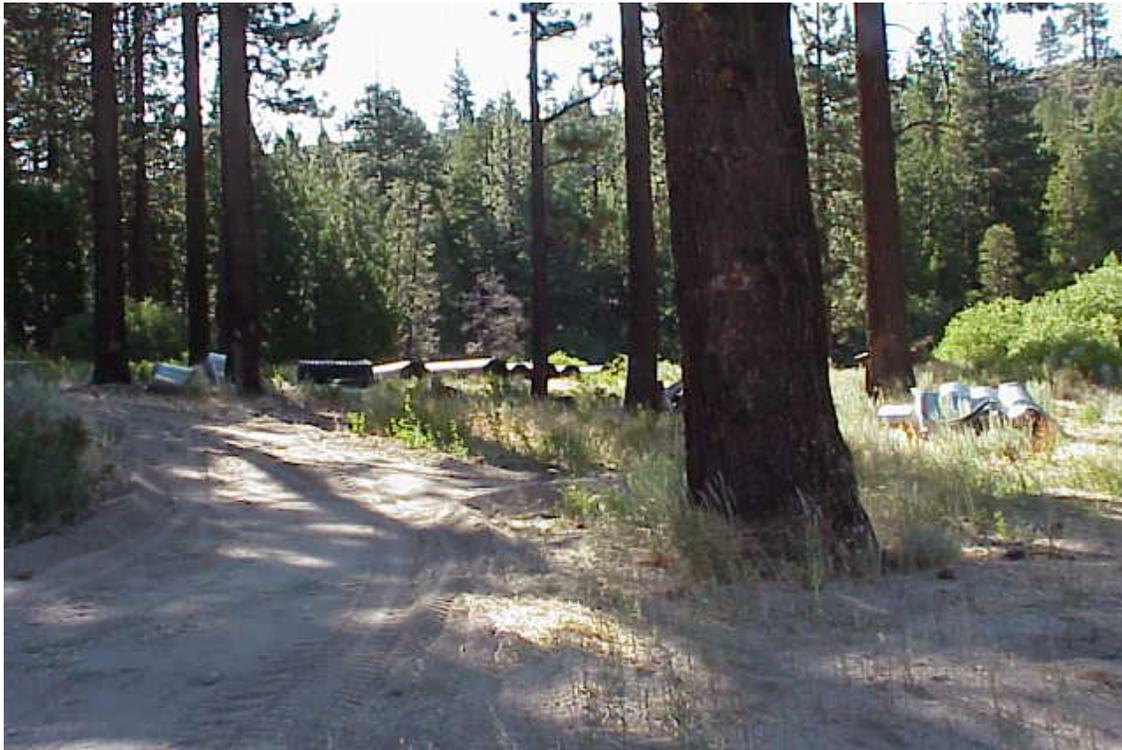
Photo No. 24 Looking East at Piping Located on the Southern Portion of the Site

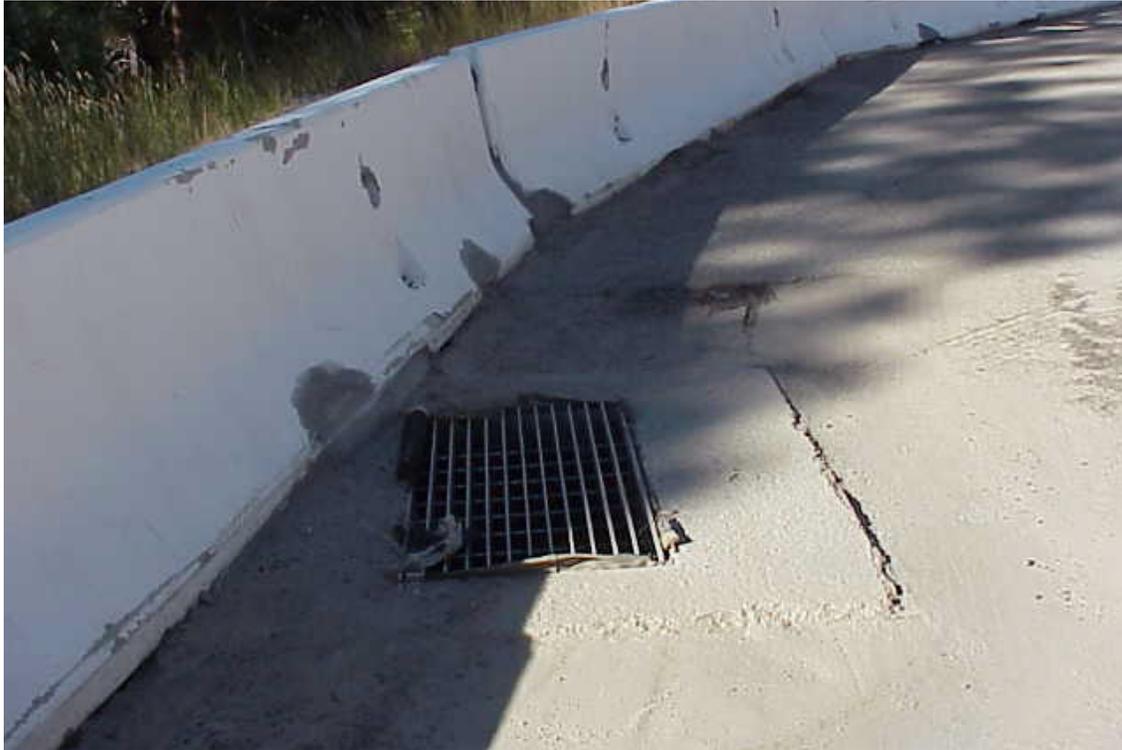
Photo No. 25 Looking South at the Drain Inlet Located in the Eastern Portion of the Site

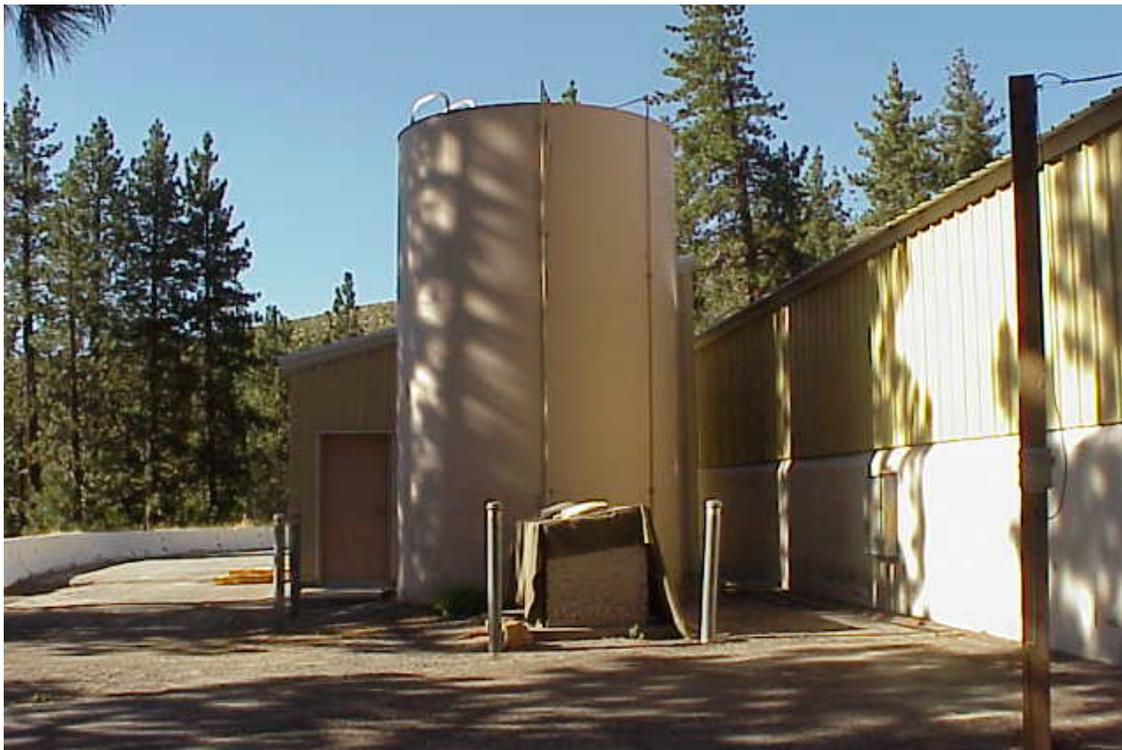
Photo No. 26 Looking South at the Domestic Water Well, Water Storage AST and Pressure Tank Building (Forefront to Back) and the Sand Storage Building to the Right

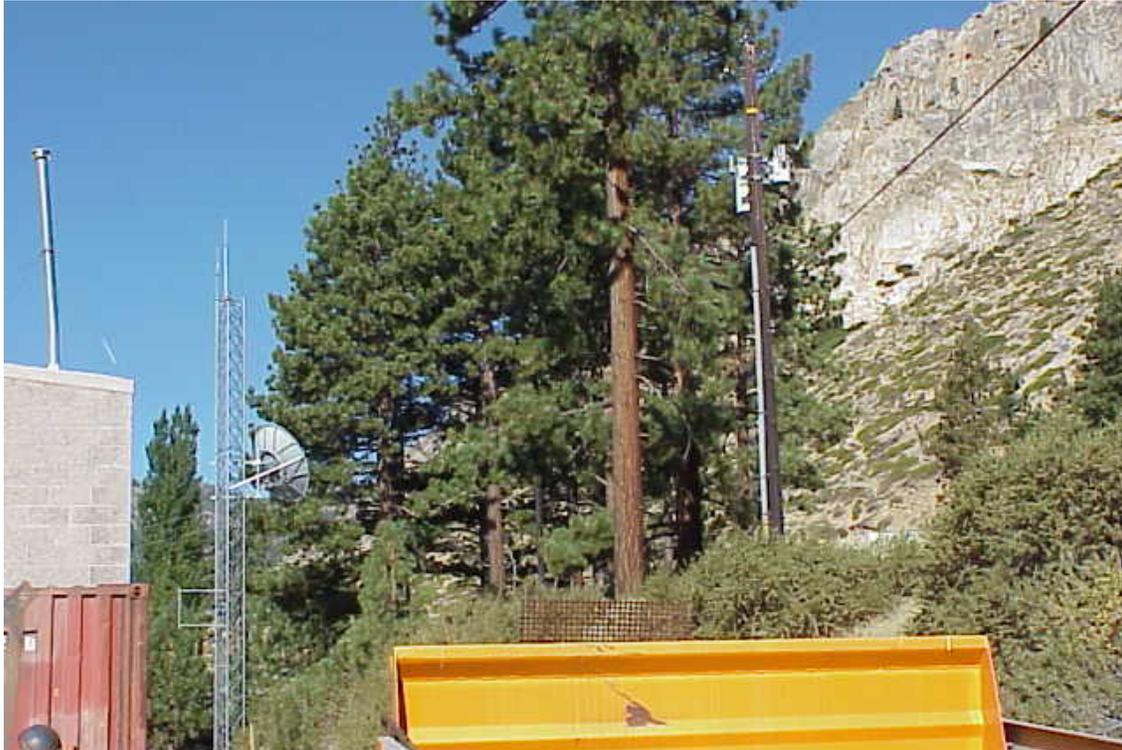
Photo No. 27 Looking West at the Radio Tower and Pole-Mounted Transformer Located North of the Equipment Building

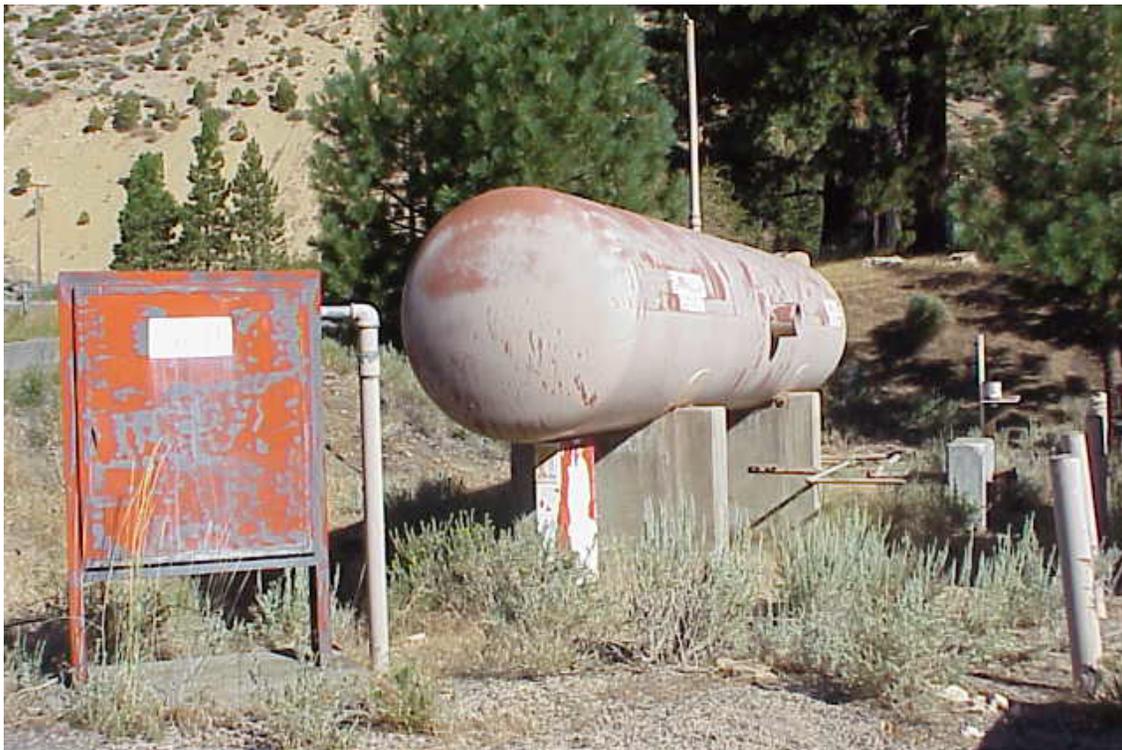
Photo No. 28 Looking Northwest at the LPG AST

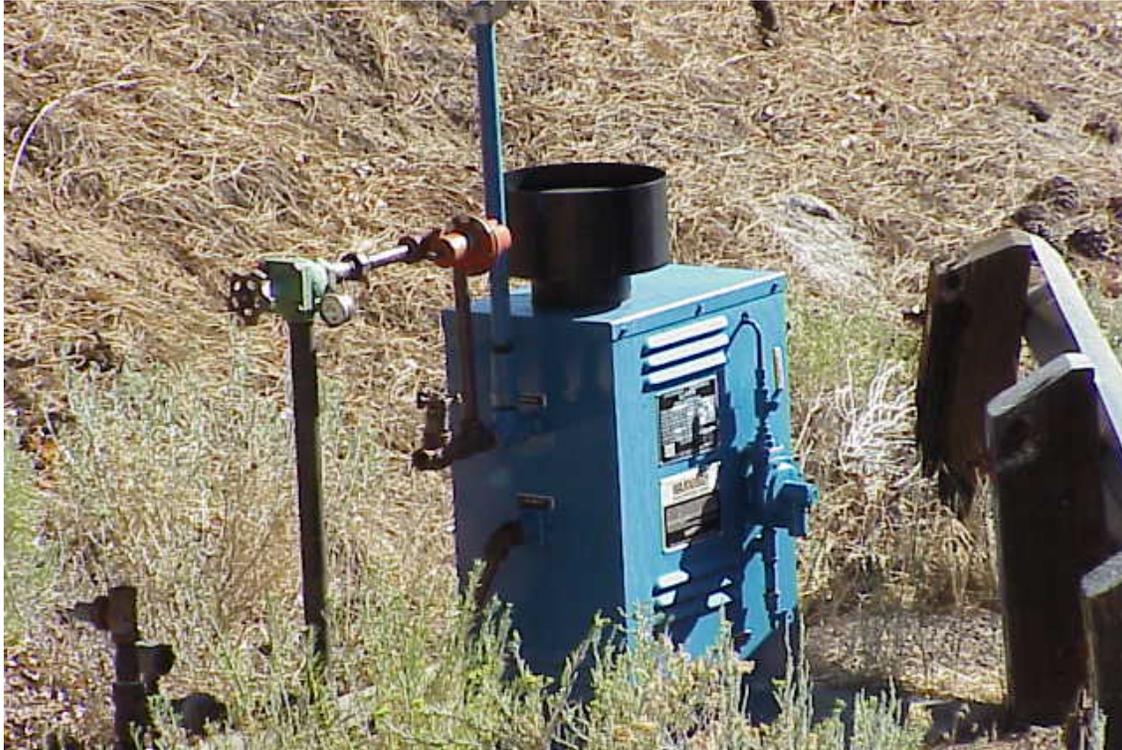
Photo No. 29 Burner Unit Associated With the LPG AST

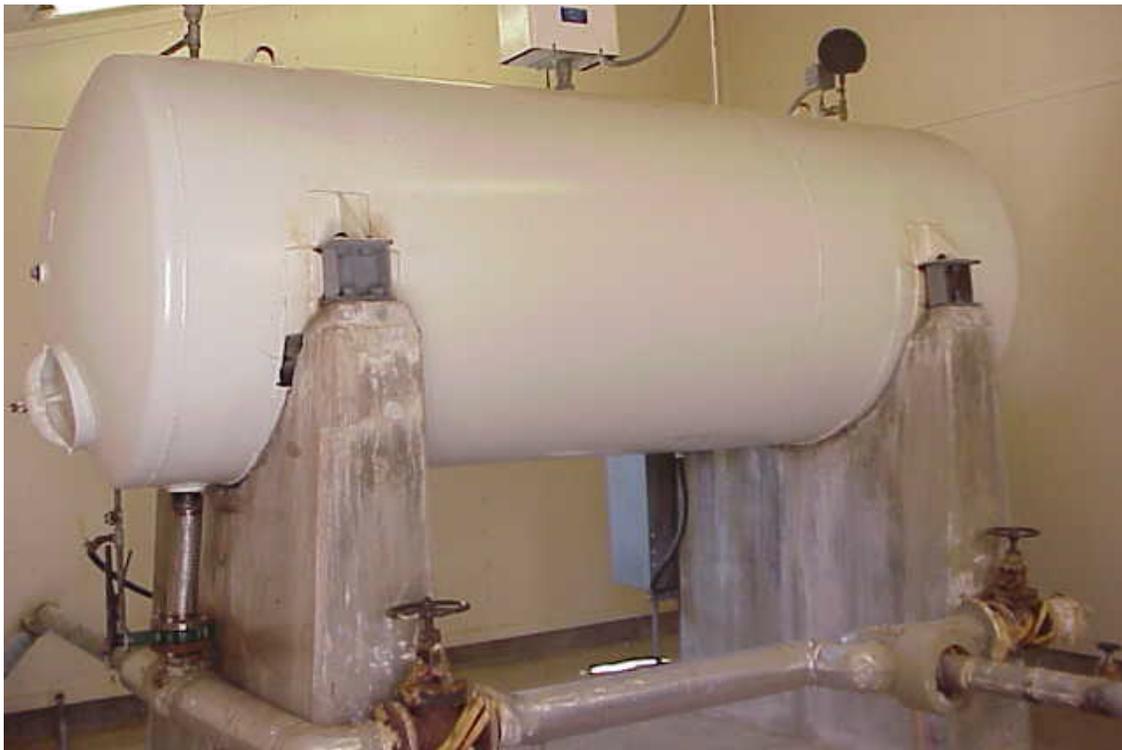
Photo No. 30 Water Pressure AST Located in the Water Pressure Building

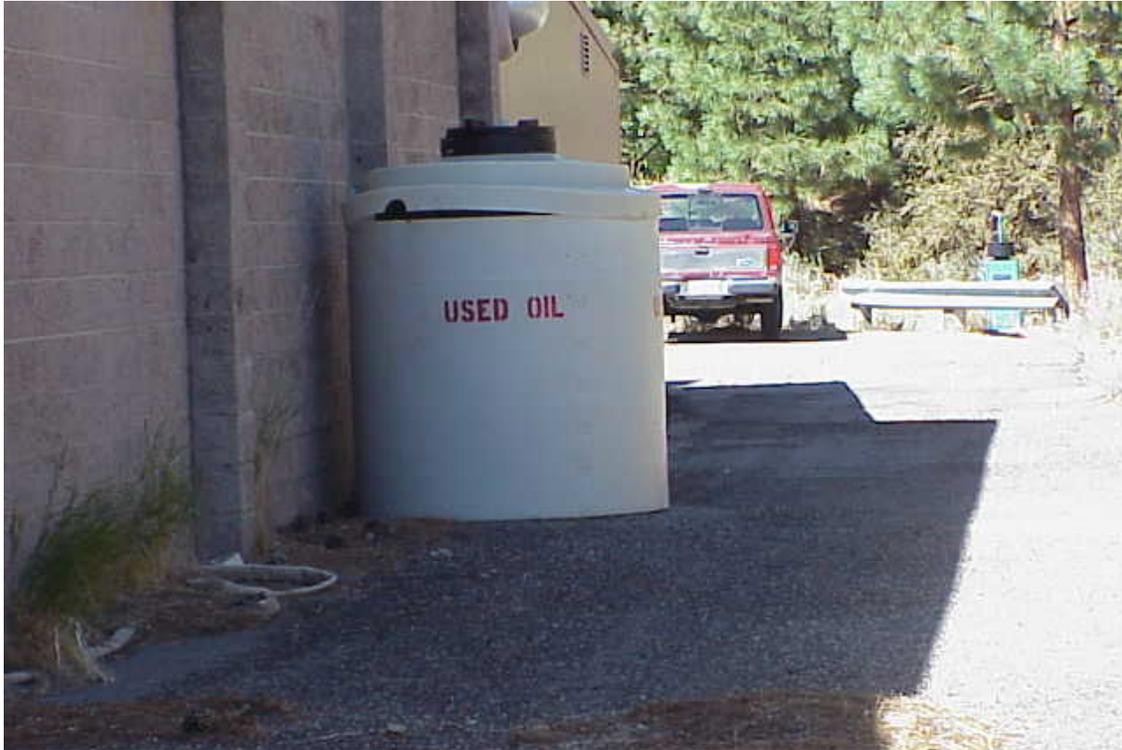
Photo No. 31 Out of Service Waste Oil AST Located North of the Equipment Building
